## Building pathologies. Analysis of three case studies

Michela Monaco<sup>1</sup>, Immacolata Bergamasco<sup>2</sup>, Antonino Iannuzzo<sup>3</sup>, Antonio Gesualdo<sup>4</sup>,

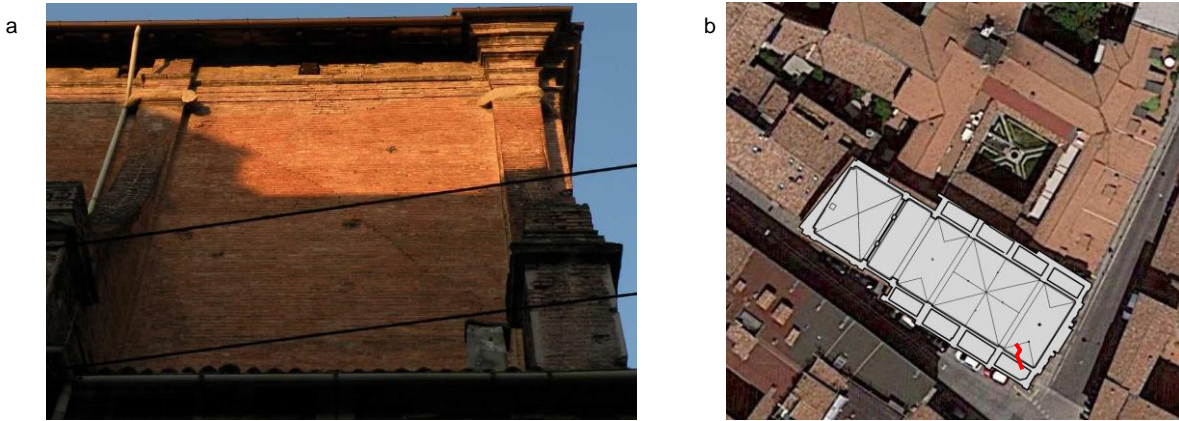
**Figure 2.** (a) Diagonal crack in the masonry wall at the second level; (b) Position of the Church and its surroundings.

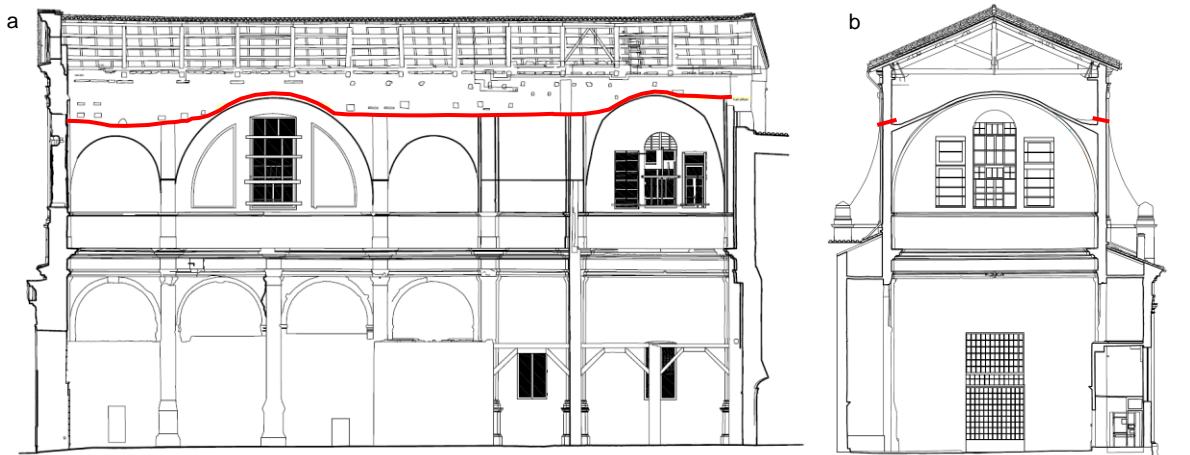
**Figure 3.** (a) Longitudinal section of San Barbaziano Church; (b) Transversal section of the Church.

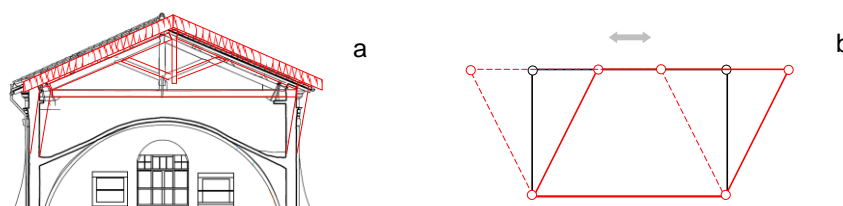
**Figure 4.** (a) Possible nave mechanism; (b) structural scheme.

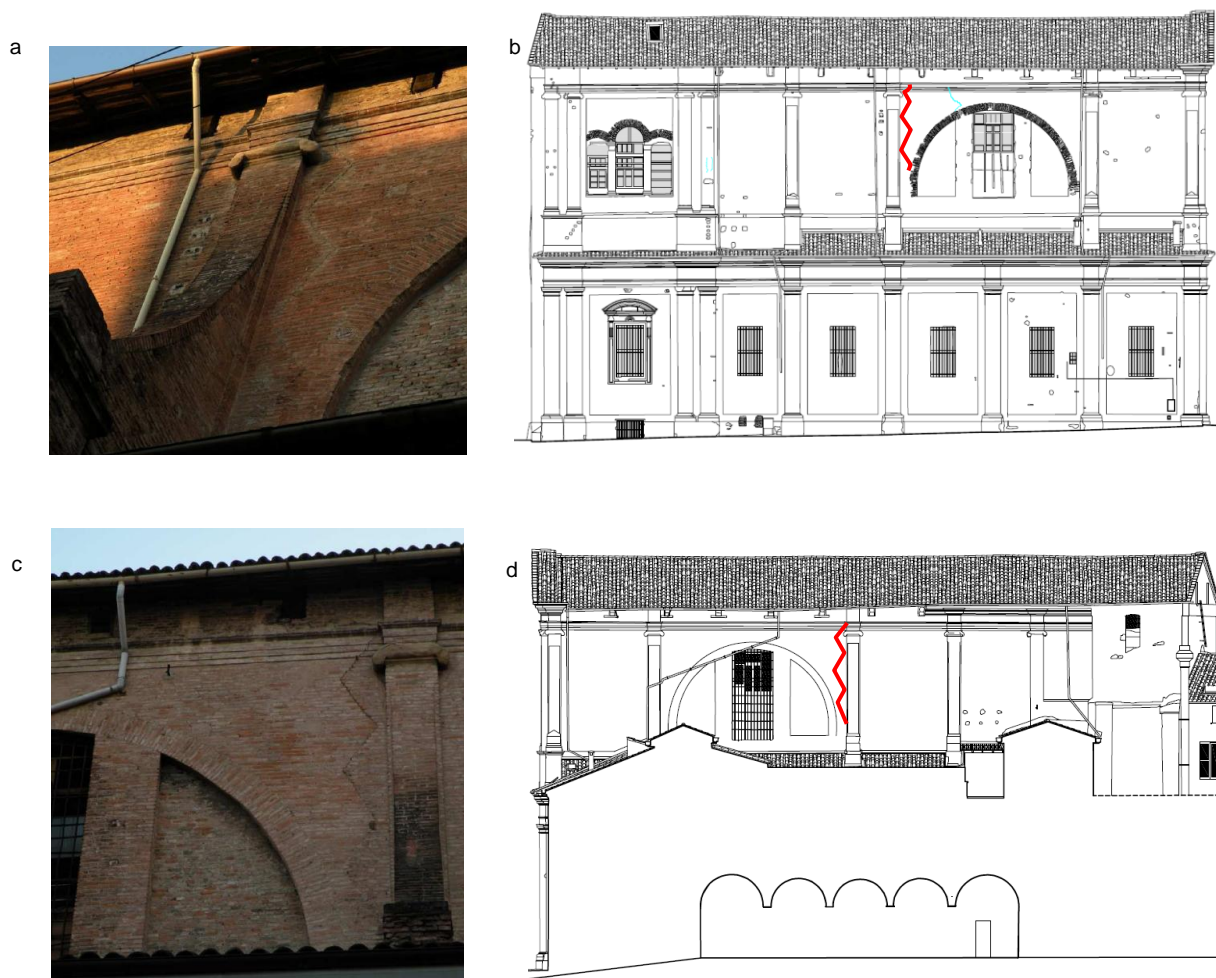
**Figure 5.** (a, c) Bad masonry tothing; (b, d) Position of the tothing.

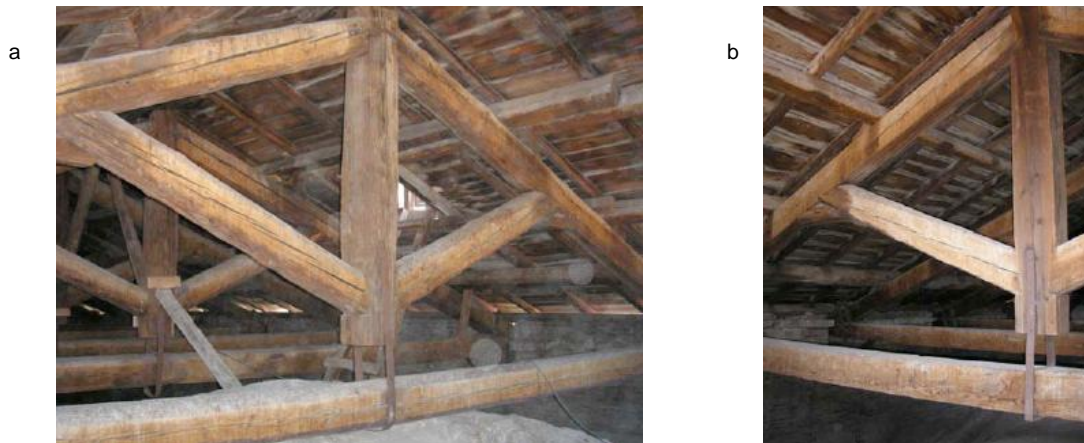
**Figure 6.** (a) Circular cross sections; (b) rectangular cross sections.

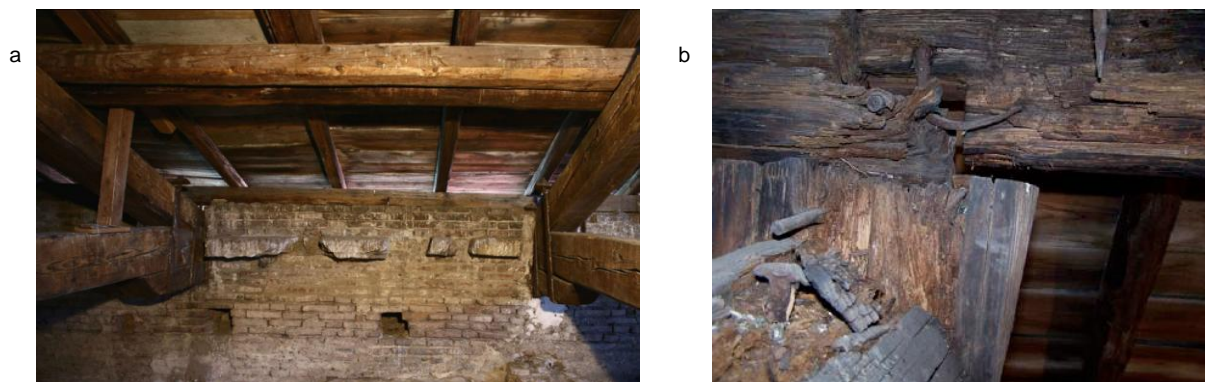
**Figure 7.** (a) Truss end supports; (b) Post-rafters connection

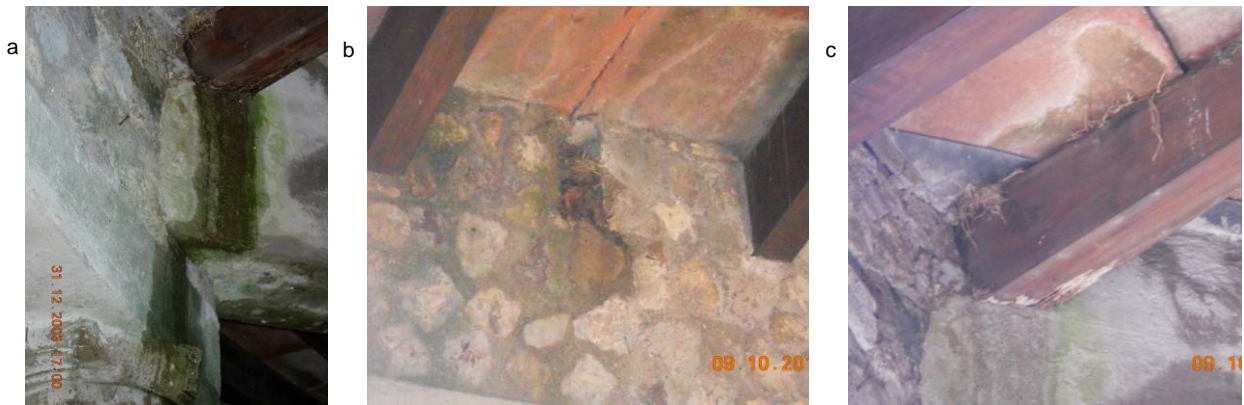
**Figure 8.** (a) Rafter end support before collapse; (b) End support after collapse; (c) Actual end support conditions of the remaining rafters

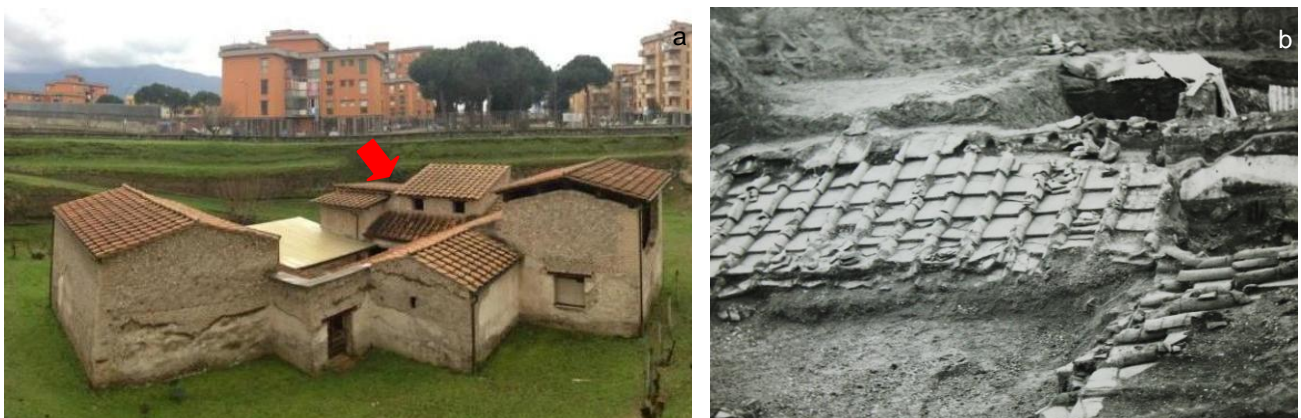
**Figure 9.** (a) General north view of the Villa; (b) The excavation of Villa Regina: detail of the original *porticus* roofing.

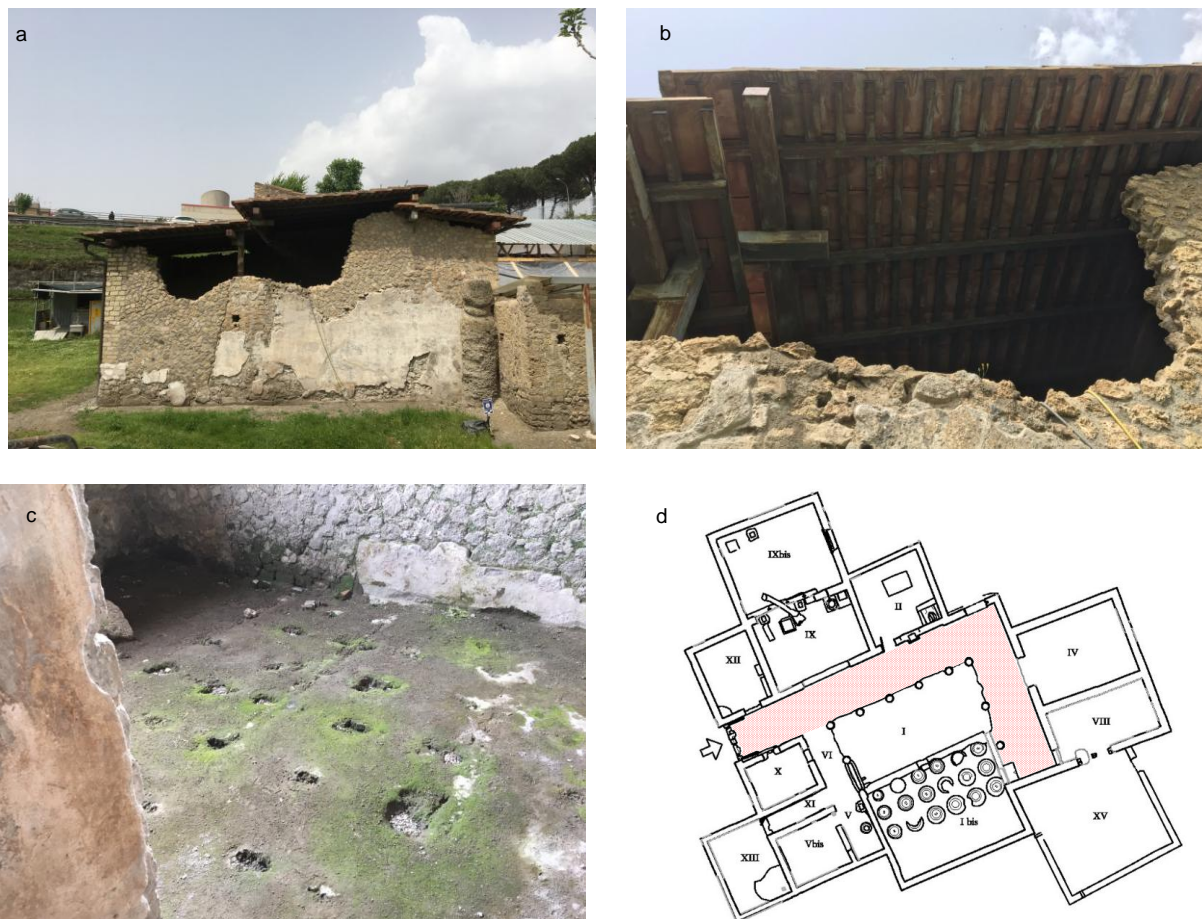
**Figure 11.** (a) North view of Villa Regina; (b) Detail of the roof; (c) Effects of leaching by rainwater; (d) plan of the villa
