## Structural Evaluation and Rehabilitation Proposal of an old building located in a Region of High Seismic Hazard

**Abstract:** In regions with high seismic vulnerability, there are many old buildings that could be damaged or collapse with a major seismic event. This is the case of a church built in Argentina in 1956, and to date, it has been subject to more than a dozen earthquakes of intensity VI or higher. This situation has not only led to the appearance of pathological manifestations in the building, which allow us to infer abnormal structural behaviour, but has also revealed the need for a comprehensive structural adaptation in accordance with the descriptions of current constructions standards. In this regard, the objective of this work is to show the evaluation methodology carried out for the aforementioned building, as well as the proposed structural intervention strategy in order to achieve its rehabilitation.

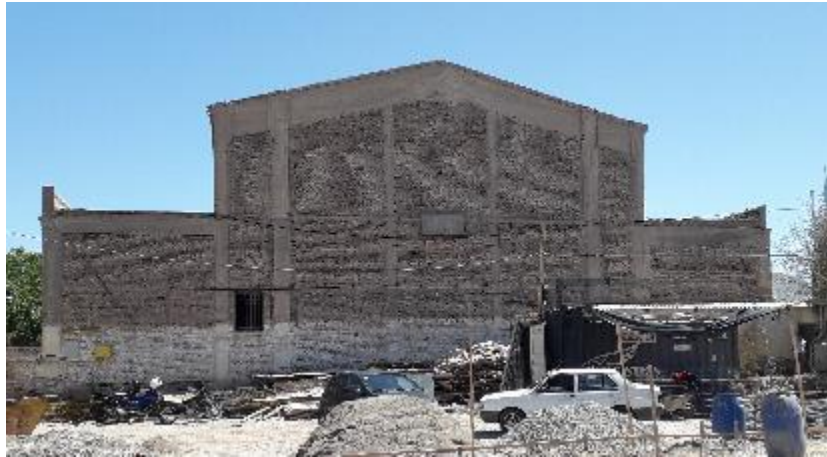
**Figure 3: Rear facade**

Its architectural configuration consists of a central auditorium and lateral auditorium above which the tribune sector is located, Figure 2. Although the original architectural project of the church contemplated the construction of the apse of the main altar in the rear sector, the main door and the bell towers in the front sector, this could not be completed. For this reason, the openings corresponding to the first and last reinforced concrete frame in the east-west direction were filled with masonry, Figure 3.

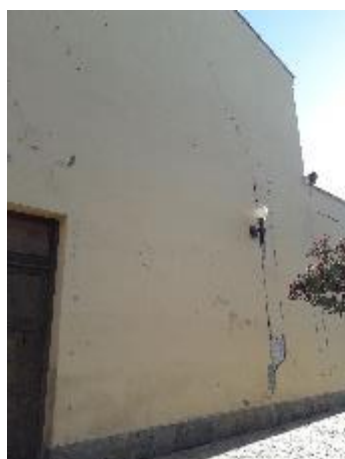
. Cracks in the front and rear masonry walls. As mentioned above, both the front and back masonry walls were built on a temporary basis. For this reason, after the construction of the frame columns and beams, the masonry was placed as a filler. As there is no link between the masonry and the reinforced concrete structure, and due to the earthquakes produced in the region, these cracks could then correspond to the seismic action and the lack of wall-structure connectivity, Figure 4. The same would correspond to the rear closing masonry wall condition.

**Figure 4: Cracks in the front facade**

All the masonry walls of the original work will be transformed into reinforced masonry walls with distributed reinforcement and shotcrete, Figure 13; constituting this structural typology as the main one against the seismic demand.

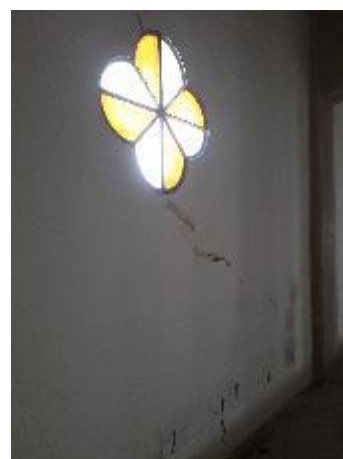
. Cracks in lateral masonry walls. The upstairs side walls, in the grandstand sector, have diagonal cracks in correspondence with the windows, Figure 5.

**Figure 5: Cracks in side wall**

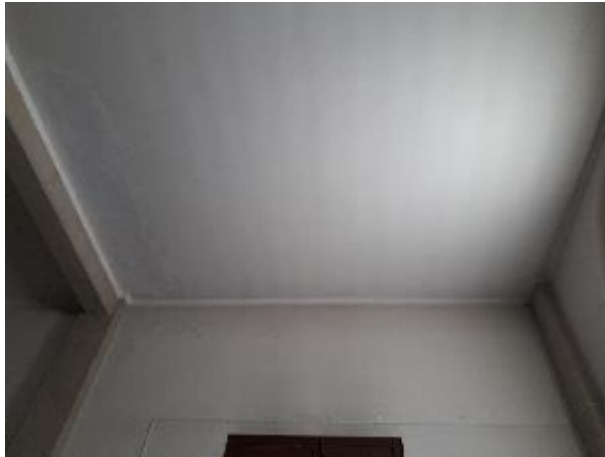
. Moisture and corrosion in slabs. Various sectors of the slab are affected by the presence of moisture, Figure 6. In addition, linear cracks were observed in some sectors of the slabs that would coincide with the location of the joists, which could be an indication of a corrosion process in the slab reinforcement.

**Figura 6:** Moisture and cracking in slabs

For the reinforcement of joists in slabs with insufficient capacity, or in areas where there is a loss of reinforcement due to corrosion, carbon fiber plates will be used. In addition, a specific treatment will be applied to the joist areas where corrosion has affected the concrete and reinforcement; and ceramic elements will be removed when fractures or loose parts are detected..

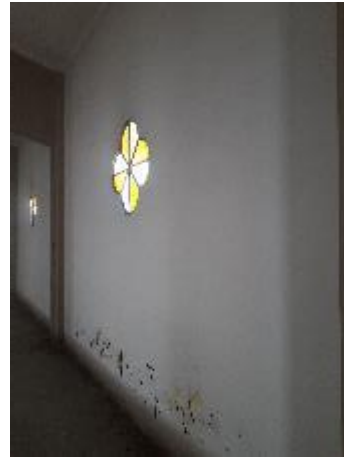
. Moisture in walls. The walls located above the lateral auditoriums in the tribune sector, show signs of moisture, Figure 7. As they are reinforced masonry walls, this humidity has caused the corrosion of their reinforcement.

**Figura 7:** Moisture in walls

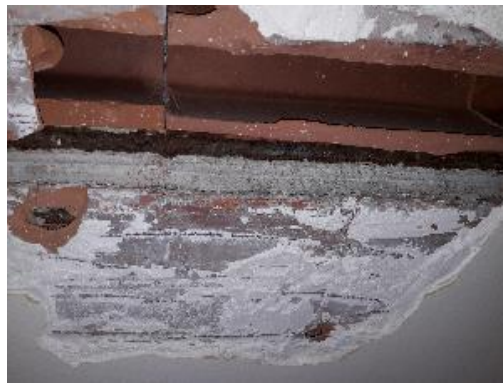
It was determined that the slabs are of the ribbed type. These slabs generally present the problem that the rib reinforcements do not have an adequate concrete coating, which means that they are exposed to a premature onset of corrosive processes. Thus, in the mechanical surveys it was observed that the reinforcements were in an active corrosion process, Figure 11. These reinforcements were made up of AL-220 type steel bars. On the other hand and as a consequence of the active corrosive processes mentioned above, in some sectors of the slabs the ceramic elements that compose it were cracked and with a sudden risk of detachment.

**Figure 11:** Slab reinforcement corrosion
