XVIII CONGRESSO INTERNACIONAL SOBRE PATOLOGIA E REABILITAÇÃO DAS CONSTRUÇÕES

XVIII INTERNACIONAL CONFERENCE ON BUILDING PATHOLOGY AND CONSTRUCTIONS REPAIR

17 TO 19TH NOVEMBER 2022

## STRUCTURAL REINFORCEMENT IN METALLIC COVER DAMAGED BY CORROSION

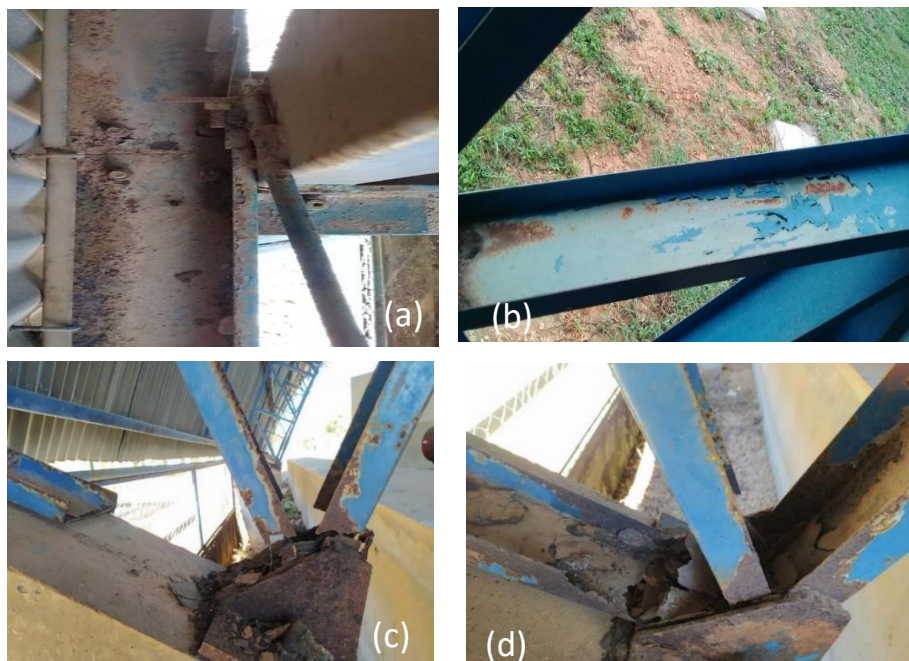
The identification of the pathologies present in the roof structure was performed by visiting the gymnasium and taking the necessary photographic records. The main(bpa)thology identified was corrosion, especially at the structural connection points. It was observ(ead) that all the lower flanges, diagonals and uprights that make up the first node of the scissors show a high level of corrosion, with paint peeling off, and some pieces are also broken. This factor indicates a possible accumulation of water in the region. Moreover, the plates used to make the connection between the steel structure and the concrete supports are, in general, degraded by corrosion, with reduction in the length of the pieces, especially those that form the first node of the bottom bar of the trusses. Figure 2 shows the records made during the on-site visit.

**Figure 2** - Records of pathological manifestations in the pieces

It is possible to see that the geometry of the structure and the positioning of the profiles contribute to the accumulation of water at the joist support nodes on the concrete column. The entire inclination of the roof is directed to these regions, and the meeting of the flanges with the diagonals and uprights creates a space conducive to water storage. Furthermore, interaction points between different building systems, in this case the steel structure and reinforced concrete, are areas that require attention when painting, as the concrete can transfer moisture to the metal parts.

In general, the condition of the structure's profiles indicated that the pieces were not treated and painted properly, not all the necessary layers were applied, and that the painting system was not maintained. The elements that make up the highest parts of the roof do not present serious manifestations such as a reduction in the cross section or rust spreading; however, it was found that in some spots there is detachment of the painting system, probably due to poor preparation of the surface for the service. It was also observed that only one layer of protection was applied, probably of the type of finishing coat.

According to Castro (1999), uniform corrosion that causes the gradual loss of profile thickness is caused by the direct contact of carbon steel with the aggressive environment due to the absence of protection, inadequate protection or even lack of paint maintenance. It is noteworthy that project errors such as the

Due to the state of degradation of the parts that make up the first node of the trusses, it was determined in the project that all the lower flanges, diagonals and uprights that make up the first (lower) node of the scissor be replaced. The base plates and lateral connection, and the connection bolts between the steel structure and the concrete support were also changed. As all the trusses had these parts damaged, the project determined that the elements would be replaced one truss at a time, and one side at a time, to avoid extreme movements in the structure during the execution of the service.

Furthermore, since it was identified that this area is prone to water accumulation, due to the geometry of the roof and the arrangement of the profiles, concreting was performed until the formation of the second shear knot, as an extension of the support column. The concrete to be used has no structural function, it served only as a protection layer for the vulnerable area. To improve the adherence between the concrete and the steel pieces, it was indicated to install welded round bars with 8 mm diameter and 16 cm length, in the metallic profiles, obeying a 10 cm spacing between the bars. These rebars act as staples inside the concrete improving the interaction with the metallic structure. Drainage holes were also drilled in the lattice pieces immediately above the concrete area, to prevent the accumulation of water in the profiles. These determinations were exposed in the project with explanatory drawings.

As for the treatment of the parts not compromised by corrosion, it was proposed to correct the paint system due to the identification of some points of detachment of the paint film, also considering the time that the cover has not received maintenance since it was started. According to the recommendations of the 2017 Design and Durability Manual of the Brazilian Center for Steel Construction (CBCA), since the paint system on the other parts of the roof, those that have not been replaced, is superficial, manual cleaning to remove rust was performed using a steel brush and sanding.

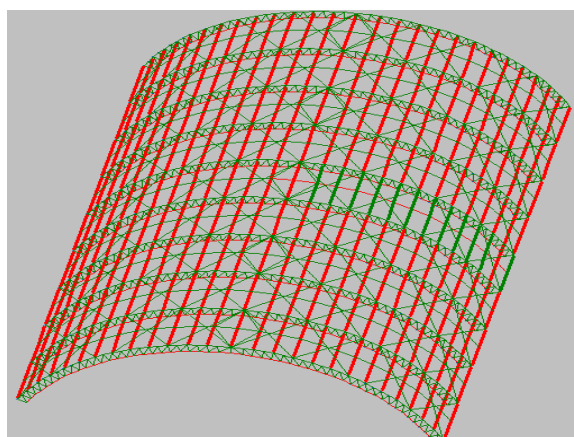
After launching the structure, the stability of the roof was analyzed for the ultimate limit state (ULS), also in the Cype3D software, to identify the current safety situation of the gym. The bars identified in red in Figure 4 below were not successful in the verification according to the limitations established by NBR 14762 - Design of steel structures made of cold formed profiles, and ABNT NBR 8800 - Design and execution of steel structures in buildings (Limit State Methods). Weakness points were identified in the lower flanges of the trusses and in the purlins. According to the analysis of the results, the necessary interventions were proposed to solve the unmet verifications, resulting in a project for structural strengthening of the gymnasium roof. For the results to be presented in the next section, consider:

**Figure 4** - Ultimate Limit State Verification  
Source: Author (2020)

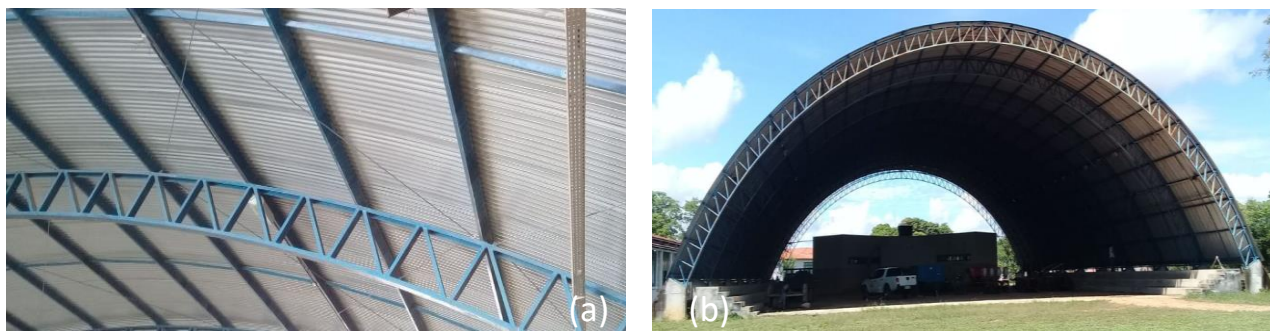
In the case of the gymnasium roof analyzed in this study, the scissor structure does not present any interlocking for the lower chords in order to reduce the free length for the bending of the elements. Thus, the buckling length for the lower flanges of the scissor beams is limited by the spacing between the concrete supports at the ends of the truss, totaling a value of 37.06 m, not enough to limit the bending of the part around the axis, as required by the standard, as evidenced in Figure 5 below.

**Figure 5** - Registration of the truss bottom flanges  
Source: Author (2020)

Similarly, the greater the value of the effective length of buckling in the axis, the lower the compressive strength of the part. Given the above, it is observed that the absence of interlocking in the bottom flanges of the trusses is the factor responsible for the ineffectiveness in verifying the slenderness index and the compressive strength of the pieces.

For both identified problems, it was proposed the installation of angle brackets made of bent steel profile 50x50#2.30 mm in A36 steel, in the lower flanges below each truss. One flange of the French hand was locked below the bottom flange, and the other flange on the steel joist at a distance of 80 cm from the connection node between the joist and the upper flange (oaf) the truss. In this way the buckling length of the bottom chords became the distance between the purlins, which are spaced every 1.47 m, a much smaller space than the original. This reduction provides a reduction in the slenderness index of the part and increases its compressive strength.

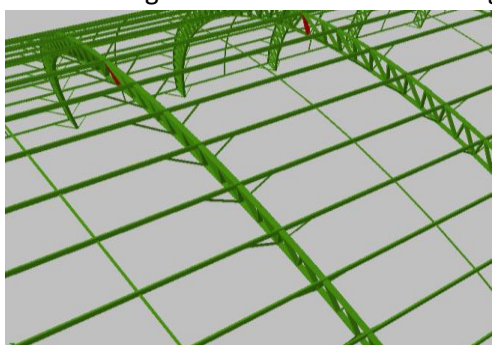
**Figure 6** - Representation of the installation of French hands  
Source: Author (2020)

After inserting the angle brackets, the checks were performed according to the limitations set forth in the standard. Figure 6 below shows the modeling of the installation of the angle brackets on the structure.

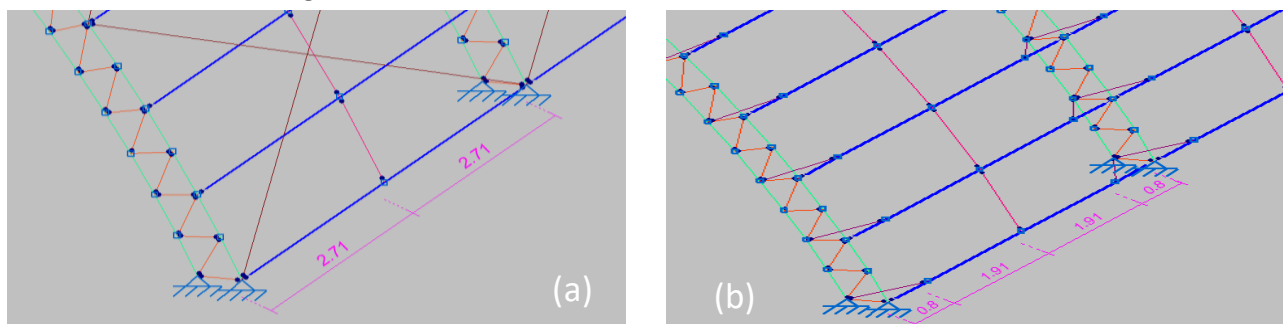
The installation of the French hands proposed to solve the instability of the bottom flanges, also helped in solving the problem of the purlins, since the locking of the French hand is done with a tab attached to the bottom flange of the truss and the other tab attached to the purlins. In this way the unbraced length of the purlins is reduced, thus decreasing the bending moments generated in the bar in the direction of its length axis. Figure 7 below shows a comparison between the lengths of the purlins in a span between two shears, before and after installing the French braces.

**Figure 7** - Comparison of the lengths of the purlins before and after the intervention Source: Author (2020)

By reducing the requesting moments in the purlins it was possible to solve the three non-conformities presented by the elements, according to the standards, since both unmet verifications are calculated as a function of the requesting bending moment. Thus being reduced the loads, the bending resistance of the pieces became sufficient to support the request.

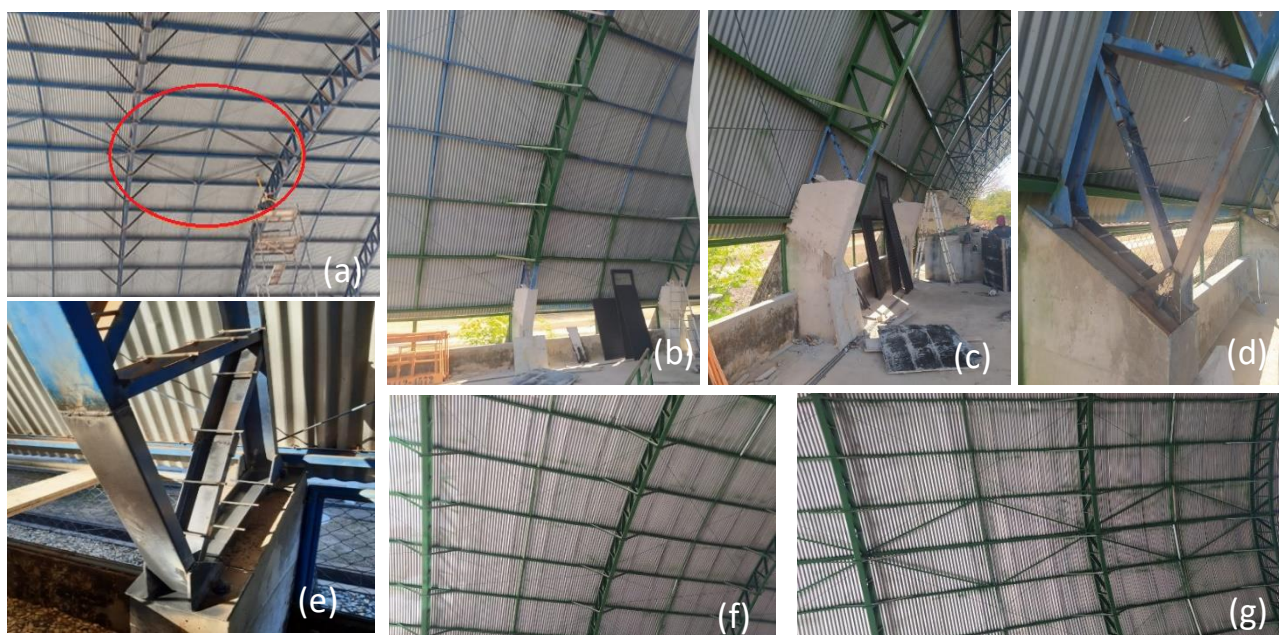
**Figure 1** - Interventions performed on the roof Source:  
Author (2020)

**Detail 01** - Replacement of the compromised lattice profiles, replacement of the connecting elements with the concrete pillars and concreting up to the second lattice node; **Detail 02** - French hand installation; **Detail 03** - bracing installation; **Detail 04** - installation of the rigid ties.

Thus, an identification of the meeting points of the plates in each mapped detail was performed to determine the thickness of the welding leg. They were dimensioned according to NBR 8800 (2008). In all connections executed, the length of the weld bead is equal to the entire meeting edge between the two profiles, this is also an alternative to avoid cracks that promote the accumulation of water, opting therefore for a continuous weld. After all the verifications were made according to the efforts calculated in software, the interventions were arranged in the project specifying the welding points, welding type, thickness and electrode, with quantitative material and explanatory notes. The detailing of the welds in the project followed the provisions of ABNT NBR 7165 (1982) - Graphical welding symbols for ship and railway construction. The dean's office of the IFTO - Tocantins Federal Institute of Science and Technology Education was responsible for preparing the budget spreadsheet, as well as for the other projects required to complete the work, such as renovating the changing rooms, installing the bathrooms, among others. A bidding process was elaborated, and the construction company Sambaiba Construções Ltda was responsible for the execution of the remodeling project. The Figure 8 below shows the reinforcements installed in the roof and the other interventions.
