## Analysis of cracks in family houses buildings in the city of Erechim - RS

Mariana KROGEL<sup>1</sup>, Marinês LANGOSKI<sup>2</sup>, Rodrigo Gazolla FERRARESE<sup>3</sup>

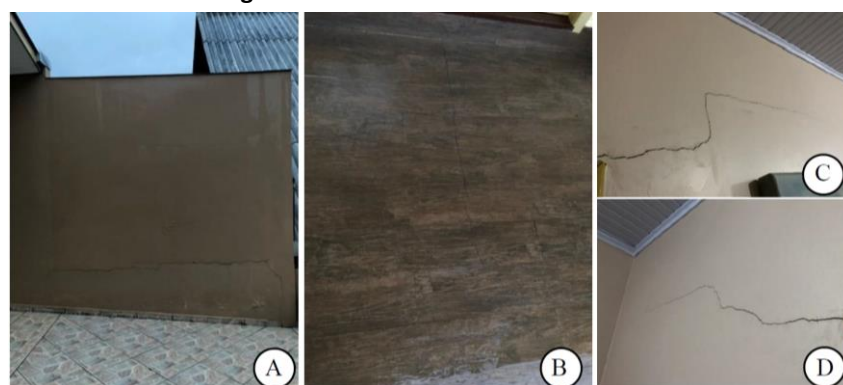
**Figure 6** – Cracks found in residence 1.

**CATALOGED:** Four cracks were found in the residence and a high level of cracks, among the cracks shown in Figure 6 are on (A) the external wall, due to its history and currently has the presence of moisture; (B) porcelain floor, caused by poor application of the laying mortar, allowing the piece to be affected by the traffic of people and (C and D) internal wall on both sides, caused by the presence of concentrated load not foreseen in the project.

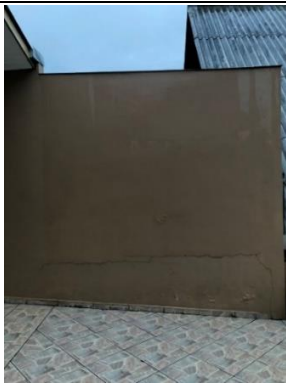
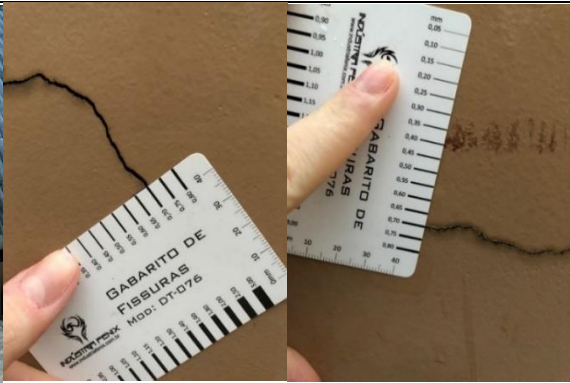
#### 4.1.1 – Crack A

**CAUSE:** The wall is located at the boundary of the house; the house does not have a superstructure where such a wall already needed reinforcement, as it arrived in a state of almost collapsing due to the high formation of cracks, thus flaming; this happens because the slenderness of the element does not support such a load, generating an imbalance in the element that is not associated with any structural element, such as a beam or column.

Currently, the masonry wall has a pillar on the side to support the weight of the masonry; however, the cracks reappeared, starting vertically at the meeting of the masonry-pillar and progressing horizontally along the entire length of the masonry. The main cause associated with existing cracks is the presence of moisture; that behind the wall there is the roof of the neighbor with one of the waters descending towards the wall, with a gutter next to this masonry wall, where this horizontal crack manifests itself, at the height of the gutter along its entire length.

**MEASUREMENT ANALYSIS:** The crack behaves as progressive active, where it is having a progressive increase over time. Being the worst type of crack when related to therapy, according to the literature.

**INTERVENTION:** Regarding the analysis of measurements, its behavior is directly related to its nature, if you perform a correction even with the use of screens, it may open again due to its slenderness, firstly it is recommended to stop the moisture present and treat it as a joint of movement. Therefore, this joint will serve to relieve and absorb its active movement. Like this:

- 1st) With a chisel, widen the active crack along its entire length;
- 2nd) Clean the surface, removing the dust caused by the widening of the opening;
- 3rd) Carefully fill the opening with plastic sealant;
- 4th) Finishing.

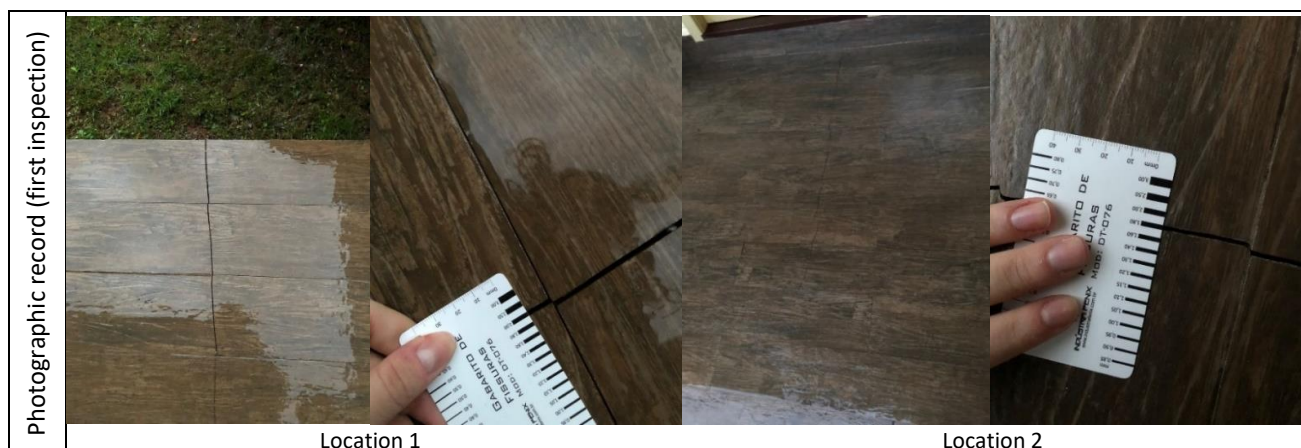
#### 4.1.2 – Crack B

**CAUSE:** The case is a crack in a porcelain floor, the piece is 20x100cm, the application was carried out on a ceramic floor using an ACIII mortar; one can point out the workability between the divergent pieces, where the crack appears perpendicular to the longest length of the piece, the most susceptible side. In addition to the cracks, it is possible to observe displacement and hollow pieces, due to the size of the piece, it is also possible to point out the poor application of the laying mortar, allowing the piece to suffer when someone steps on it.

**MEASUREMENT ANALYSIS:** The crack remained active, with this variation due to temperature, colder days with larger openings and hot days with smaller openings.

**INTERVENTION:** Restoring rigid coatings, in this case porcelain tiles, is not feasible. Therefore, what I would recommend doing is replacing the plate, or the entire set, reviewing and/or placing expansion joints on the floor, so that there is a gap that the piece can suffer when there is movement under it. Applying these pieces following the manufacturer's guidelines, arranged in the box itself or on the site, and maintaining its application using an ACIII mortar.

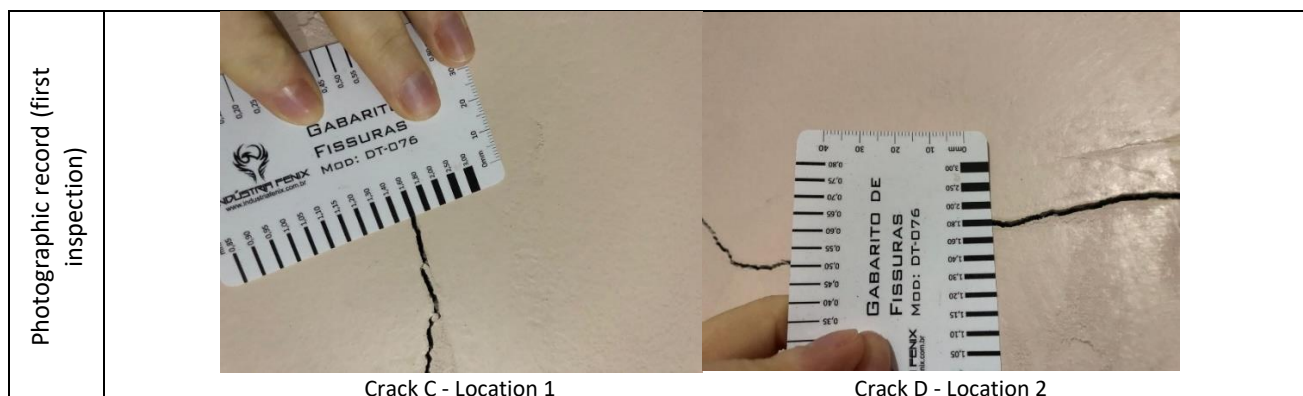
#### 4.1.3 – Cracks C and D

**CAUSE:** The main associated cause is the presence of a concentrated load not foreseen in the project, it is a 1,000-liter water tank resting on the roof trusses, the crack originates where this load is located and progresses to the apex of the go, in this case the door; because it is a weakened region mainly because it does not have a lintel.

**ANALYSIS OF MEASUREMENTS:** The crack behaves as an active one, in colder temperatures it has a more accentuated opening, being a characteristic considered typical.

**INTERVENTION:** It is recommended to eliminate this concentrated load, correct it with a hexagonal mesh steel or polyester mesh in the cracked area, closer to the anchorage area, and use flexible mortars (PVA, acrylic, etc.). In addition to the execution of a lintel at the top of the door, to receive possible relief of tensions. Like this:

- 1st) Remove the old coating from the cracked area plus the anchoring area (supporting area of the screen, which may vary from 30 to 50cm);
- 2nd) Clean the surface, removing the dust caused by the old coating;
- 3rd) Execute chapisco;
- 4th) Place the screen on the roughcast layer, considering the support region of at least 30cm;

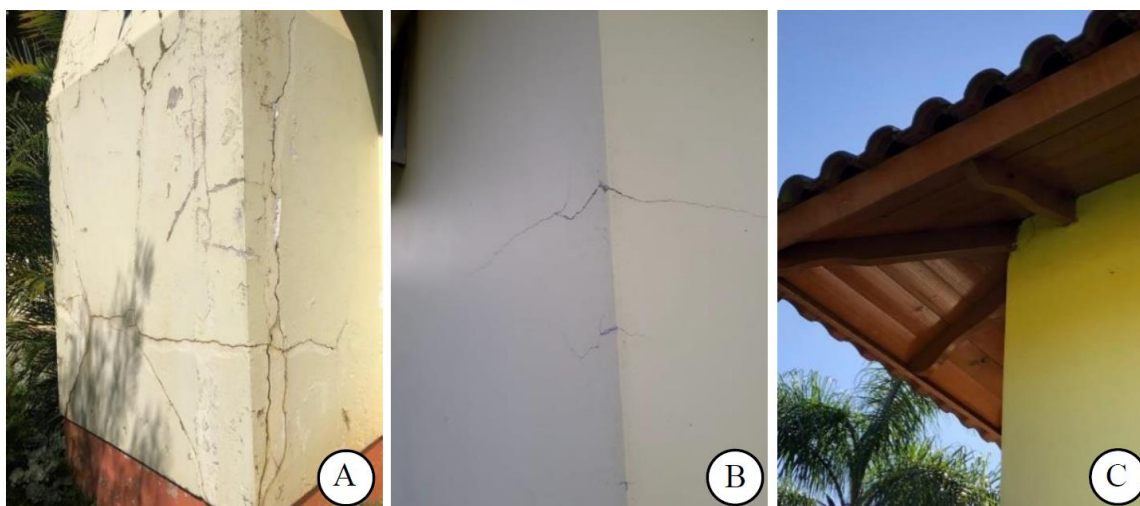
**Figure 8 – Cracks found in residence 2.**

**CATALOGED:** Three cracks stood out in the house in addition to a high number of cracks. Figure 6 presents the cracks found, being (A) barbecue, due to the thermal movement associated with the architectural details; (B) back wall of the house, caused by effects on the top of the element and (C) below the roof, due to overload.

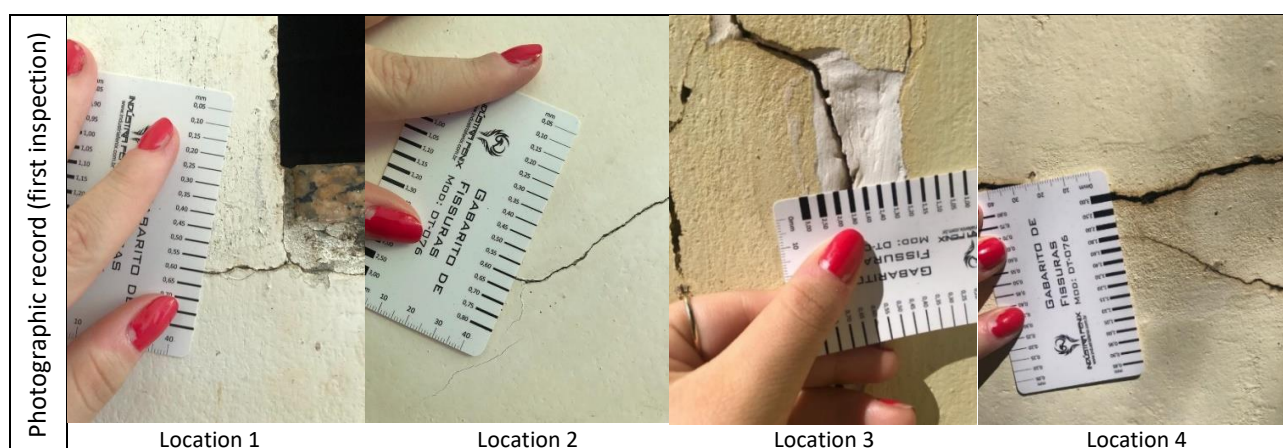
### 4.2.1 – Crack A

**CAUSE:** A possible cause is thermal movement, where the resistance of the blocks used is less than the resistance of the laying mortar, thus bursting cracks crossing the blocks; On the front face of the barbecue, there are also no beams in the span, promoting the progression of cracks. The detail of the architecture of the house (the orange/yellow tooth) in the state where the cracks are found is allowing the parts to collapse,

this is possible to observe by the behavior of the crack in this tooth, it is as if it were suffering deflection of the component.

ANALYSIS OF MEASUREMENTS: The cracks are active and regardless of the temperature they are progressing, based on their measurement history and appearance, a possible collapse of the parts can be concluded. So much can be said about it, due to its evolution into a crack.

INTERVENTION: It is recommended as soon as possible to condemn the element and redo it. Because due to the number of existing openings in the element and in the behavior in the measurements, the repair is impracticable. So, to redo follow the recommendations:

- 1st) Clean the site after demolition and use materials of origin and quality;
- 2sd) Use a 1:3 ratio (1 measure of cement to 3 of sand) for laying the ceramic blocks;
- 3rd) Joint thickness of 1 cm, in addition to not having plumb joints and completely filled;
- 4th) The service must be started by the corners, obeying plumb, level and square in the survey;
- 5th) Carry out mooring at the corners of the element;
- 6th) Where the existing element (not demolished) meets the reconstructed part, use a tie screen to avoid cracking, that is, when roughcasting apply a polyester screen on top of it and then normally apply the subsequent layers on top of it;
- 7th) On the face of the barbecue opening, make a lintel and counter-beam of 30 cm on each side of the gap;
- 8th) Finishing.

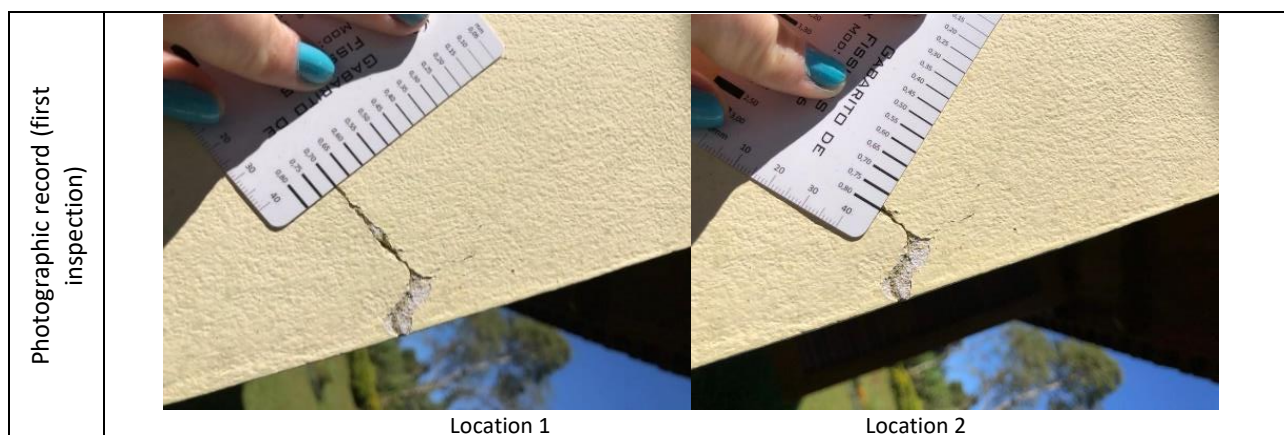
#### 4.2.2 – Crack B

**CAUSE:** This crack is located below the crack on Sheet 03, which due to the tensions exerted by the overload can result in openings in the supported body, that is, the tensions acting on the top of the element influence the body, looking for a corner to manifest itself .

**ANALYSIS OF MEASUREMENTS:** The opening remained constant, there was no great variation in opening when comparing opening x temperature. For this reason, it can be stated that the crack occurred due to the element having worked due to the tensions exerted on its top, as stated in its cause of manifestation. That is, if the tensions exerted at the top cease, this crack also ceases, and can be treated monolithically, thus its therapy being treated as passive.

**INTERVENTION:** With stagnation of crack progression due to excessive load, it is recommended to correct the openings with an epoxy resin, throughout the opening, as follows:

- 1st) With a chisel, widen the active crack along its entire length;
- 2nd) Clean the surface, removing the dust caused by the widening of the opening;
- 3rd) Carefully fill the opening with epoxy resin;
- 4th) Finishing.

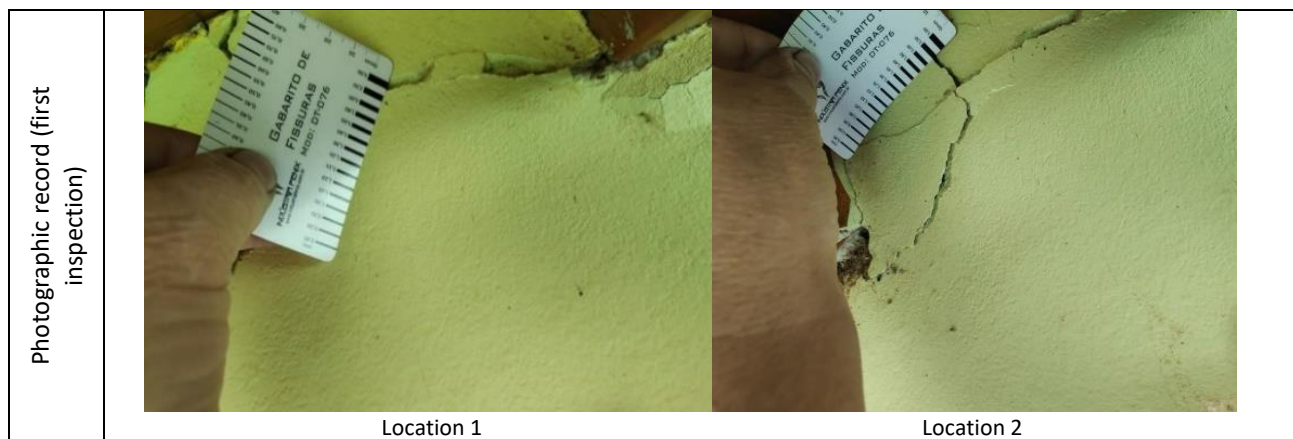
#### 4.2.3 – Crack C

**CAUSE:** The main cause associated in the case presented is the concentrated load overload, typical case of load not foreseen in the design, generating high compressive stresses; vertical and inclined openings appear. In addition to being possible to observe that in all corners of the house there are openings of this type, because they always look for the most fragile way to appear, that is, the corners.

**MEASUREMENTS ANALYSIS:** As predicted by crack B, the movement of the opening was stopped, working as passive. For this to have occurred, this opening also needs to be behaving passively, since it is responsible for the occurrence of the previous crack. To explain this occurrence of overload on the element, it is as if the deformations that the overload exerts had “settled”, that is, the element has already deformed to the maximum with such existing overload.

**INTERVENTION:** With stagnation of crack progression due to excessive load, it is recommended to correct the openings with an epoxy resin, throughout the opening, as follows:

- 1st) With a chisel, widen the active crack along its entire length;
- 2nd) Clean the surface, removing the dust caused by the widening of the opening;
- 3rd) Carefully fill the opening with epoxy resin;
- 4th) Finishing.

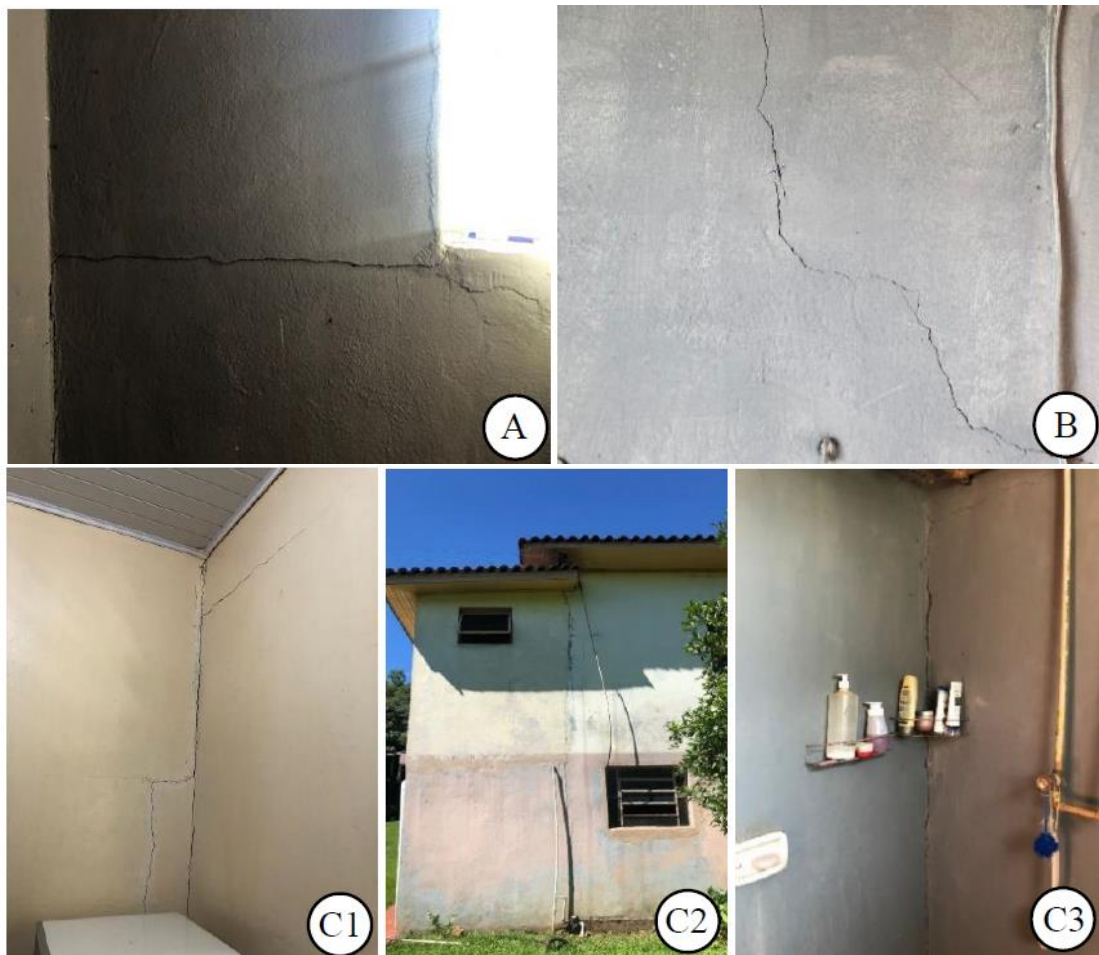
**Figure 10** – Cracks found in residence 3.

**CATALOGED:** The house has cracks with characteristic causes, mainly because they manifest themselves in the places where the expansion is being carried out. In Figure 10, the cracks mapped in the house can be seen, (A) at the base of the window, running along the corner of the wall, caused due to the absence of a slat in the basement window associated with differential settlement, (B) located in the basement, caused by overload not foreseen in the project and (C1, C2 and C3) settlement in the expansion area of the house.

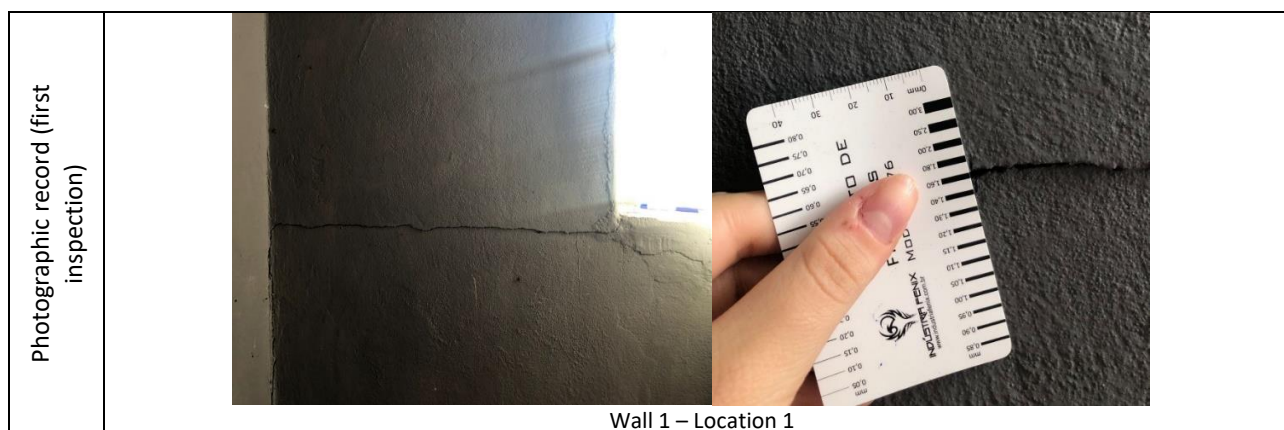
#### 4.3.1 – Crack A

**CAUSE:** The wall is located in the basement of the residence, part where it was enlarged in the renovation of the house for the execution of a bathroom in the basement, the repression of the area can be observed during the inspection, in addition to the lack of lintel and lintel in the window, point out the cause in the alteration of the soil by the unforeseen expansion reform.

**MEASUREMENT ANALYSIS:** The crack can be seen as active and progressive, which is an expected behavior due to the existence of settlement at the site. This occurs because when the foundations are tested against repression, there are requests that are not foreseen in the project and that are manifested in the masonry and in the superstructure, which are the tensile and shear stresses.

**INTERVENTION:** In the same way as mentioned in Sheet 01, remedy the problem with the soil, assessing the need for reinforcement in the foundations to perform any crack correction, following the correction in the same way, but executing lintel and counter lintel in the window:

- 1st) Remove the old coating from the cracked area plus the anchoring area (supporting area of the screen, which may vary from 30 to 50cm);
- 2nd) Clean the surface, removing the dust caused by removing the old coating;
- 3rd) Execute chapisco;
- 4th) Place the screen on the roughcast layer, considering the support region of at least 30cm;
- 5th) Redo the plaster over the applied canvas;
- 6th) Carry out a 30cm lintel and counter lintel on each side of the window;
- 7th) Finishing.

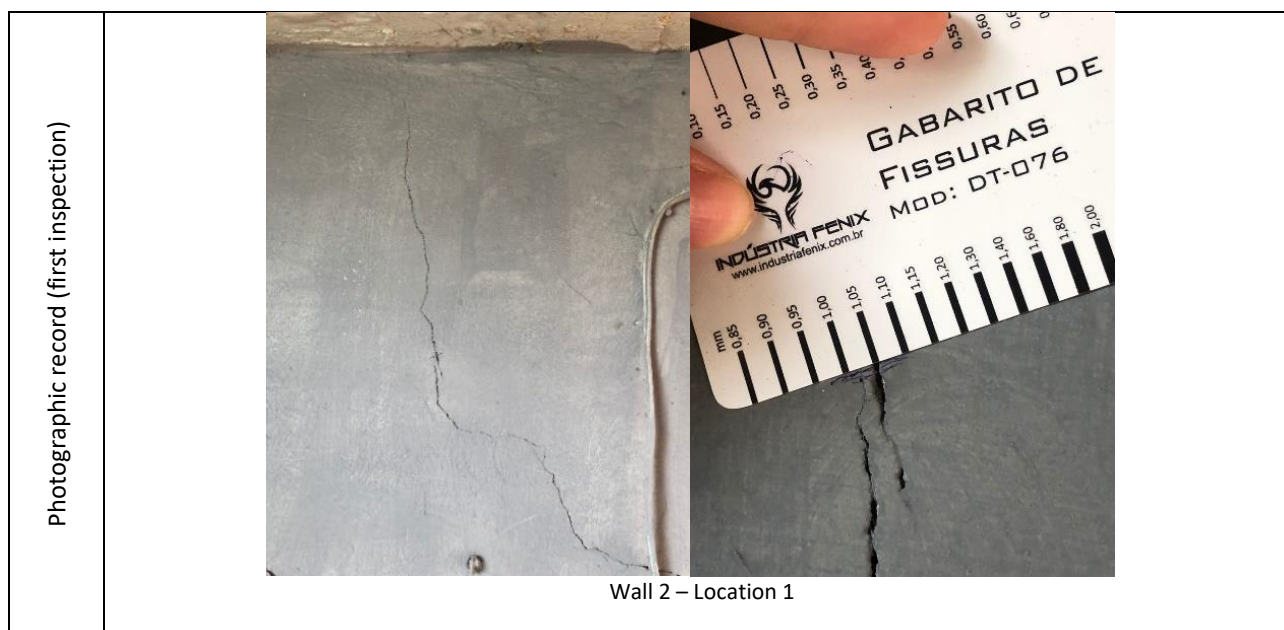
#### 4.3.2 – Crack B

**CAUSE:** The renovation was divided into two stages, first the execution of the lower floor (the basement) and after it was built on top, at that time the ceiling slab of the lower floor was used as support for a 1000 liter water tank, in this representing a concentrated load on the slab, still placed early on, which a while later was removed for the execution of the upper floor. In that exact place where the water tank was supported, there is currently the evaluated crack.

**ANALYSIS OF MEASUREMENTS:** From the measurement history carried out, it can be pointed out that the cause of the opening was momentary, since its observation appeared right when there was a water tank precociously supported in the place and there was no variation in its magnitude over time, according to locals. Although they do not point out the existence of opening movement, in the history there was a minimal variation, which can be pointed to the temperature and humidity existing on the day.

**INTERVENTION:** Correction is recommended using a hexagonal mesh steel or polyester mesh in the cracked region, more in the anchorage area, and using flexible mortars (PVA, acrylic, etc.). Like this:

- 1st) Remove the old coating from the cracked area plus the anchoring area (supporting area of the screen, which may vary from 30 to 50cm);
- 2nd) Clean the surface, removing the dust caused by removing the old coating;
- 3rd) Execute chapisco;
- 4th) Place the screen on the roughcast layer, considering the support region of at least 30cm;
- 5th) Redo the plaster over the applied canvas;
- 6th) Finishing.

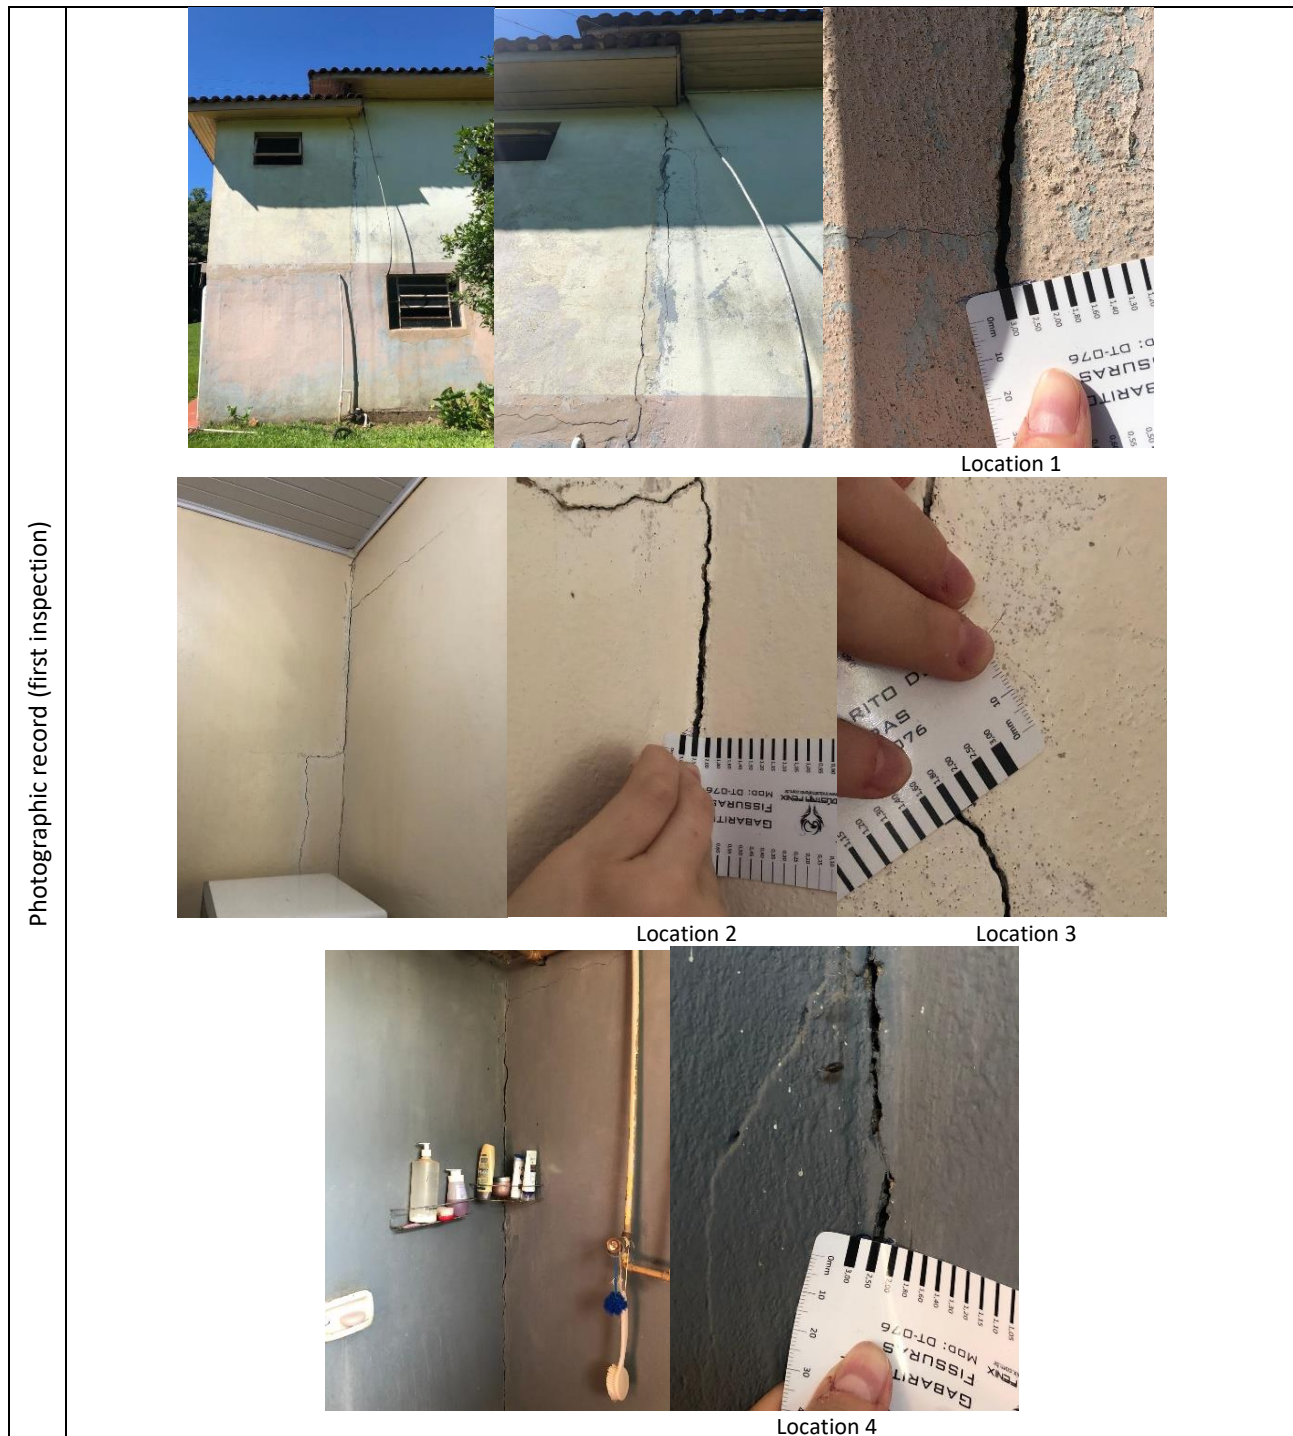
#### 4.3.3 – Cracks C

**CAUSE:** Upon inspection, it can be seen that the enlarged part of the residence is descending, giving evidence of the existence of repression, where the existing side sidewalk is completely cracked. An aggravating factor can be pointed out with the lack or poor compaction of the soil after the execution of the new foundation next to the existing one. In the first Figure, the enlarged area can be seen, the one with the lowest roof; in

this process, a bathroom was built in the basement, a bathroom and service area on the floor of the house, in addition to the access stairs.

ANALYSIS OF MEASUREMENTS: The cracks are manifesting themselves as active and progressive, with a marked magnitude, proving the existence of settlement. From the collection of information obtained, it is possible to point out different soil resistances, being the resistance where the existing foundation was (before the renovation) and the resistance after touching the soil to execute the expansion foundation, where this ends up affecting the resistance of the layers of this soil, which is called a stress bulb. Creating as if it were a neighboring work destabilizing the soil of the existing construction.

INTERVENTION: Soil analysis is recommended, to monitor settlement, using equipment such as a tassometer and inclinometers. To be able to perform a correction, monitoring will be necessary, as due to proof of the magnitude of the opening working progressively regardless of the temperature variation, any apparent correction is inefficient, as there are chances of this movement continuing. If proven, immediately reinforce the foundations and then correct the crack as follows:

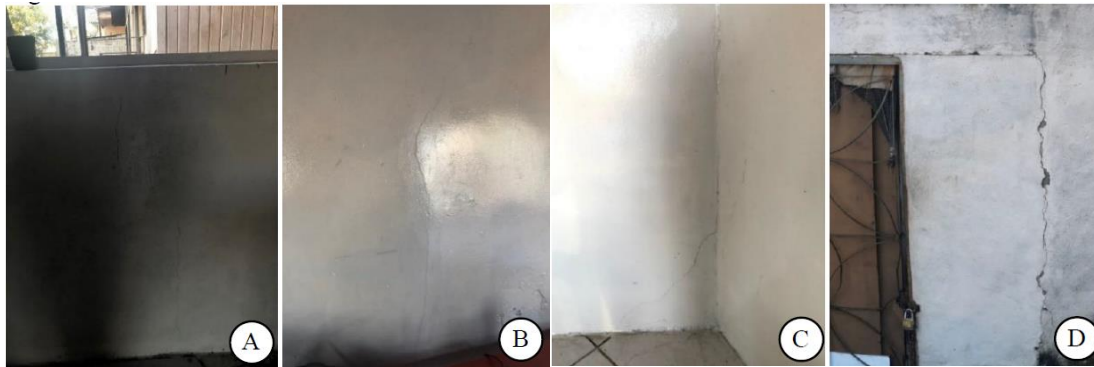
**Figure 12** – Cracks found in residence 4.

CATALOGED: Figure 12 shows the mapped cracks, namely, (A) below the window, progressing downwards (crack caused due to the absence of a lintel); (B) on a flat wall, that is, without the presence of openings (crack characteristic of overload); (C) thermal movement of the reinforced concrete structure, manifesting itself in the sealing masonry blocks and (D) in an external wall in the connection between the structure and the masonry.

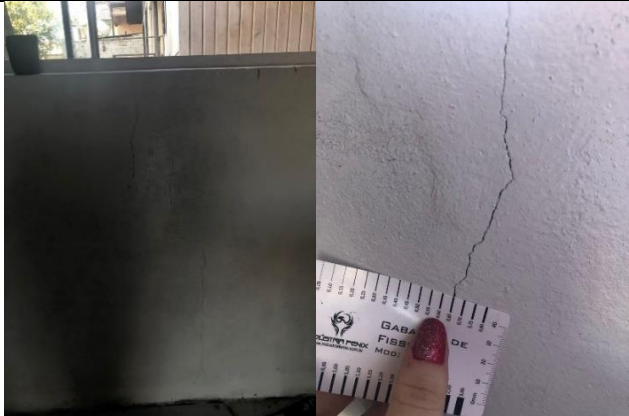
#### 4.4.1 – Crack A

CAUSE: It appears just below the window, due to the absence of a lintel, this happens because all constructions exert vertical loads that are transmitted to the ground, when there is an opening (a window) there is a vanishing point for this load passing through the masonry, where it generates a relief of tensions and if there is no adequate lintel and counter lintel, it will crack.

- 1st) Remove the old coating from the cracked area plus the anchoring area (supporting area of the screen, which may vary from 30 to 50cm);
- 2nd) Clean the surface, removing the dust caused by the old coating;
- 3rd) Execute chapisco;
- 4th) Place the screen on the roughcast layer, considering the support region of at least 30cm;
- 5th) Redo the plaster over the applied canvas;
- 6th) Finishing.

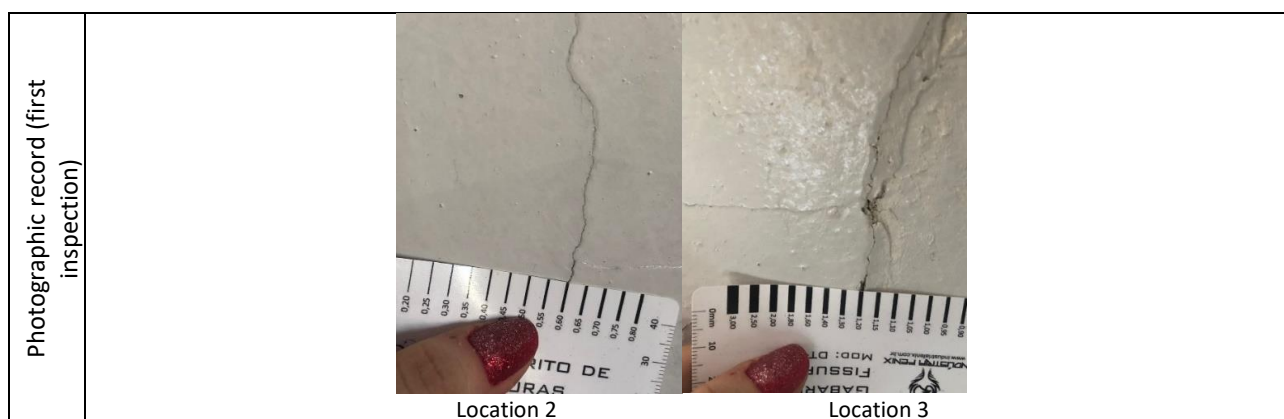
#### 4.4.2 – Cracks B and C

CAUSE: The crack in Figure B occurs in a wall without an opening, appearing vertically, being a typical crack due to overload, where it is promoted by the transverse deformation of the mortar under this load exerted. In Figure C, it occurs on the same wall, but in the lower right corner, being characteristic of the thermal expansion of the structure, which ends up manifesting itself in the masonry as it is the most fragile element. Analyzing it in context, as they are cracks in the same wall, it is the deformation of the structural elements, due to the undersized structure given by the lack of materials, this is evidenced by the lack of a technical manager, the absence of a structural project and the correction carried out in June 2022 have been inefficient.

Note: If screen correction is ineffective, it is recommended to immediately structurally reinforce the residence.

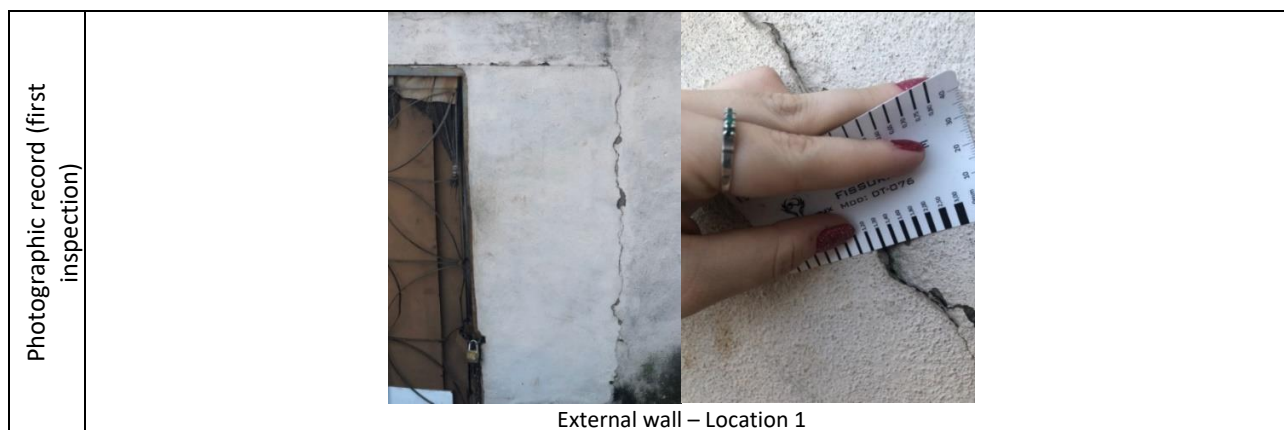
#### 4.4.3 – Crack D

CAUSE: The main cause associated with this manifestation, which is considered common to all, is the thermal movement of the reinforced concrete structure; characterized by the separation of the masonry interface and reinforced concrete structure. This occurs due to the absence of adequate constructive details in this connection between interfaces, in addition to the excess of water present in the component, which can expand the masonry and when dry it retracts. The presence of water can be pointed out due to its degradation aspect, such as dark spots and the accumulation of dust on the surface, with fungi proliferating in the element.
