## Analysis of Pathological Manifestations in the Municipal Public Market of the City of Frecheirinha – CE: Case Study

### 4.1 Pathological manifestations found in the municipal market of Frecheirinha

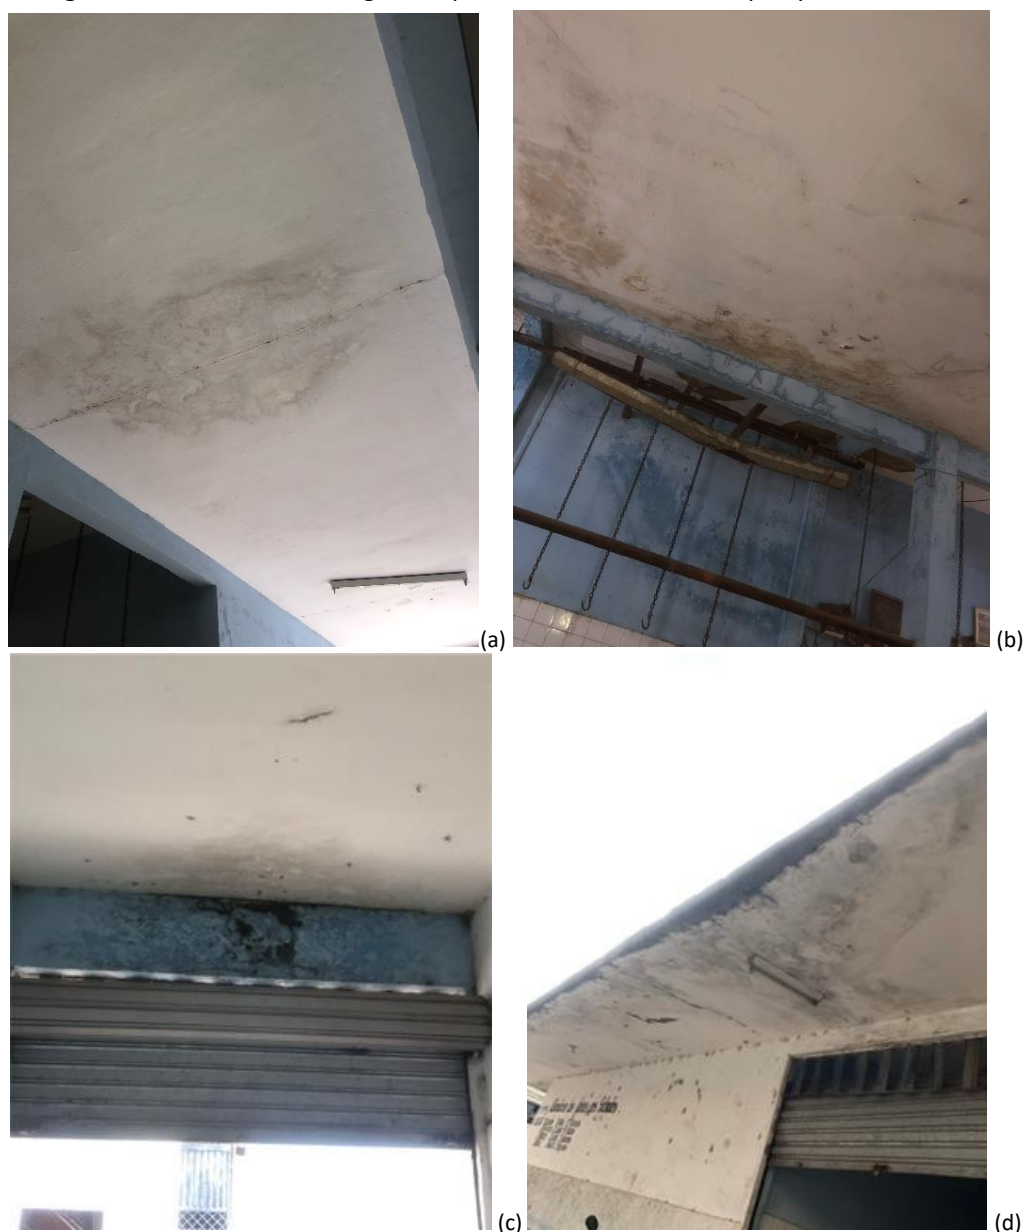
In Figures 8 (a), (b) and (c) stains due to seepage in the ceiling of the building were identified. As it has only one floor, it is assumed that infiltrations in the slab may come from a lack of or poor waterproofing of the roof structures (ruffs, gutters), poor suitability in laying the tiles or even damaged tiles. In Figure 5 (d) there is infiltration in the structure of the market marquee on the rear facade, its causes are due to the absence of a drop left in the upper part of the marquee together with the lack of a waterproofing layer on it.

Due to the location, stains on the ceiling make the appearance of mold more susceptible, since it is conditioned to an environment exposed to low temperature and the presence of abundant humidity, in addition to the fact that the water present is not running.

**Figure 8** – Stains on the ceiling of the public market in the municipality of Frecheirinha.

According to Santos and Beckhauser (2018), for the recovery of stains, it is necessary to remove the paint film without adherence to the surroundings of the pathological manifestation. Then clean the area using brushes or sandpaper, remove crystalline deposits and traces of contaminants, apply a suitable primer to improve adhesion and wait for correct curing. After carrying out the necessary procedures, the area will be ready to receive a new coating.

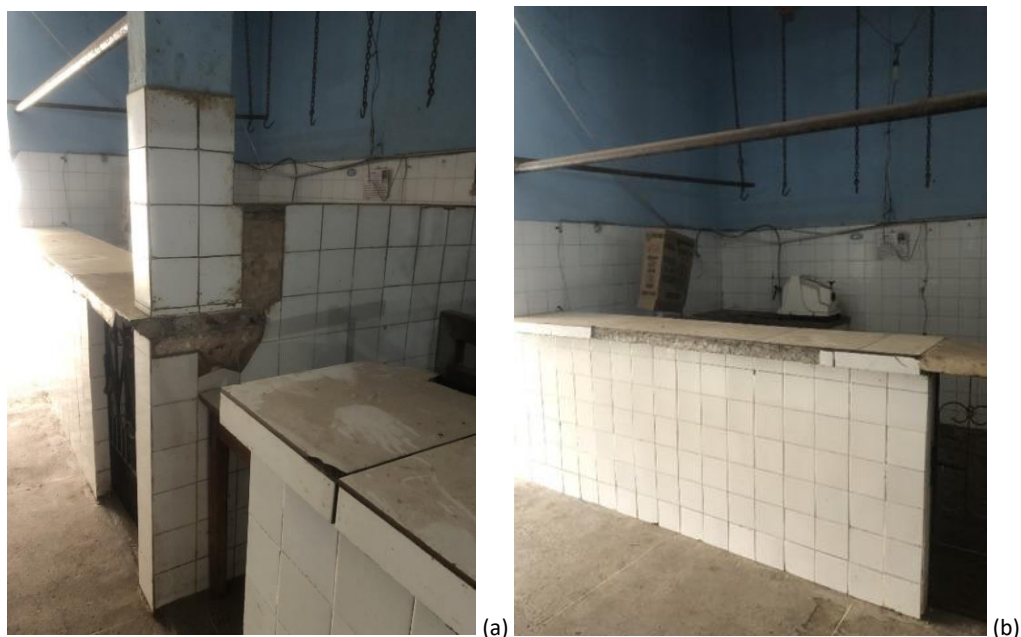
In addition to stains, the detachments of ceramic tiles were the ones with the highest incidence. Figure 9 (a) shows that there was a detachment of complete pieces, in addition to part of the ceramic plates, which indicates that there was cracking of these before the displacement. Figure 9 (b) shows that there was total detachment of the pieces, located in the upper part of the workbench.

The main causes for the occurrence of detachments are the poor execution of the application of the adhesive mortar by not performing the adhesion cords using a notched trowel, the lack of correct preparation of the substrate, or even, carrying out the laying on whitewashed paint, not performing double bonding, when

necessary, the presence of moisture in the place without waterproofing, causing the lack of adhesion between the plates and the substrate.

**Figure 9** – Detachment of complete parts, in addition to part of the ceramic plates.

The recovery of the compromised ceramic coating consists of the replacement of faulty ceramic parts. All compromised ceramic pieces and adhesive mortar remains must be removed, checking the state of the non-compromised pieces. Then, the existing deep imperfections must be corrected with mortar coating and wait for the adequate curing time, preparing the substrate. Then, apply a primer for walls, in the case of wet areas it is necessary to waterproof and, after drying, install the new ceramic coating, using double gluing in order to have a better adhesion between the ceramic and the substrate (Santos; Beckhauser, 2018).

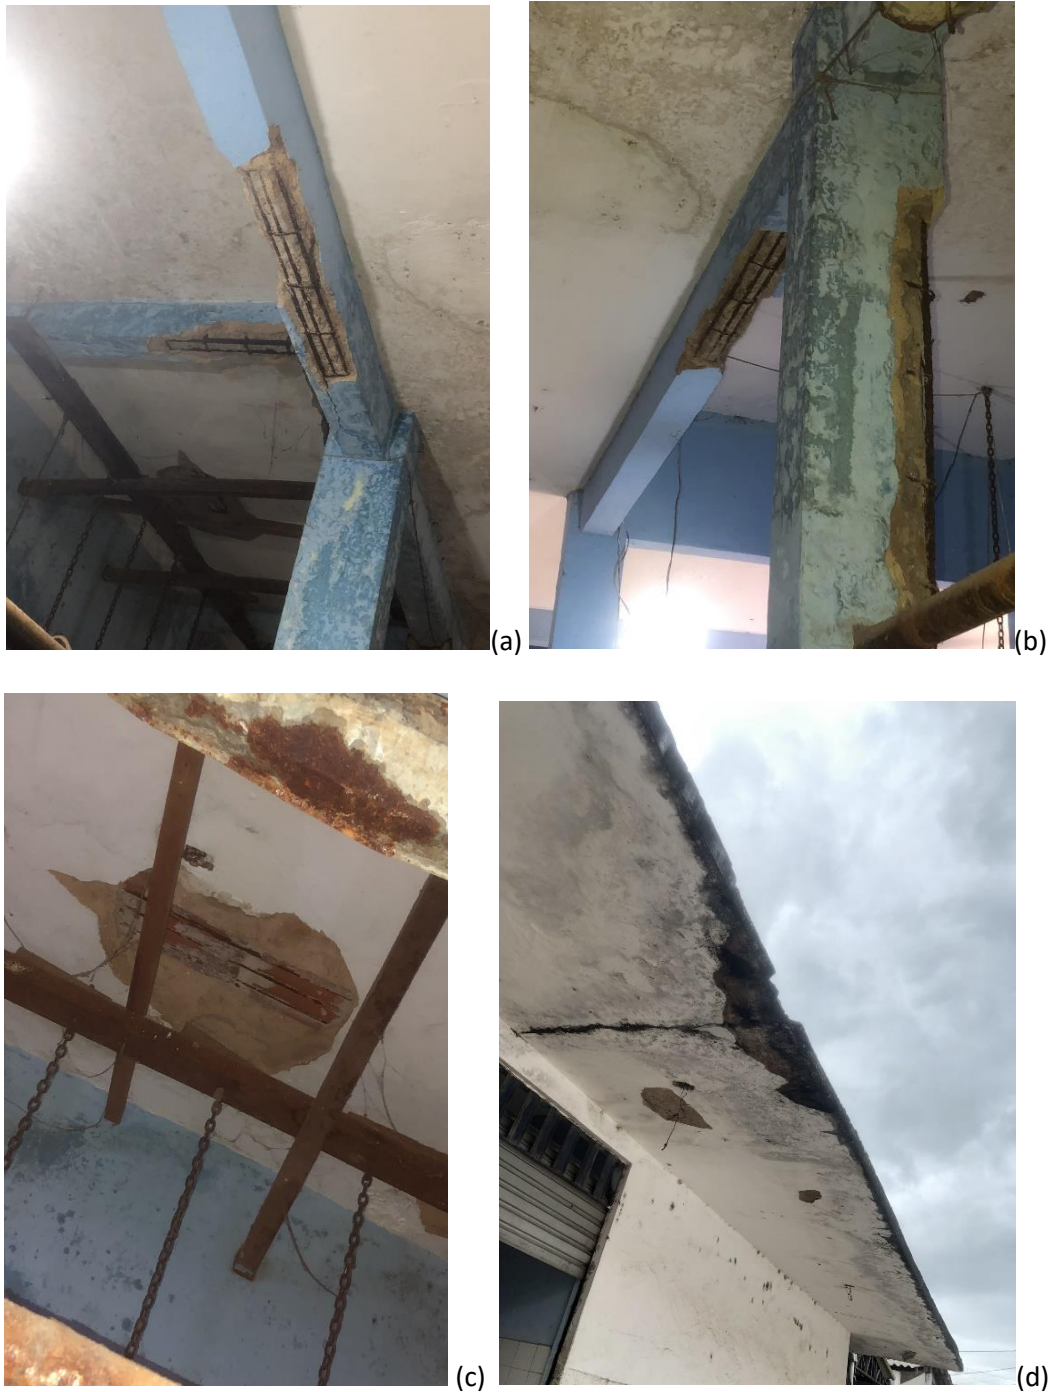
Figures 10 (a), (b), (c) and (d), in addition to showing stains caused by humidity, also show two pathological manifestations that exist together, namely corrosion of the structure's reinforcements and deterioration of the concrete. Concrete disaggregation is related to reinforcement corrosion, in addition to physical impacts. In addition, flaws in the construction process, such as the execution of concrete in the work itself, inadequate proportions of its components, consolidation, can contribute to the disintegration of the concrete.

As for the occurrence of corrosion of the reinforcements, it is mainly due to the execution of inadequate covering, leaving the reinforcements exposed to the air. The presence of moisture also contributes to oxidation. The lack of waterproofing or problems in hydraulic and pluvial installations are crucial factors for the origin of humidity.

**Figure 10** – Corrosion of the reinforcement of the structural elements of the public market.

For the recovery of deteriorated concrete, recovery works are necessary and, when necessary, structural reinforcement of the reinforced concrete pieces, with the application of the technique of scarification, covering and increasing the section. Scarification consists of enabling better adhesion conditions between the existing part and the repair, where the degraded and disaggregated material is removed by the action of corrosion and then the reinforcements are treated with the application of a rust inhibitor (Gonçalves et al., 2022).

Gonçalves et al. (2022) recommends that adequate covering of concrete structures be carried out, soon after, the increase of the section is carried out, which is the most adopted method for increasing the reinforcement and structural reinforcement and, finally, the application of filling the voids to the self-compacting concrete base.

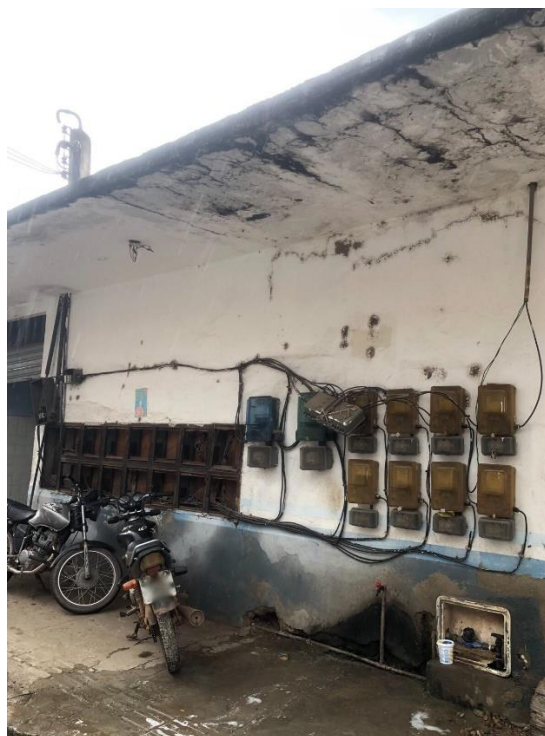
In Figure 11, it is possible to identify electrical installations exposed on the market sidewalk, where there is a high traffic of people and materials, generating life risks for the population.

Exposed electrical wiring transported from one frame to another without being embedded, the risk of being peeled and exposed to moisture, non-standard frames and without covers, exposed circuit breakers, and even hydraulic pipes at the bottom of the sidewalk. It is recommended that an electrical installation project be carried out by a qualified professional, following safety standards and that the situation be applied to other types of existing installations in the building that are probably outside the standards and safety advice.
