## Analysis of pathological manifestations through damage map: case study in Buildings I and K of the Polytechnic School of Pernambuco

**Abstract:** Building inspection in constructions is important to verify that the building is in good safety condition for its occupants, identify problems that harm people's comfort or even determine preventive maintenance to avoid problems early, helping to extend the life of the building. One of the ways to document the condition of a building is through the damage map. The objective of this article is to present the survey of the existing pathological manifestations on the facades of Buildings I and K of the Polytechnic School of Pernambuco, representing them using damage maps to contribute to the maintenance and restoration services of the analyzed buildings. To this end, the architectural survey of the facades of Buildings I and K was carried out, the photographic survey was done using smartphone and drone and finally, the creation of the damage map. With the analysis of the results, it was noticed the presence of 14 pathological manifestations, where the most recurrent were grime and efflorescence. The front and right lateral facades presen

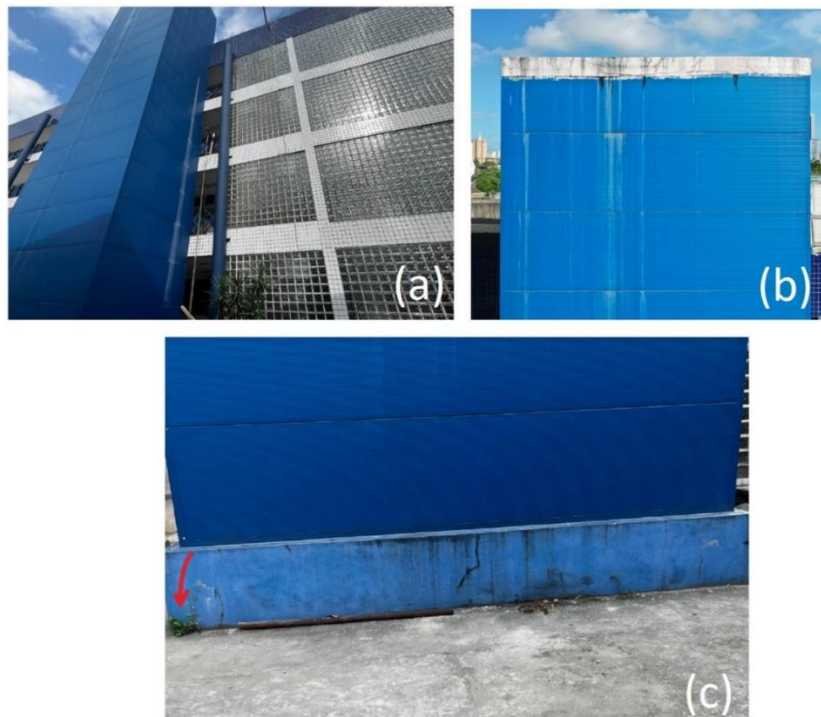
Regarding the shaft of the elevator, on the front and right-side facades, efflorescence was noted, according to Figure 4a, due to rain that causes the carriage of salts from the structure to closer to its base. Figure 4b shows grime at the top of the elevator shaft, on the front facade; this pathological manifestation was probably due to the carriage of the asphalt blanket and solid waste particles present in the parapet. According to Figure 4c, there was also grime at the base of the elevator shaft, formed by the carriage of solid waste particles and vertical cracks; in addition, the presence of vegetation was also noticeable on the front facade.

**Figure 4** – Efflorescence in the elevator shaft (a), grime at the top of the elevator shaft (b), and dirt, cracking, and vegetation at the base of the elevator shaft (c)

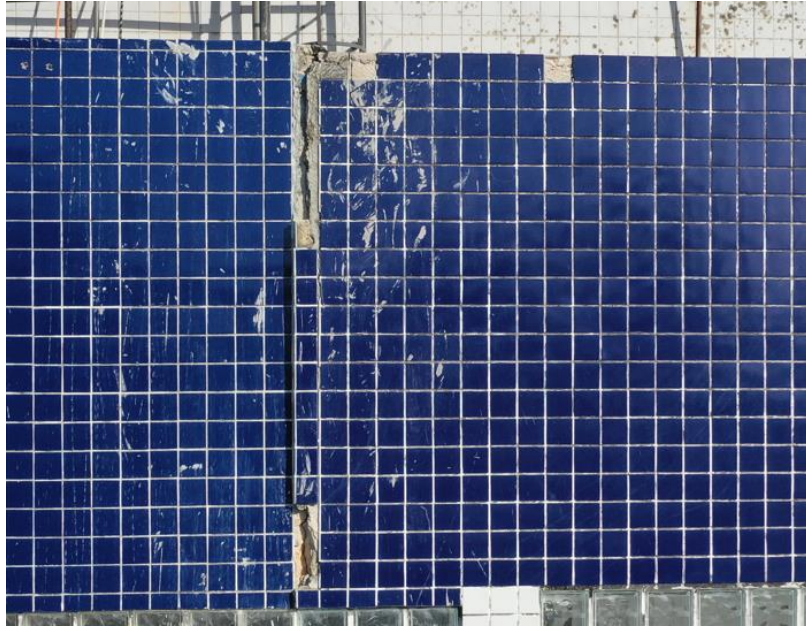
On the upper floors of the facade with ceramic cladding, it was noticeable the presence of grime stains, possibly from the absence of proper cleaning after the application of the grout. It was also noticeable ceramic detachment occurring mainly in regions where the tablets were cut to adapt their dimensions, as shown in Figure 5.

**Figure 5** – Grime stains and ceramic detachment

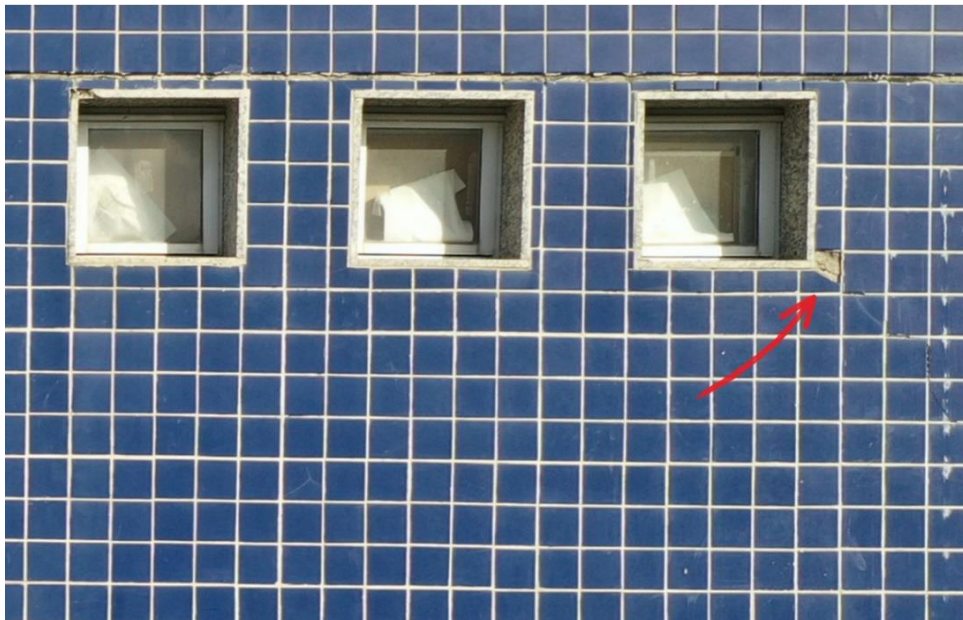
It was noticeable the presence of cracks in the ceramics and grout, which may cause ceramic breakage, as shown in Figure 6. Most cracks occurred in the region of the corners of the windows, tending to form cracks at 45°, possibly caused by the absence of lintels and sill.

**Figure 6** – Cracks in the windows

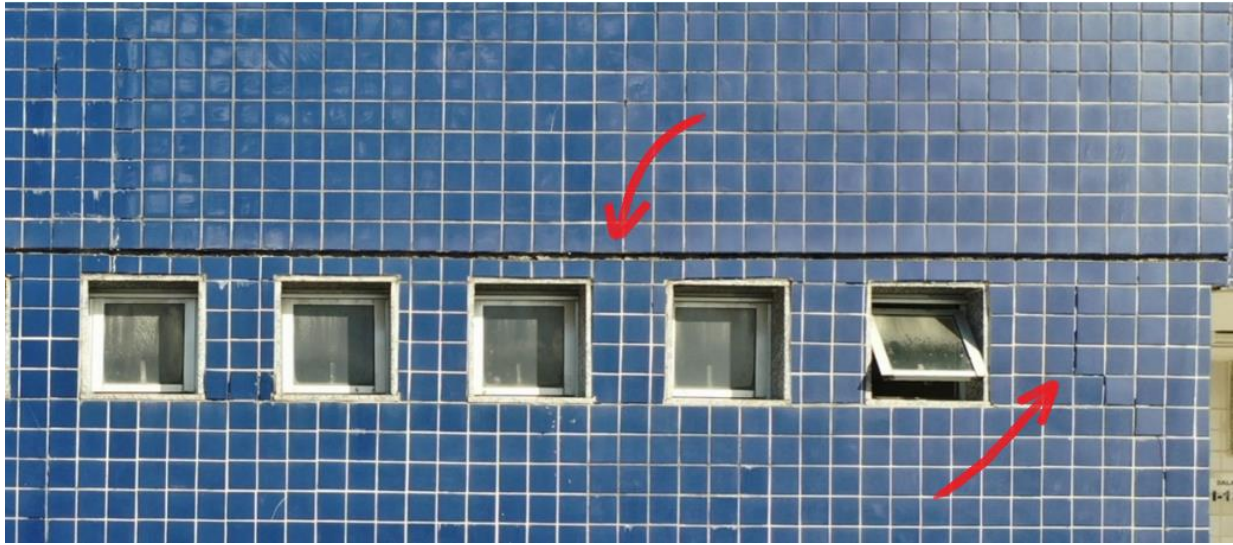
The excess cracking of the grout could cause its separation, noticeable in regions that have indications of being affected by cracks in the grout. In addition, there was separation of the material used in the expansion joint, possibly due to the absence of the use of sealant, as shown in Figure 7.

**Figure 7** – Grout separation

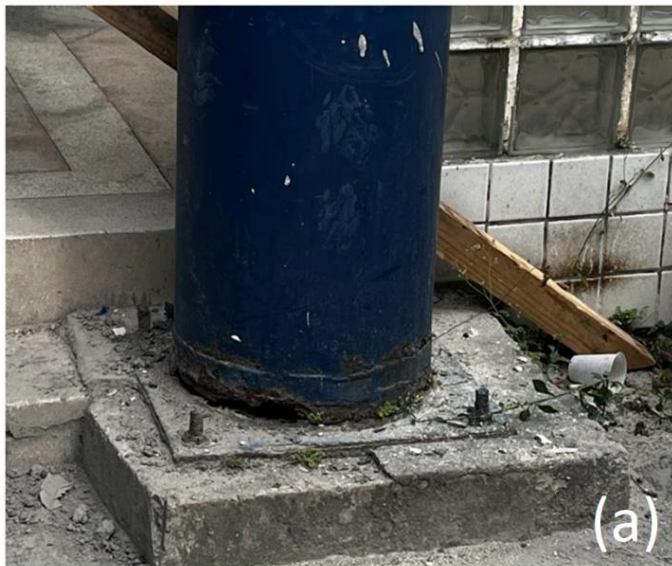
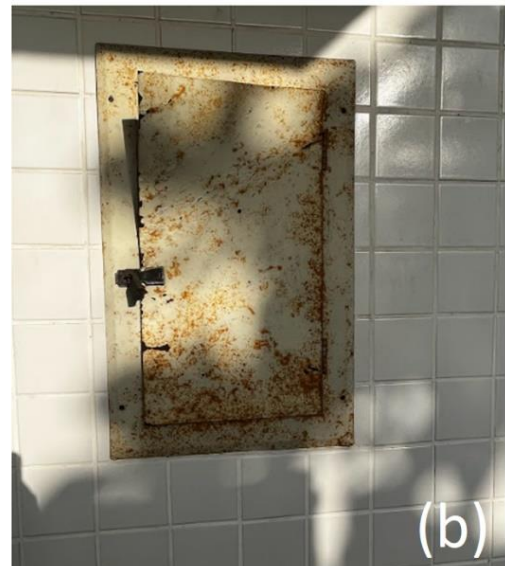
In the building were found spots with steel corrosion. The first spot was at the base of the metal pillar as shown in Figure 8a; this pillar is used as an ornament of the façade and part of its base has lost contact with the ground as a result of corrosion. Figure 8b indicates the occurrence of corrosion in the distribution panel present on each floor. And as a result of this pathological manifestation, there was a loss of the integrity of the panel, which may offer risk of electric shock to the students of the educational institution.

**Figure 8** – Corrosion of the base of metal pillar (a) and corrosion of the distribution panel (b)

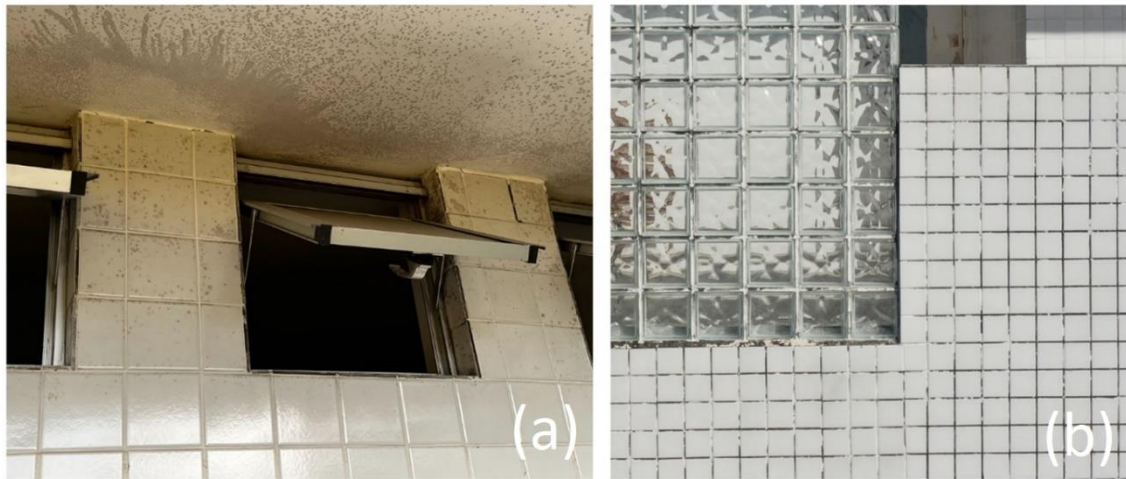
On the third floor of building K, the presence of mold was observed in the region close to the windows frames, as shown in Figure 9a. It was also noted the presence of mold in the grout of the ceramic cladding and on the glass blocks of the facade, as shown in Figure 9b.

**Figure 9** – Presence of mold on the third floor (a) and mold on the grout of the facade (b)

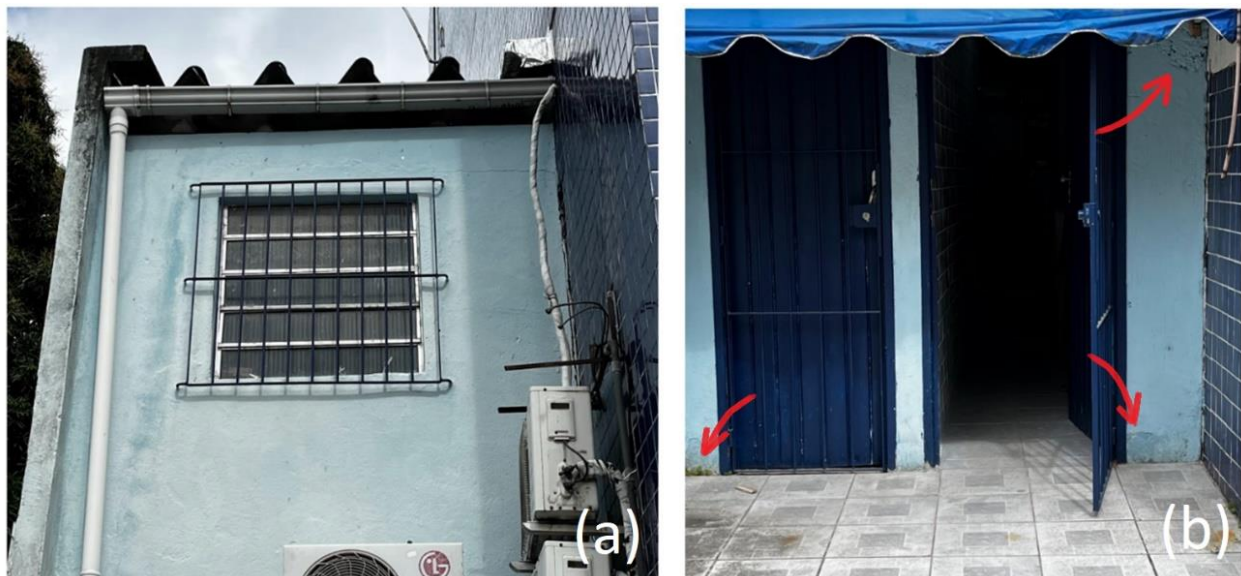
In the region to the left of building I, there is a two-story extension where the warehouse operates from. In this region it was noticeable the presence of grime, coming from the carriage of solid particles from the gutters, and moisture stain, resulting from the infiltration of water from the roof, as shown in Figure 10a, as well as spots where the presence of vegetation occurs near the ground and identification of concrete breakdown, possibly occurred due to failure in concreting, shown in Figure 10b.

**Figure 10** – Grime and moisture stains (a); separation of concrete and vegetation (b)

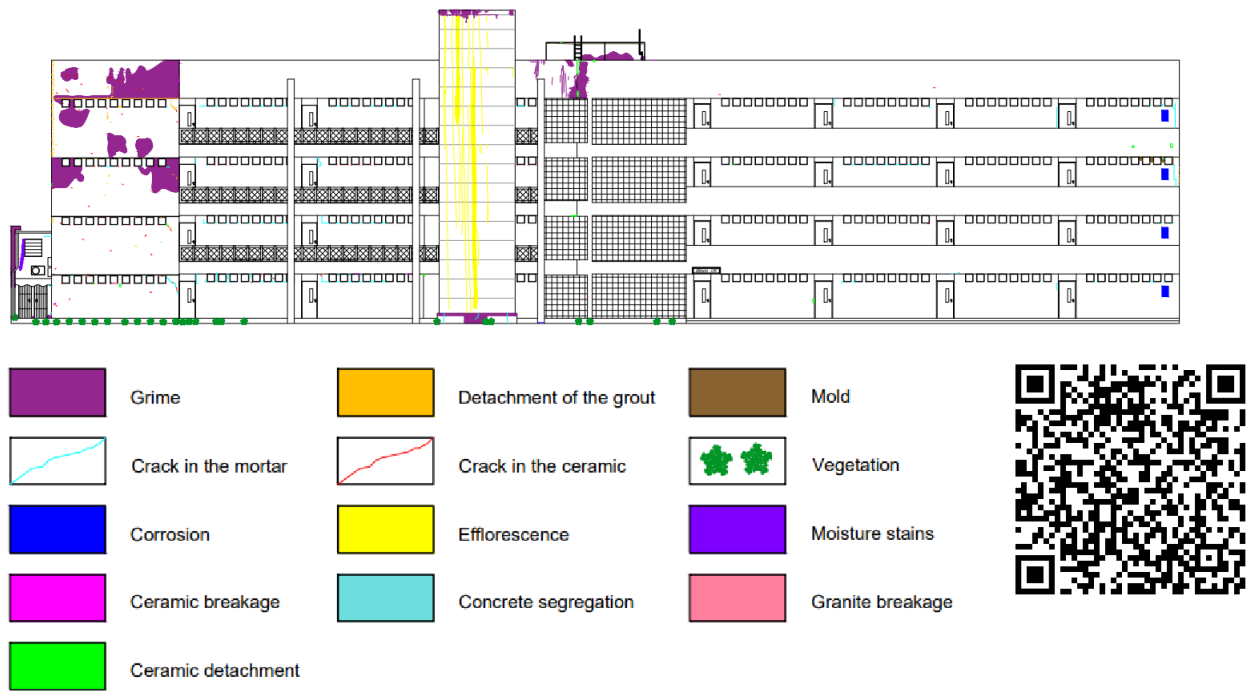
Figure 11 illustrates the damage map of the front facade, indicating the pathological manifestations observed in this facade, with a QRcode to visualize it in higher image resolution. Through the damage map it was possible to perceive that dirt and efflorescence are the most present pathological manifestations in the front facade. It is noticeable the presence of grime predominantly in building I and the elevator shaft, as well as efflorescence from the top to the base of the elevator shaft.

Regarding the presence of mold as a pathological manifestation in the ceramic tile grout and glass block, because it is present in almost all the facades of buildings I and K, it was not represented in the damage map so as not to overlap its graphic representation to the other pathological manifestations and hinder the visualization of the damage map.

**Figure 11** – damage map of the front façade

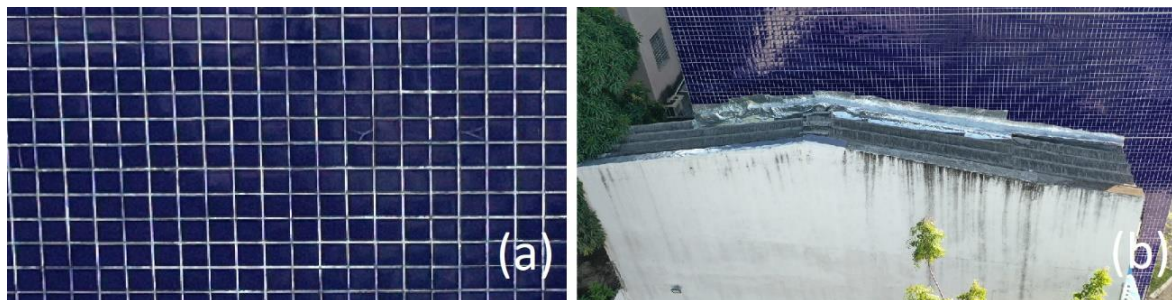
As well as in the front facade, the left side facade presents grime in the ceramic cladding of the main facade and of the attic region, as well as grime in the region of the warehouse and in the painted mortar cladding. Cracks in the ceramic and mold in the grout of the ceramic cladding were also noticeable. Figure 12 illustrates the presence of the aforementioned pathological manifestations.

**Figure 12** – Mold in the grout and cracks in the ceramic (a); grime in ceramic cladding and grime in the painted mortar coating (b)

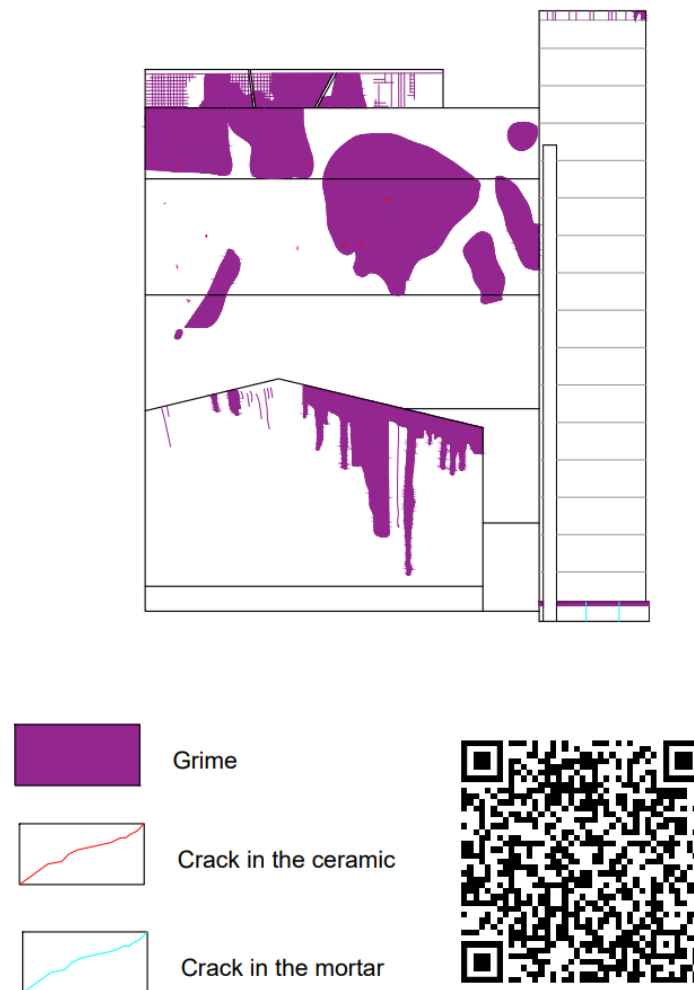
Figure 13 shows the pathological manifestations of the left lateral facade on the damage map, with a QRcode to visualize it in a higher image resolution. Through this visualization it was possible to evidence a large presence of grime, especially in the tallest region of the building. The presence of cracks in the ceramic was also noticeable.

**Figure 13** – Damage map of the left side façade

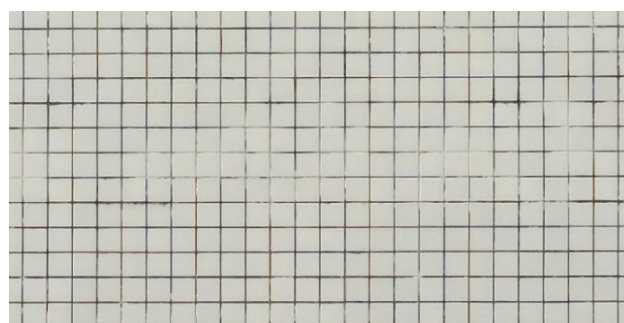
In addition to the pathological manifestations identified in the elevator shaft, mold was found in the main right-side facade, in the ceramic grout, as shown in Figure 14. During the drone inspection, it was not possible to record the attic, so its pathological manifestations were not recorded.

**Figure 14** – Mold in the ceramic grout

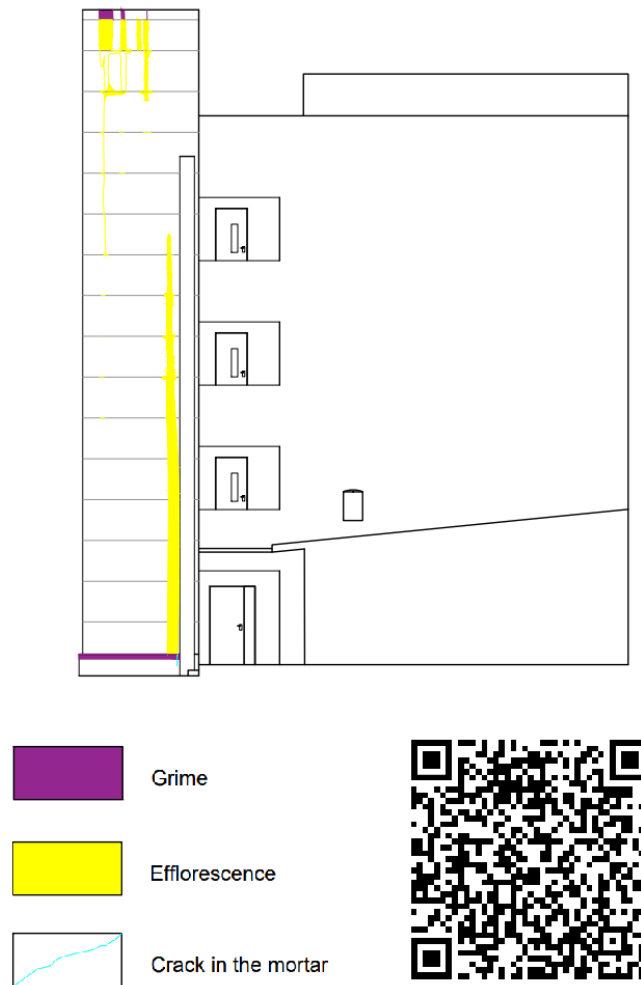
Figure 15 presents the damage map of the right-side facade, with a QRcode to visualize it in a higher image resolution, identifying only the presence of dirt and efflorescence in the elevator shaft.

The right lateral facade was the facade with less presence of pathological manifestations, this may be due its South facing orientation, receiving less solar incidence. Thus, the front facade faces the West, having a higher

solar incidence in relation to the other facades studied and has a greater record of pathological manifestations.

**Figure 15** – Damage map of the right-side façade
