## Damage maps of façades of a public university

Thus, the objective of the present work is to carry out the identification of the building defects present on the façades of Block D of POLI and to elaborate a map of damages, with the intention of contributing in the planning of maintenance and conservation of the façades of the structure.

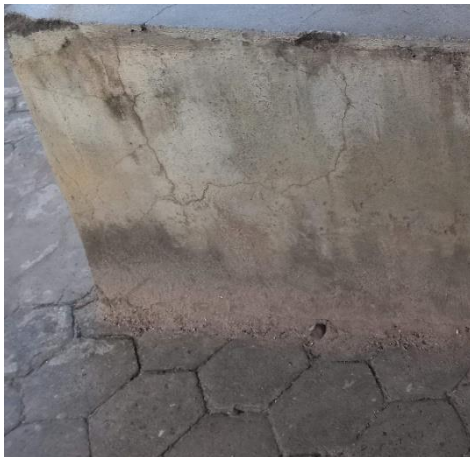
On the ramps that provide access to the rooms, the presence of dirt, cracks, and fissures on their sides were observed, as shown in Figures 5 and 6. These mapped fissures may have been caused by hygroscopic changes in the material used for the ramp coating during the execution process. As for dirt, its appearance may have been caused by the absence of rainwater drainage mechanisms in the building and institution, which leads to flooding on days of heavy rain and, consequently, darkening in the lower regions of the facades.

**Figure 5** – Fissures on ramp

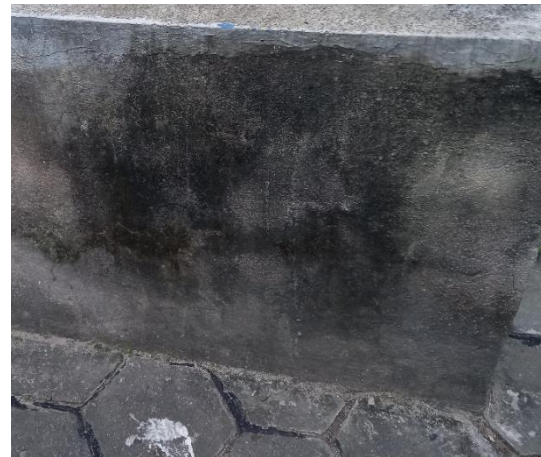
**Figure 6** – Dirt on the ramp

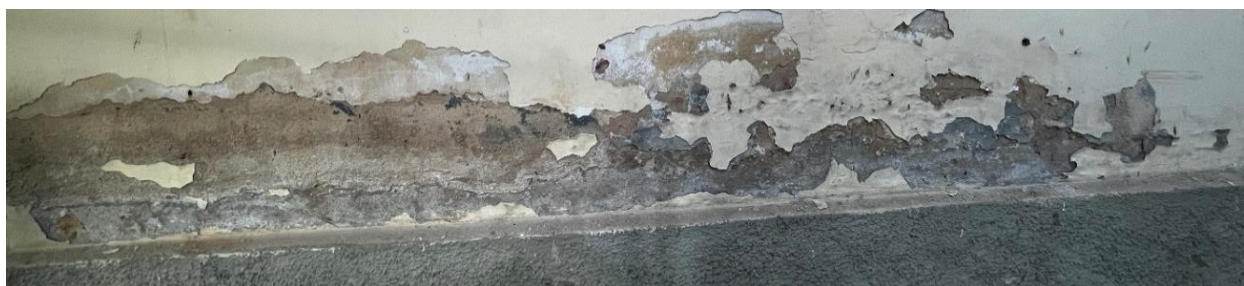
In the lower part of the façade, the presence of paint detachment from one or more layers of paint was identified, in almost its entire length, leaving the mortar coating exposed and susceptible to aggressive agents, in addition to fissures indicating future detachments. It is possible that the façade was painted more than once and the substrate was not properly prepared for the application of the new paint, resulting in these problems that cause unpleasant aesthetics for the building, as can be seen in Figure 7.

**Figure 7** – Paint detachments

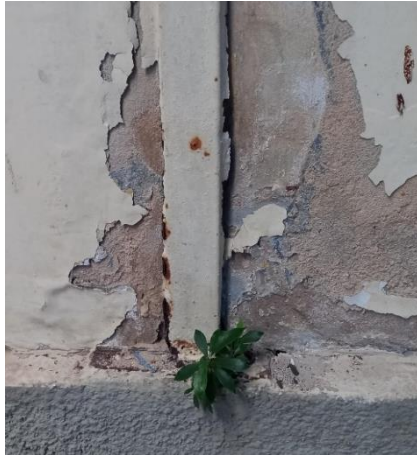
The building has a tiled roof, which is made up of horizontal supporting metal parts and metal pillars, which are also part of the structure of the façades. In the vertical pieces, the presence of corrosion and vegetation was identified, as in Figures 8 and 9, indicating the presence of water in this region. Corrosion could have been caused due to lack of cover or some type of adequate protection on the pillars, in Figures 8 and 9 it can be seen that the only protection would be the paint that was used to paint the entire building and is highlighting on the sides of the pillars. pillars, making the region susceptible to the entry of rainwater.

**Figure 8 – Corrosion and vegetation**

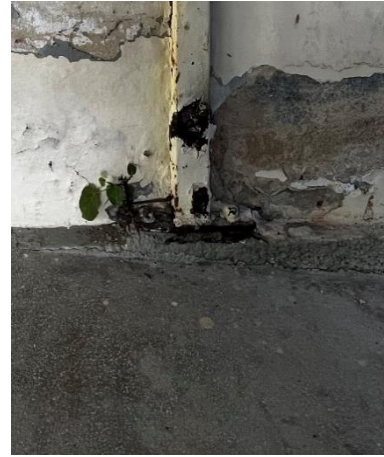
**Figure 9 - Corrosion and vegetation on the column**

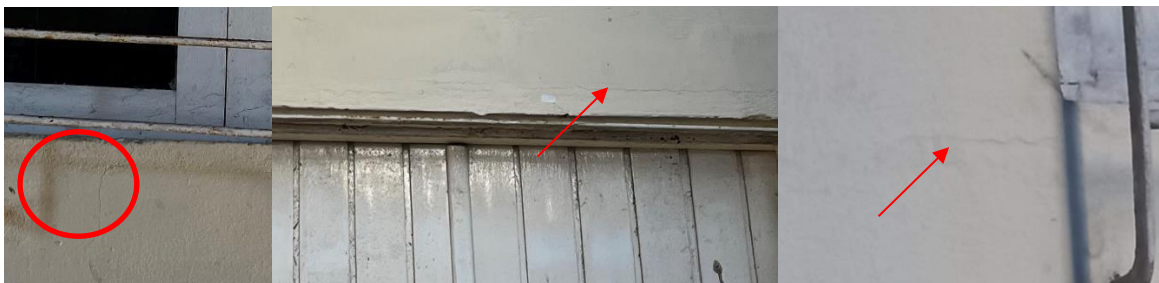
In all doors and windows, the presence of fissures was identified, which can be seen in Figure 10. Some of them are at a 45-degree angle, indicating the absence of lintels and sills, while others may have been caused by thermal expansion of the door and window materials, as this façade receives a lot of sunlight as it faces west.

**Figure 10 – Fissures on doors and windows**

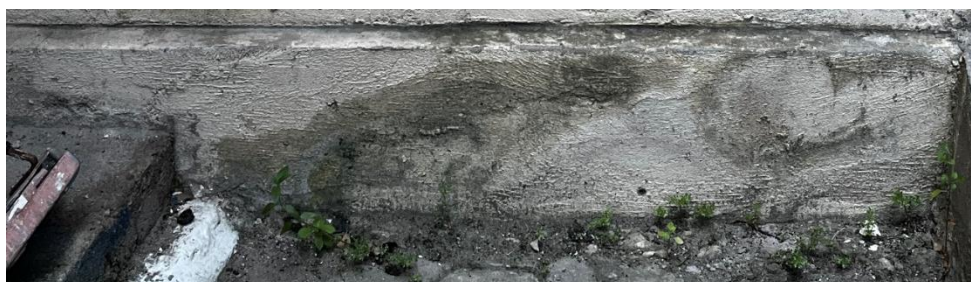
In the back part of the building, where the extension group's laboratory is located, in addition to the 45° fissures in the window, the presence of dirt and vegetation was also identified, which can be seen in Figure 11, indicating the presence of water that can be the condensers that are to the side, on the right side façade.

**Figure 11 – Dirt and vegetation**

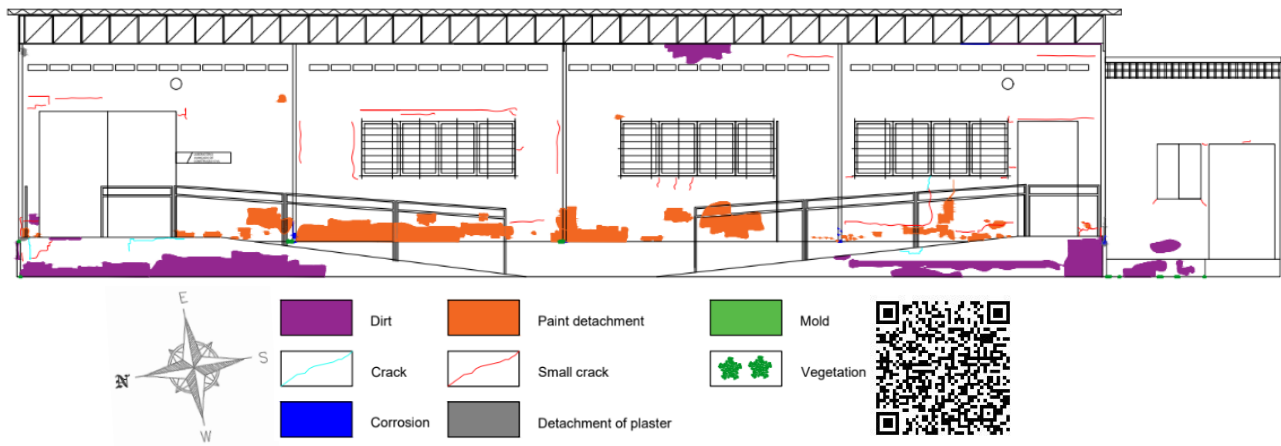
**Figure 12** – Damage map of the front façade

For a better visualization of the location of the aforementioned problems, a damage map of the façade was prepared, which can be seen in Figure 12. On the map, it is possible to identify the predominance of orange,

purple and red colors that represent paint detachment, dirt and fissures, respectively. The façade has a large presence of defects, eight different types, due to the lack of conservation, bringing an undesirable appearance to the building, mainly the front façade.

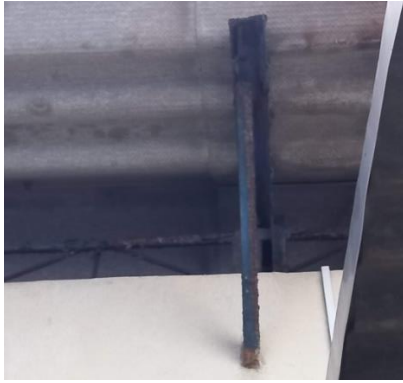
In the supporting structures of the roof, it was possible to identify the presence of corrosion, as shown in Figure 14. This problem may have been caused due to contact with rainwater or water from the condensers located in the adjacent building, Block C. In addition, the absence of an anti-corrosive treatment to protect the steel components can accelerate the corrosive process.

**Figure 14** – Pieces with corrosion

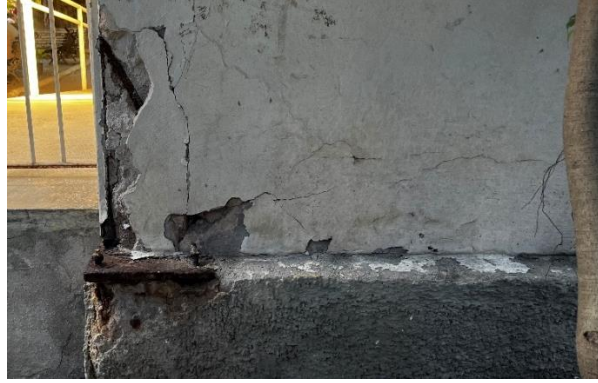
**Figure 15** – Pillar of the right side façade

The presence of corrosion was also identified at the end of the metallic pillar that is part of the support of the tile, as shown in Figure 15, the corrosion may have started due to the peeling of the plaster that kept it protected.

In Figure 15, it is possible to see the presence of a crack in the plaster, which shows that the facade is still susceptible to further detachment in that region. In addition, there are several fissures and paint detachment, which are constant problems throughout this facade, as shown in Figure 16.

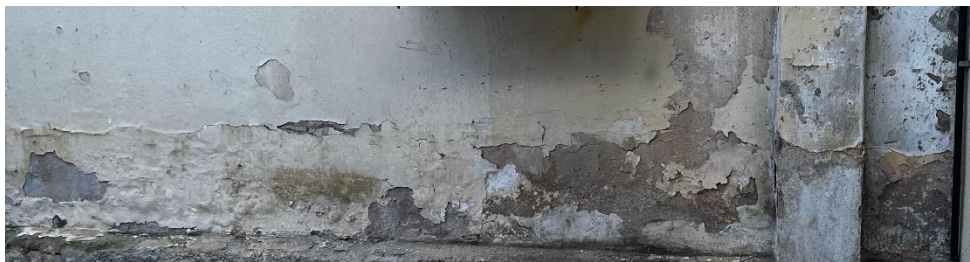
The possible causes for these damages may be similar to those of the front facade, such as lack of preparation of the substrate to receive the new paint, in addition to the presence of water from the condensers generating moisture. It is worth noting that the lack of substrate or plaster can contribute to the appearance of the courses of the masonry, making them susceptible to degrading external agents.

**Figure 16** – Fissures and paint detachment

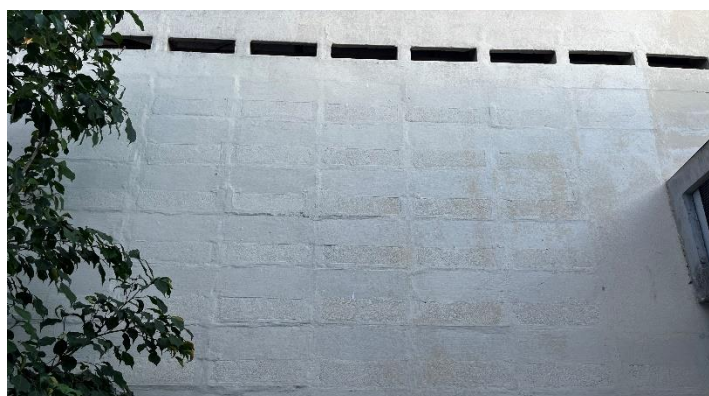
On this façade, there are two air conditioning condensers and the presence of a fissure above each one was noted. The possible cause would be due to the closure of some previously existing openings on all façades, Figure 17 shows the presence of small openings and just below the closing marks of others, which may result in later cracks.

**Figure 17** – Marks on the façade

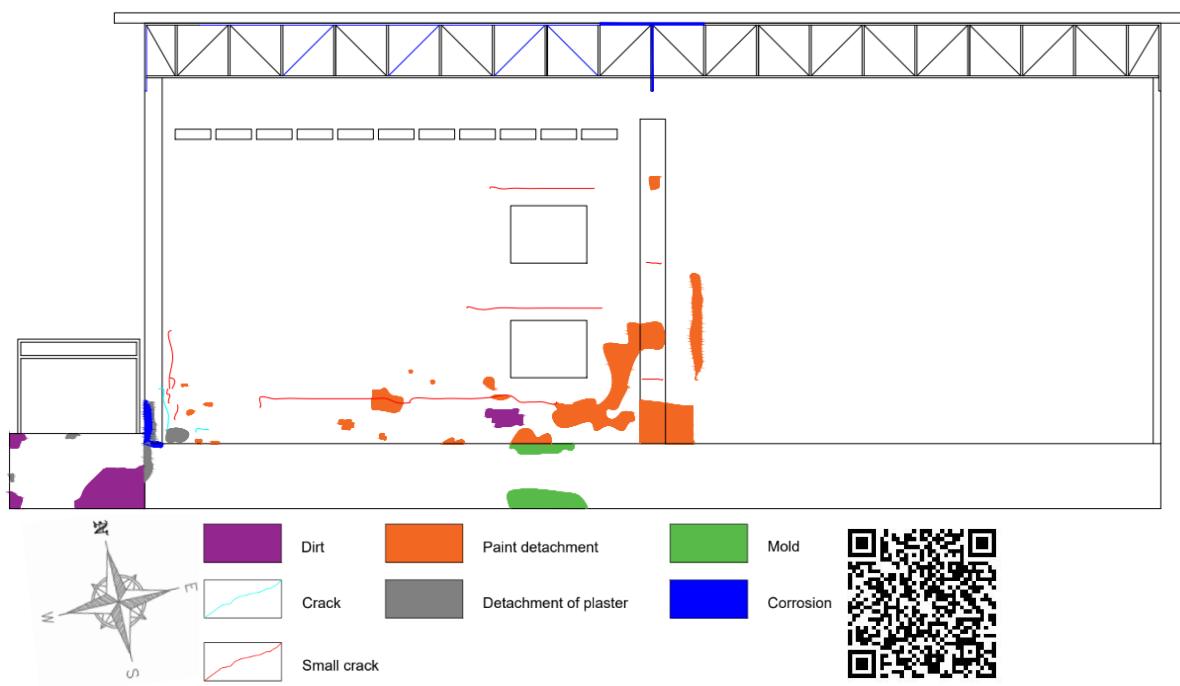
**Figure 18** – Damage map of the right side façade

In the lower part of the façade, below the condensers, the presence of mold stains was also identified, possibly due to the humidity caused by the equipment. In the area of the ramp there is also the presence of dirt and peeling plaster, which are represented in the damage map in Figure 18.

As previously mentioned, from the pillar it is not possible to visualize the façade, therefore, the map is blank in the region on the right. As for the left region, there are many types of anomalies, there is a lower presence of dirt and a greater presence of plaster detachment when compared to the front façade. Besides that, in addition to the pillar, corrosion is also found on the metal parts of the tile.

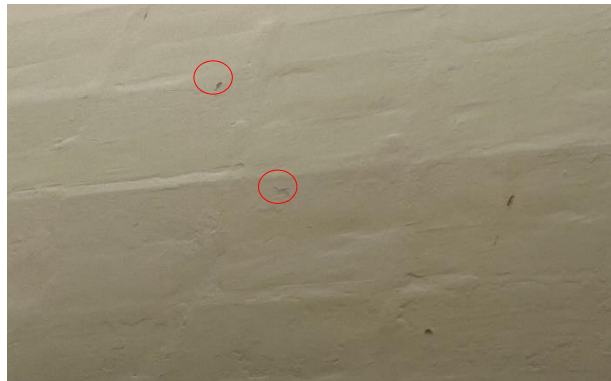
During the inspection, it was possible to find only small detachments of paint, as in Figure 20, and dirt on the lower part of the façade and on the ramp, in addition to a crack and the presence of a small vegetation, as shown in Figure 21. The crack could have originated due to the meeting of the pillar with the wall, both of different materials.

**Figure 20** – Paint detachments

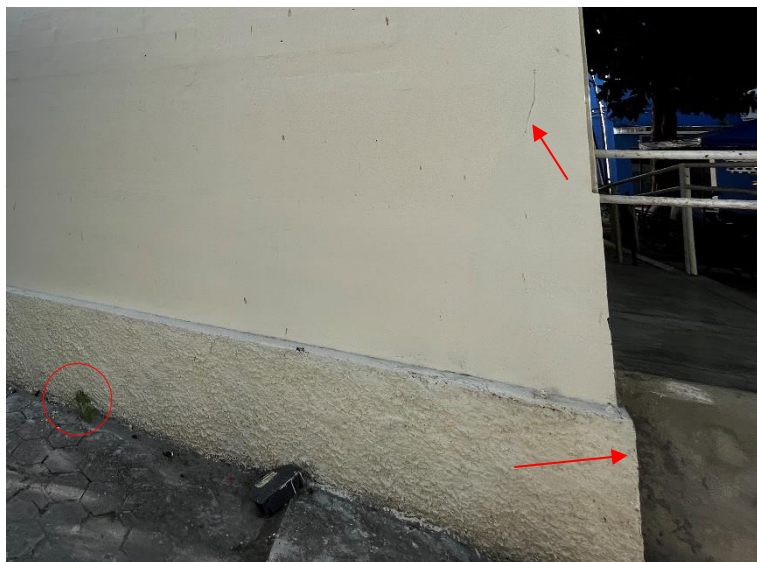
**Figure 21** – Building defects of left side façade

It was also identified the presence of dirt in the upper left part of the façade and detachment of plaster at the right end of the ramp. The detachment of plaster in the ramp regions may be due to the use of different materials for its construction and the preparation of the floor (such as the type of mortar used) or due to thermal expansion, leading to disaggregation of materials and, consequently, detachment.

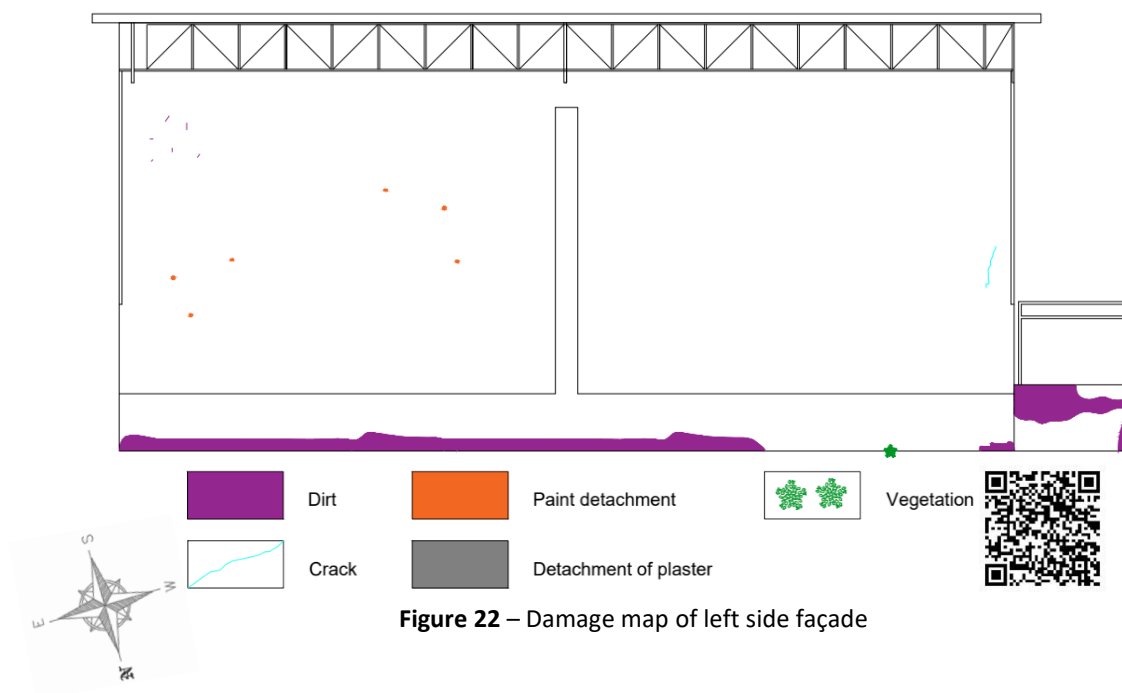
Figure 22 shows the façade damage map, gathering the location of the problems found and their respective nomenclature. In it, it is possible to see the predominance of dirt in relation to the other manifestations and it is only found in the lower region, also only a crack and no fissure was found.

The façade is in a better state of conservation than the others, which may indicate that it is less susceptible to degradation mechanisms or that it has received some type of maintenance, such as cleaning and repainting.

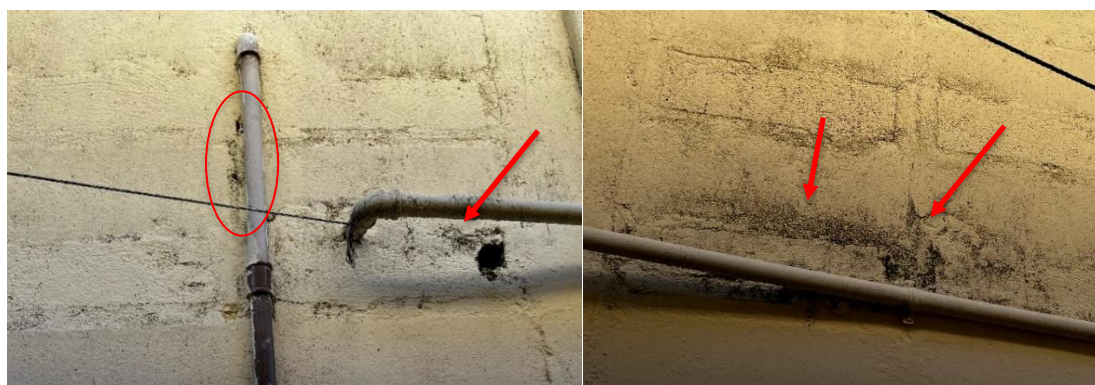
In the posterior facade, only photographic records of pathological manifestations were made, as access is through a narrow corridor to another building block. In this facade, there are three air conditioning condensers with small openings made in the facade for the passage of electrical conduits and plumbing. Due to the presence of moisture, dirt and mold stains were found, as shown in Figures 23 and 24.

Figure 23 – Dirt and mildew stains

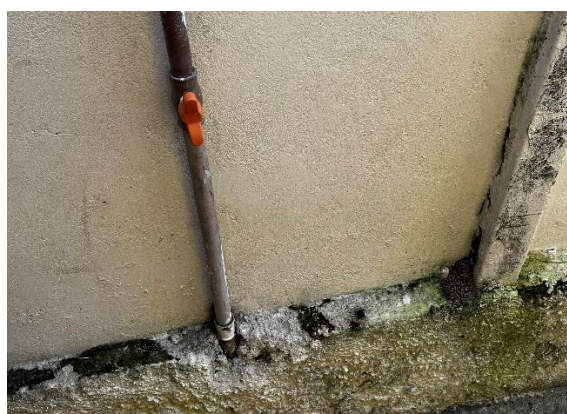
Figure 24 – Mold

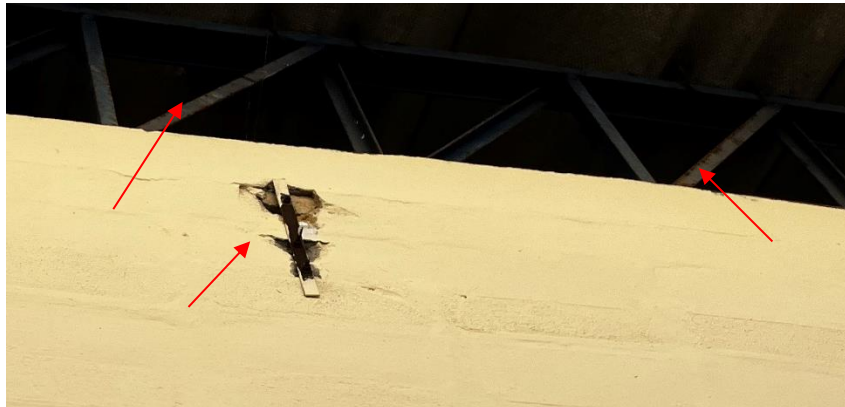
Along the length of the façade, more mold and dirt patches were seen, as well as some peeling plaster. In some parts of the roof of the building, which can be seen in Figure 25, the presence of corrosion that may have arisen due to contact with rainwater was also identified.

**Figure 25** – Pieces with corrosion

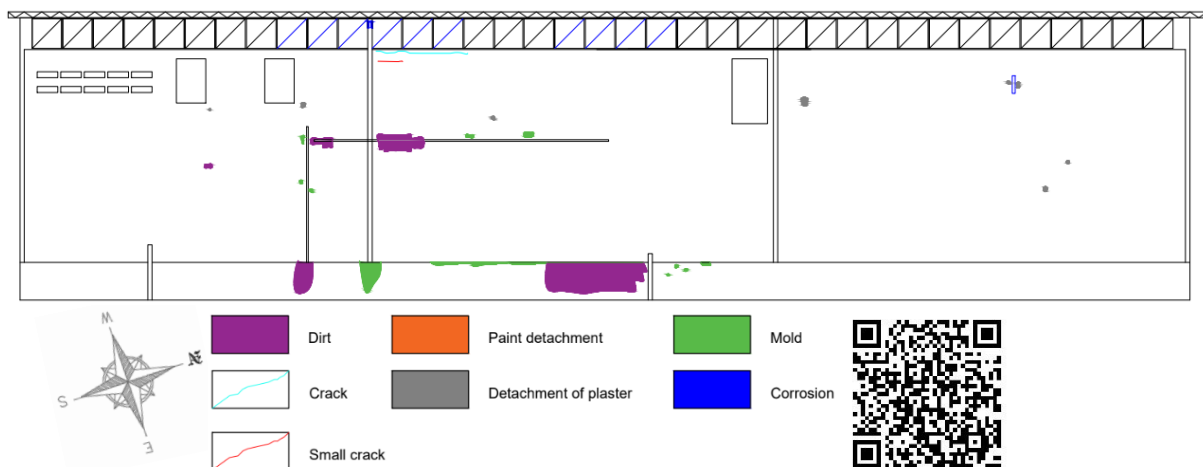
**Figure 26** – Damage map of the posterior façade

The damage map in Figure 26 shows all the façade details, however, it is worth noting that on the left part of the façade, where small openings are located, there is no damage drawn on the map because there is an entrance to another block, which is not possible to analyze the region.

The façade also shows little incidence of defects, as well as the left side, with corrosion, mold and dirt more present, in relation to the others. A crack and a fissure were identified, there is also the presence of corrosion on the supporting parts of the tile, as on the right side façade.
