## Incidence of pathological manifestations and proposition of corrective measures in an Institute of Higher Education in the city of Quixadá/CE

**Abstract:** Throughout its use, a building will certainly be exposed to degradation due to external factors, such as the natural effects of climate, and even as a result of misuse. Additionally, errors made during its construction accelerate the deterioration process. Therefore, it is essential to be alert to the performance of buildings, conducting inspections and maintenance using efficient methods at appropriate intervals, in order to minimize the occurrence of pathological manifestations that impact the comfort and safety of users. As a result, this article aims to investigate potential construction-related pathologies through visual inspection at an Institute of Higher Education located in Quixadá, Ceará, Brazil, and propose corrective technical recommendations for the identified pathological manifestations. The study employed an applied research methodology with an exploratory research objective and a qualitative approach. After inspecting and analyzing the collected data, it was found that the building exhibited a high number of

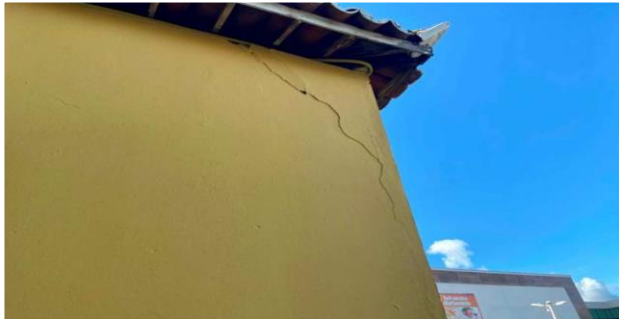
| | <ul style="list-style-type: none"> <li>• Pathological manifestation: crack caused by overloading of the masonry;</li> <li>• Causes: insufficient reinforcement; absence of a beam;</li> <li>• Risk level: medium;</li> <li>• Anomaly: endogenous; functional.</li> </ul> |

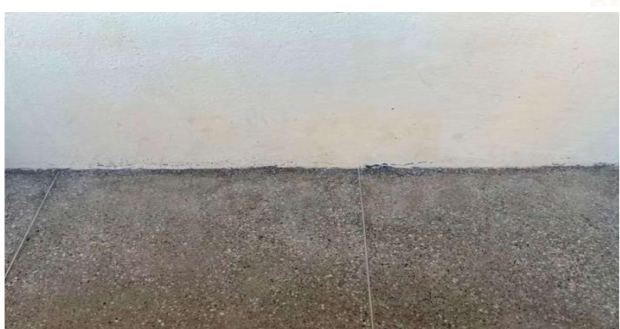
| | <ul style="list-style-type: none"> <li>• Pathological manifestation: crack in the masonry;</li> <li>• Causes: error in the execution of the joint between the masonry and the foundation;</li> <li>• Risk level: medium;</li> <li>• Anomaly: endogenous; functional.</li> </ul> |

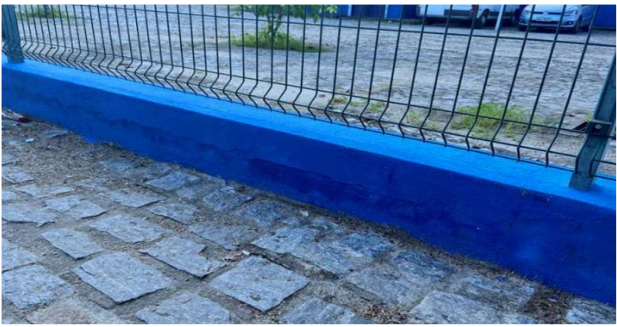
| | <ul style="list-style-type: none"> <li>• Pathological manifestation: repression fissure; thermal movement cracking;</li> <li>• Causes: tensile and shear stresses; hygroscopic movements (humidity by capillary rise); thermal expansion;</li> <li>• Risk level: medium;</li> <li>• Anomaly: endogenous; natural.</li> </ul> |

| Construction system | Technical recommendations |
|---|---|
| | Treatment of expansion joints to reduce cracks caused by thermal movement |

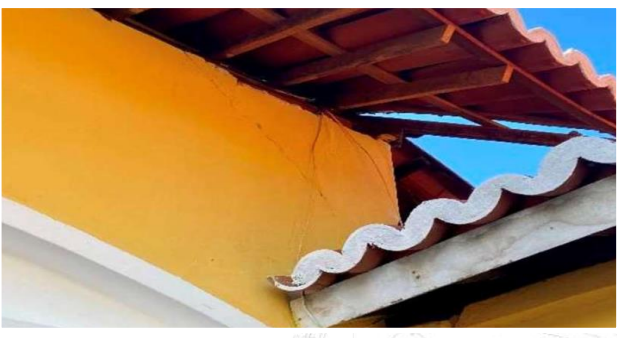
| | <ul style="list-style-type: none"> <li>• Pathological manifestation: fissure caused by overloading masonry;</li> <li>• Causes: deficiency in reinforcement; absence of a beam;</li> <li>• Risk level: medium;</li> <li>• Anomaly: endogenous.</li> </ul> |

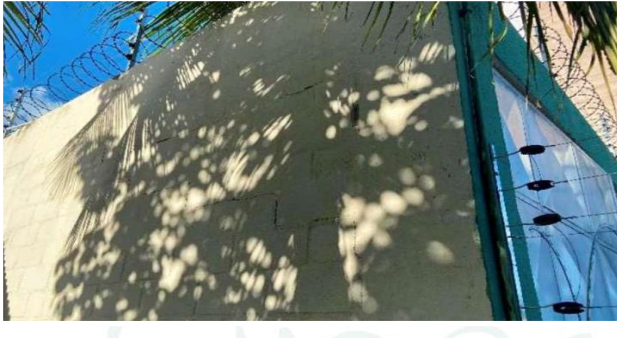
| | <ul style="list-style-type: none"> <li>• Pathological manifestation: fissure caused by overloading of masonry;</li> <li>• Causes: crushing of the mortar joints; thermal expansion;</li> <li>• Risk level: medium;</li> <li>• Anomaly: endogenous.</li> </ul> |

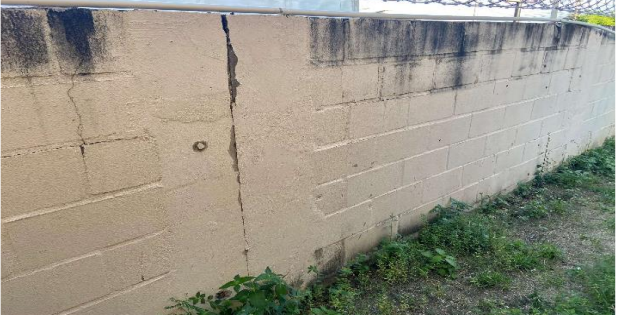
| | <ul style="list-style-type: none"> <li>• Pathological manifestation: vertical cracks due to lack of anchoring with reinforcement between the systems;</li> <li>• Causes: absence of a tie screen;</li> <li>• Risk level: medium;</li> <li>• Anomaly: endogenous.</li> </ul> |

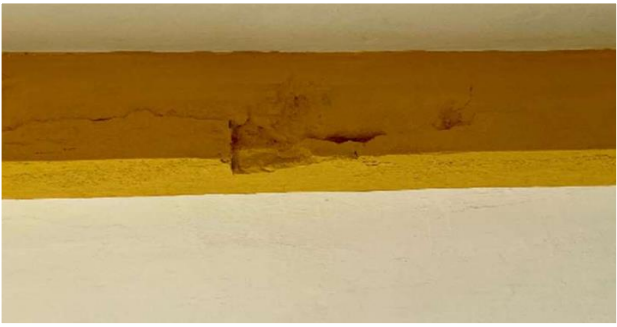
| | <ul style="list-style-type: none"> <li>• Pathological manifestation: detachment and exposed reinforcement;</li> <li>• Causes: inadequate reinforcement cover; improper positioning of the reinforcement; poor concrete quality;</li> <li>• Risk level: high;</li> <li>• Anomaly: endogenous; functional.</li> </ul> |

| Construction system | Technical recommendations |
|---|---|
| Concrete structures | Coating of exposed reinforcement with anticorrosive material to prevent further damage to the exposed steel |

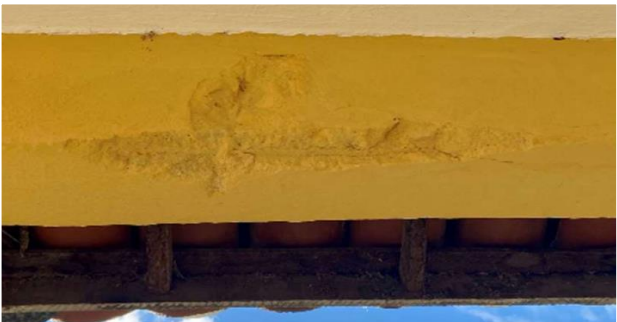
| | <ul style="list-style-type: none"> <li>• Pathological manifestation: concrete spalling and exposed reinforcement;</li> <li>• Causes: inadequate reinforcement cover; improper positioning of reinforcement;</li> <li>• Risk level: high;</li> <li>• Anomaly: endogenous.</li> </ul> |

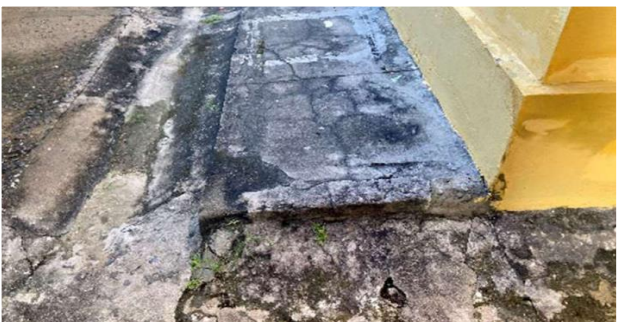
| | <ul style="list-style-type: none"> <li>• Pathological manifestation: fissures caused by shrinkage;</li> <li>• Causes: inadequate concrete placement; insufficient concrete curing; lack of reinforcement; water infiltration;</li> <li>• Risk level: minimal;</li> <li>• Anomaly: endogenous; natural.</li> </ul> |

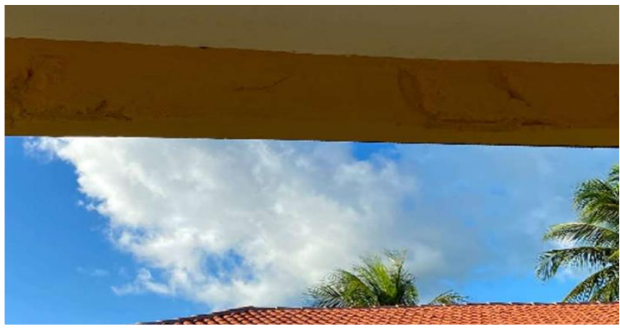
| | <ul style="list-style-type: none"> <li>• Pathological manifestation: nest of concreting and exposed reinforcement;</li> <li>• Causes: inadequate reinforcement cover; improper positioning of the reinforcement;</li> <li>• Risk level: high;</li> <li>• Anomaly: endogenous.</li> </ul> |

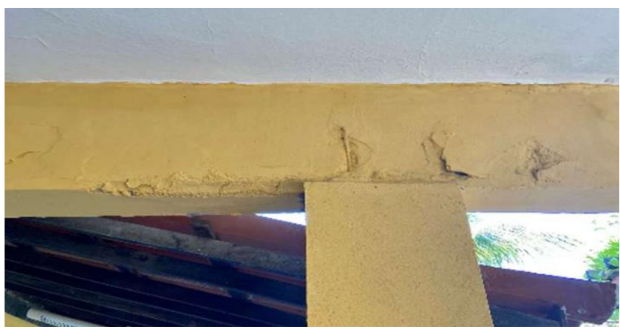
| | <ul style="list-style-type: none"> <li>• Pathological manifestation: nest of concreting and exposed reinforcement;</li> <li>• Causes: inadequate reinforcement cover; improper positioning of the reinforcement;</li> <li>• Risk level: high;</li> <li>• Anomaly: endogenous.</li> </ul> |

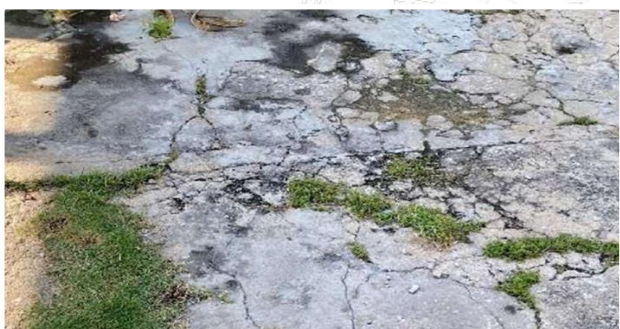
| | <ul style="list-style-type: none"> <li>• Pathological manifestation: shrinkage cracks;</li> <li>• Causes: inadequate concrete pouring; inadequate curing of concrete; insufficient reinforcement; infiltration;</li> <li>• Risk level: minimal;</li> <li>• Anomaly: endogenous; natural.</li> </ul> |

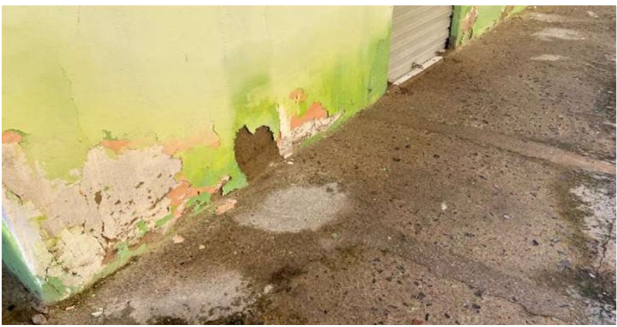
| | <ul style="list-style-type: none"> <li>• Pathological manifestation: stains and degradation of the coating;</li> <li>• Causes: rising humidity (capillary rise); lack of maintenance;</li> <li>• Degree of risk: minimal;</li> <li>• Anomaly: endogenous.</li> </ul> |

| Construction system | Technical recommendations |
|---|---|
| Floor, wall, and ceiling cladding | Renovation of completely deteriorated coatings, especially those executed with mortar, by removing the old coating and redoing it |

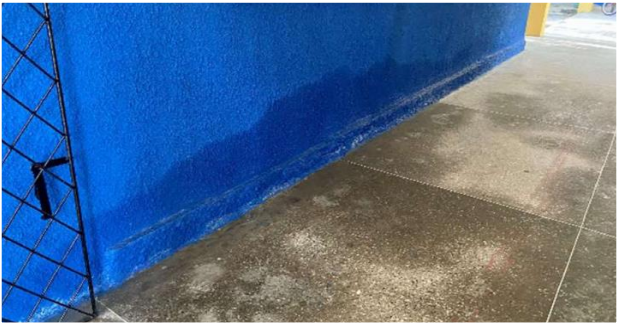
| | <ul style="list-style-type: none"> <li>• Pathological manifestation: infiltration;</li> <li>• Causes: capillary rise (rising damp);</li> <li>• Degree of risk: minimal;</li> <li>• Anomaly: endogenous.</li> </ul> |

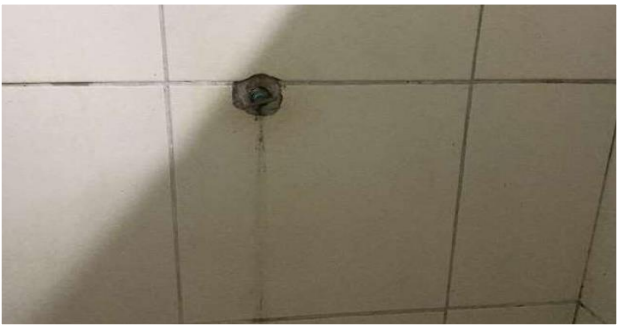
| | <ul style="list-style-type: none"> <li>• Pathological manifestation: lack of coating;</li> <li>• Causes: absence of finishing after removing a sanitary appliance; lack of maintenance;</li> <li>• Degree of risk: minimal;</li> <li>• Anomaly: exogenous.</li> </ul> |

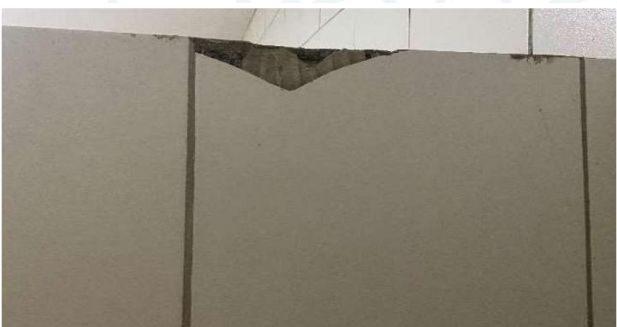
| | <ul style="list-style-type: none"> <li>• Pathological manifestation: coating breakdown;</li> <li>• Causes: misuse; possible accident;</li> <li>• Degree of risk: minimal;</li> <li>• Anomaly: exogenous.</li> </ul> |

| Construction system | Technical recommendations |
|---|---|
| | Replacement of fragmented coating with new ceramic coatings |

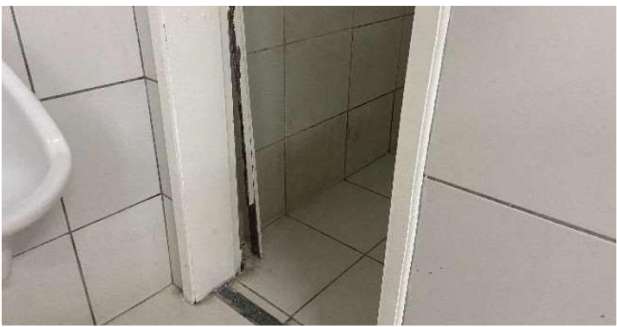
| | <ul style="list-style-type: none"> <li>• Pathological manifestation: break in the frame shape;</li> <li>• Causes: misuse; possible accident;</li> <li>• Degree of risk: minimal;</li> <li>• Anomaly: exogenous.</li> </ul> |

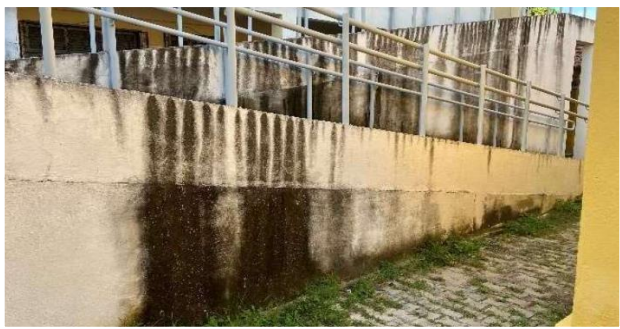
| | <ul style="list-style-type: none"> <li>• Pathological manifestation: infiltration;</li> <li>• Causes: water exposure;</li> <li>• Degree of risk: minimal;</li> <li>• Anomaly: endogenous.</li> </ul> |

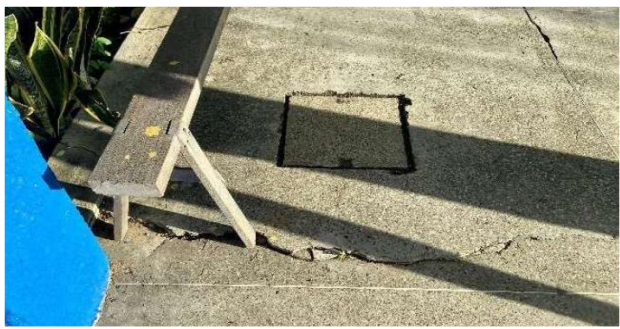
| | <ul style="list-style-type: none"> <li>• Pathological manifestation: crack in the floor;</li> <li>• Causes: uncontrolled root growth of nearby trees;</li> <li>• Risk level: medium;</li> <li>• Anomaly: endogenous; natural.</li> </ul> |

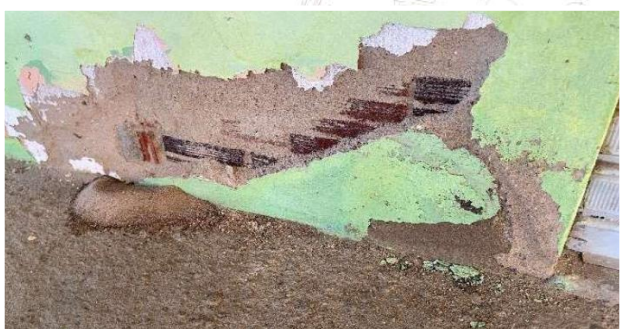
| | <ul style="list-style-type: none"> <li>• Pathological manifestation: peeling of plaster;</li> <li>• Causes: absence of roughcasting; poor mortar quality; lack of maintenance;</li> <li>• Risk level: minimal;</li> <li>• Anomaly: exogenous.</li> </ul> |

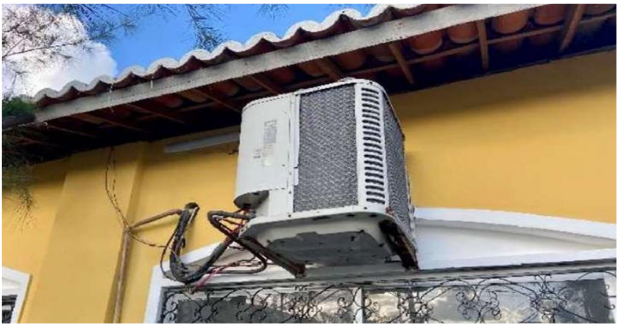
Specifically, all the air conditioning installations in the building had exposed wiring on the exterior side of the HEI, posing a risk to the lives of students who used the space daily due to the possibility of electric shocks, thermal effects, and overcurrent situations.

| | <ul style="list-style-type: none"> <li>• Pathological manifestation: exposed wiring;</li> <li>• Causes: lack of finishing;</li> <li>• Risk level: critical (high);</li> <li>• Anomaly: endogenous.</li> </ul> |
