## Use of Thermography in the Analysis of Pathological Manifestations of Historical and Artistic Building Facades in the City of Sobral - Ceará

**Abstract:** This article aims to discuss the importance of thermology in the identification of pathological manifestations in civil construction, as well as the application of thermography in 6 facades of the artistic and cultural heritage of the city of Sobral, in the state of Ceará, in Brasil, using the thermographic camera Flir model C2 – XT. Two analyzes were carried out in each structure, one in a period of direct contact with the sun's rays and the other in the absence of this solar incidence, with the objective of having two maps with different temperatures, with a greater possibility of verifying the problems on the facades of the chosen buildings, namely, São João Theater, Church of Sorrows, São Francisco Church, Church of the Rosary, Dom José Museum and Vale do Acaraú State University (UVA) – Betânia Campus. All buildings were analyzed, as well as identifying existing problems and possible potential manifestations, demonstrating and exposing solutions with applications of more modern technologies that guarantee the good perform

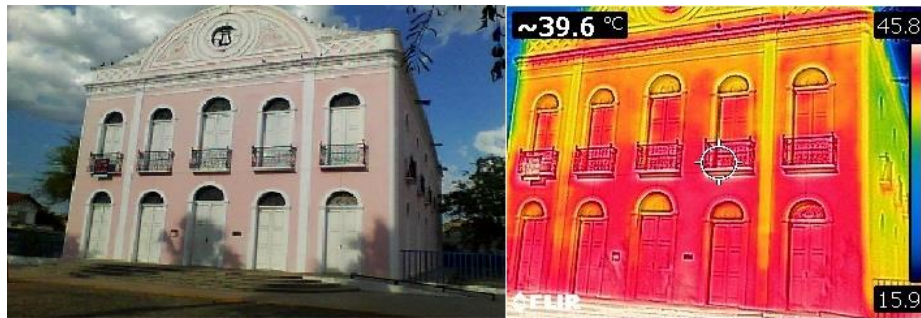
Analyzing Figure 2, the difference in temperature between the base of the building and the top is notorious, the red spots present higher temperatures already approaching the maximum recorded by the equipment, which was 45.8°C, while the more yellowish top presented a clearer and more pleasant color.

**Figure 2** - Thermographic map of the facade of São João Theater in the afternoon.

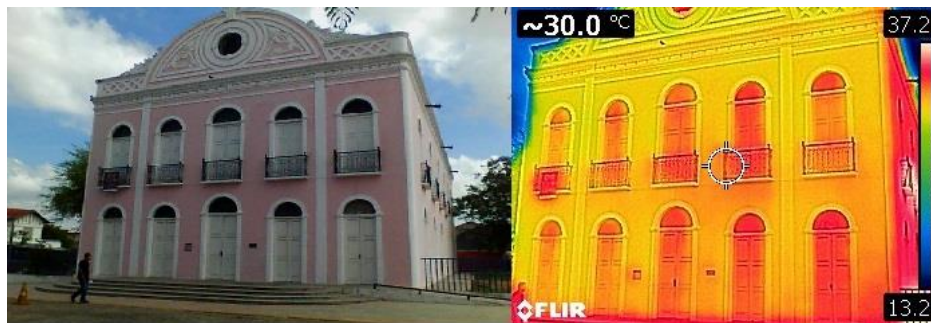
In the morning (Figure 3) with a much lower temperature and better distribution across the facade, it was possible to see only small darker heat lines in the lower part of the facade, in the line of contact between the sidewalk and the building, in addition to a larger spot in the lower right corner, which may characterize the presence of moisture coming from the soil by capillary ascending.

**Figure 3** - Thermographic map of the facade of São João Theater in the morning.

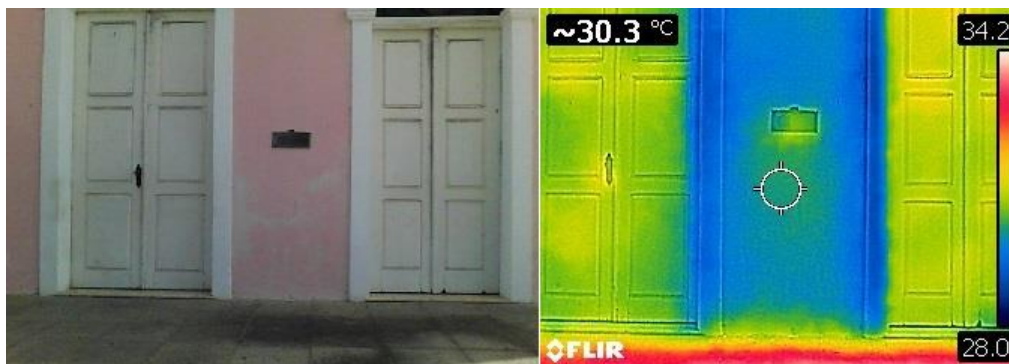
When carrying out an analysis closer to the site (Figure 4), the temperature difference was confirmed by the thermographic camera, thus making clear the presence of moisture on the facade wall as a result of capillary rise, a property of water that enables it to overcome the force of gravity and climbing on walls that do not have waterproofing protection on the foundation, including already having white stains on the paint due to the presence of moisture.

**Figure 4** - Verification of possible pathology on the facade of São João Theater.

In order to repair the presented manifestation, it is recommended that the entire plaster coating be removed and a layer of polymeric cement applied in order to isolate the contact of moisture with the coating, which is applied as soon as the layer of polymeric cement is already completely dry, ensuring the protection of the coating to be made.

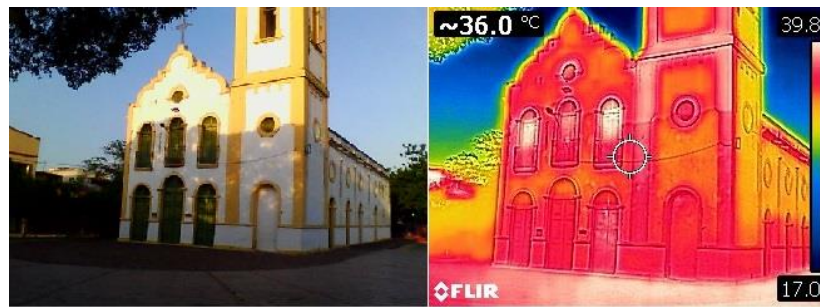
By analyzing Figure 5, the facade presented a constant and uniform thermographic map, which at that first moment ruled out any wear or manifestation due to the presence of humidity or detachment of the coating. In the morning (Figure 6) it presented a higher temperature due to the direct contact with the sun's rays. Again, the structure presented a constant and well-distributed thermal distribution, confirming that it does not have external agents interfering with the health and appearance of the front facade.

**Figure 5** - Thermographic map of Church of Sorrows in the afternoon.

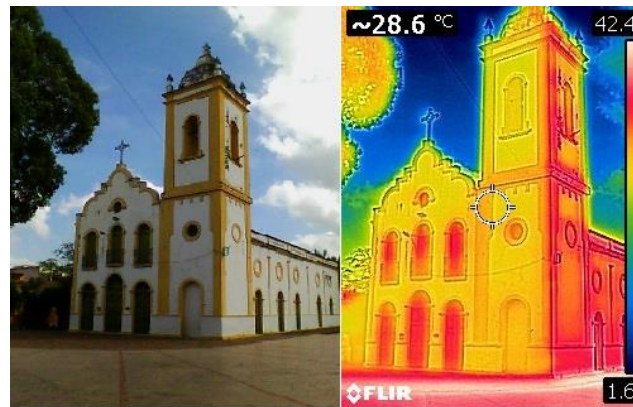
**Figure 6** - Thermographic map of the facade of Church of Sorrows in the morning.

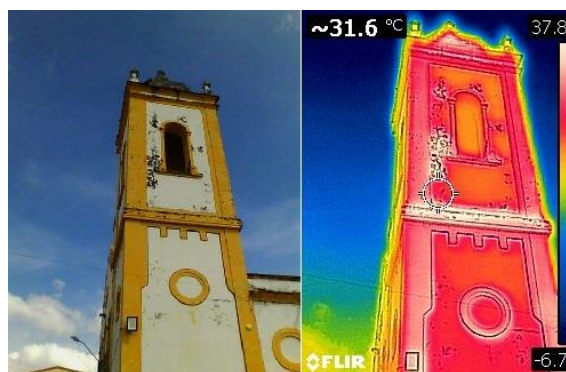
According to Figure 7, the stains on the wall showed a thermal difference that extends over an area greater than that visible on the facade, which presents a problem caused by absorption of external moisture. An application of flexible waterproofing would both absorb the deformations caused by temperature variation and ensure the durability of the coating.

**Figure 7** - Verification of manifestations on the lateral facade of the Church of Sorrows.

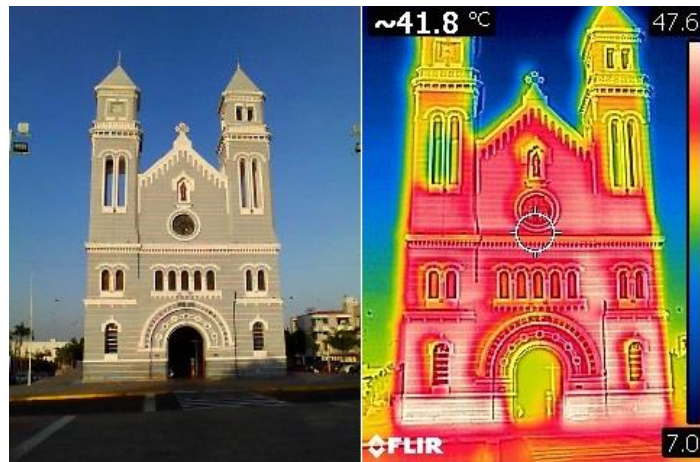
In Figure 8, with the aid of the thermographic camera, it is possible to notice a uniform distribution, but in the lower part of the building it has higher temperatures that drop as the height increases, this characterizes the presence of moisture by ascending capillary, transmitted from the ground to the the structure, with concentration in the lower part of the building.

**Figure 8** - Thermographic map of the facade of São Francisco Church in the afternoon.

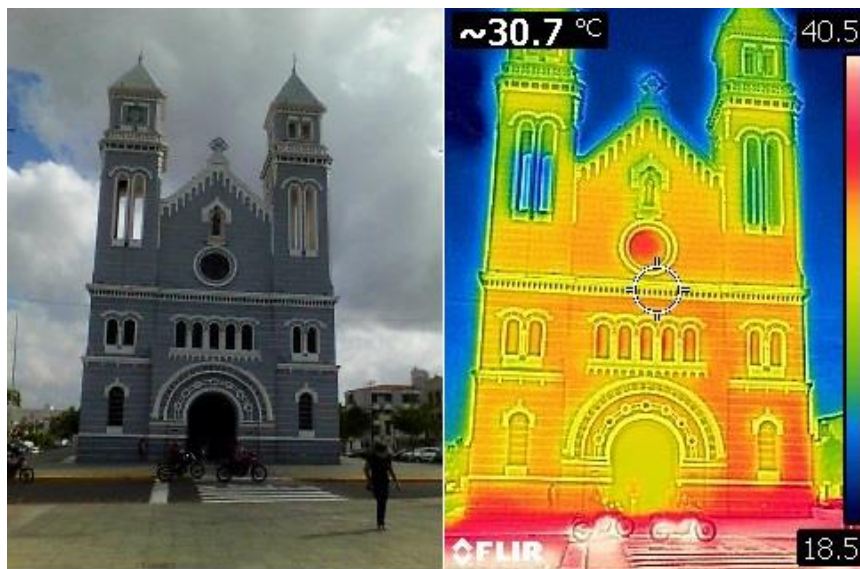
With the temperature a little lower and better distributed in the facade area (Figure 9), the change in the base of the building was better visible, which confirmed the assumptions obtained in the analysis of Figure 8, making it necessary to check the building more closely (Figure 10) to confirm the pathological manifestation. Approaching the structure, an opening in the wall cladding was visible, as well as dark stains. Through the thermographic image of Figure 10, it is possible to notice that there is a transmission of heat

**Figure 9** - Thermographic map of the facade of São Francisco Church in the morning.

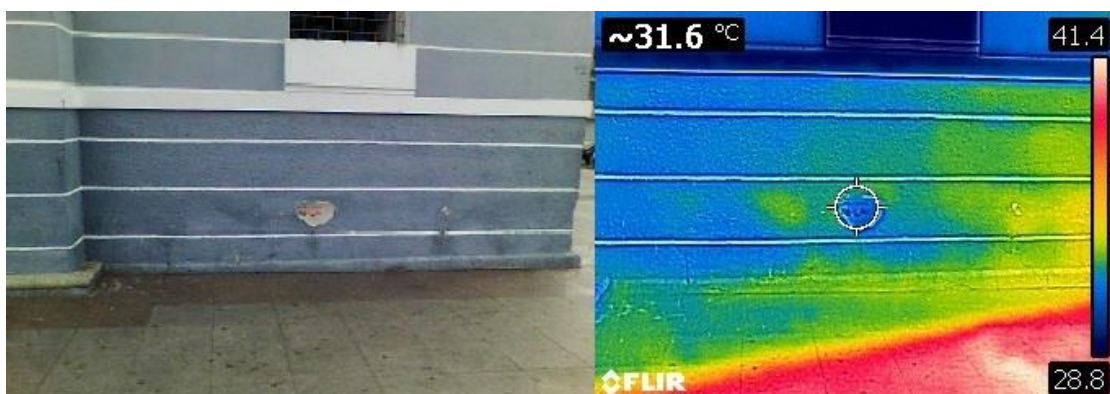
between the floor and the facade through the rising humidity by capillarity, common in old structures that do not have waterproofing in the foundation, thus also causing a detachment of the coating or which is also absorbing moisture.

**Figure 10** - Verification of pathological manifestations on the facade of São Francisco Church.

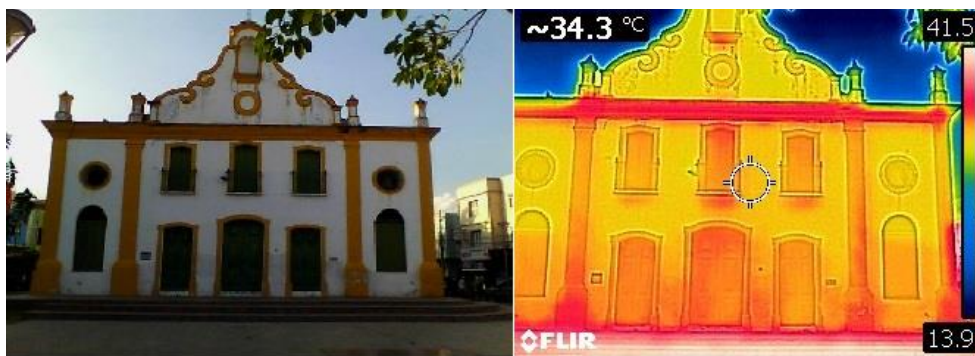
Figure 11 shows us a period in which the building does not have direct contact with the sun's rays. The presented heat map has a uniform distribution, with a slight elevation in the lower part of the building and a constant temperature in the rest, which shows a good integrity of the facade, without manifestations in the second half of the building, but in the lower part this change can be caused by the same factor as the other analyzes carried out previously.

**Figure 11** - Thermographic map of the facade of Church of the Rosary in the afternoon.

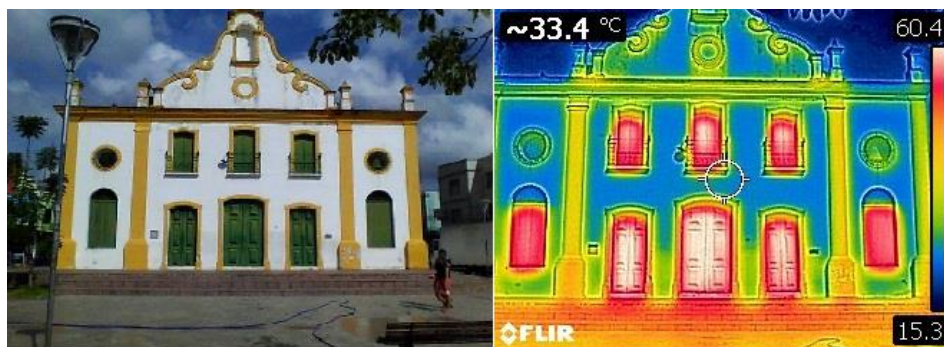
In another period (Figure 12) the pattern of thermal distribution on the facade was maintained, even with a higher temperature, due to this period the structure is in direct contact with the sun's rays. Higher temperatures are found in the lower part, while a uniform distribution is maintained in the upper part, confirming the presence of moisture by capillary rise (Figure 13).

**Figure 12** - Thermographic map of the facade of Church of the Rosary in the morning.

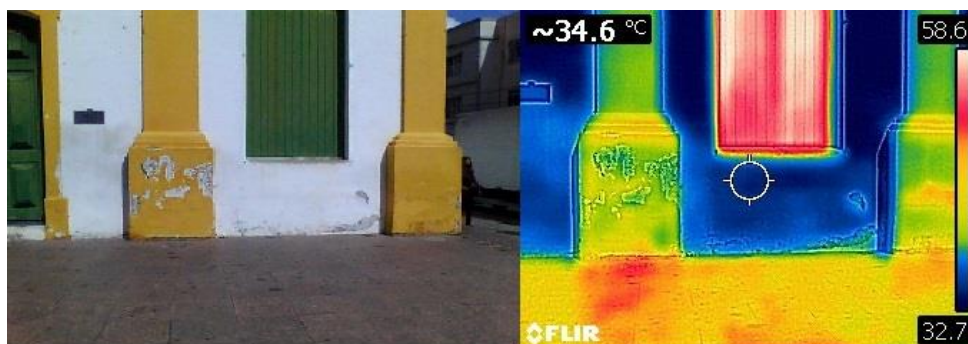
**Figure 13** - Verification of pathological manifestations on the facade of the Church of the Rosary.

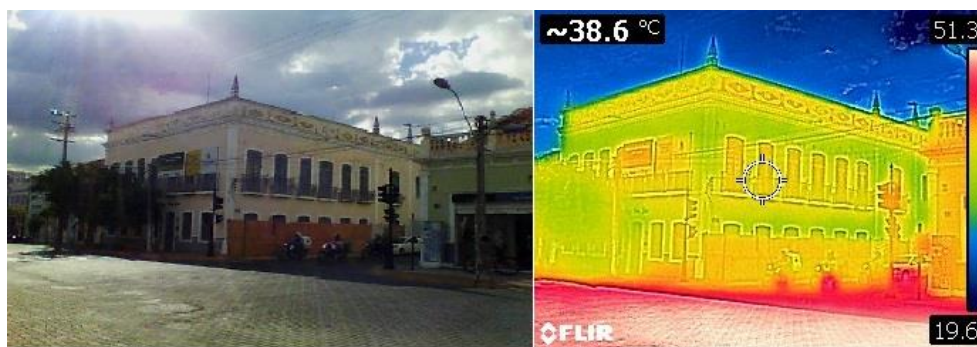
By analyzing the facades both in the afternoon (Figure 14) and in the morning (Figure 15), the same pattern of thermal distribution was observed, proving the excellent quality of the museum's facade.

**Figure 14** - Thermographic map of the facade of the Dom José Museum in the afternoon.

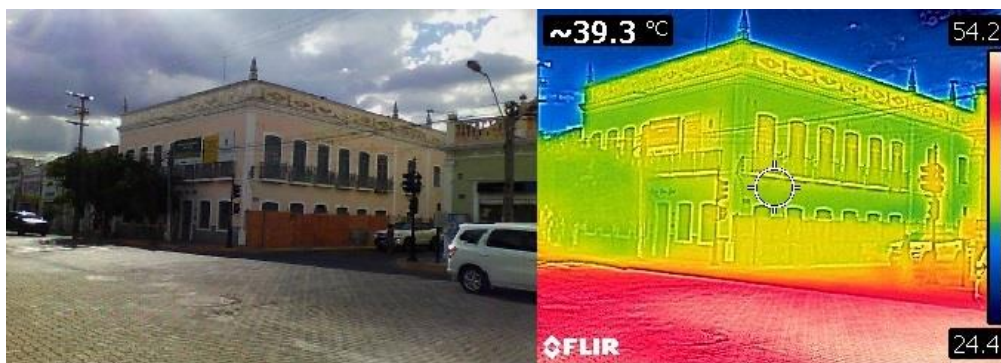
**Figure 15** - Thermographic map of the facade of the Dom José Museum in the morning.

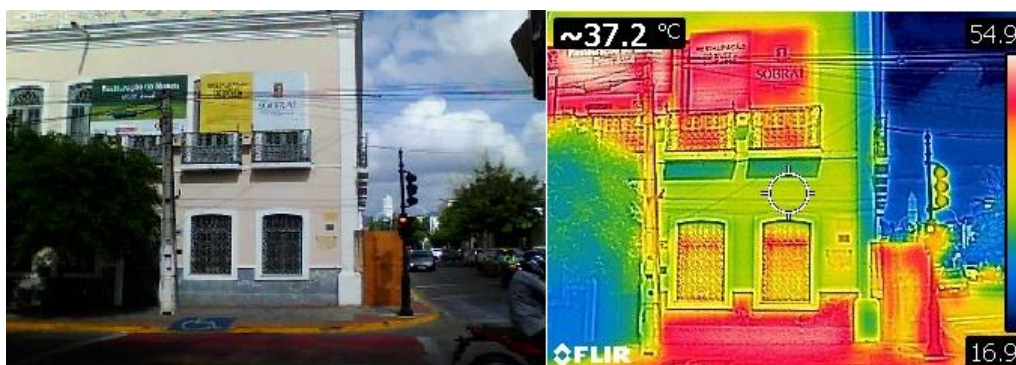
In Figure 16, a small change was noticed in the lower part, which had a higher temperature than the upper part, which raised suspicions of pathological manifestations, but this difference is caused by the change in the tone of the paint, while the lower part has a darker tone with greater heat absorption capacity, the higher a lighter tone, consequently with a lower absorption capacity.

**Figure 16** - Verification of pathological manifestations on the facade of the Dom José Museum.

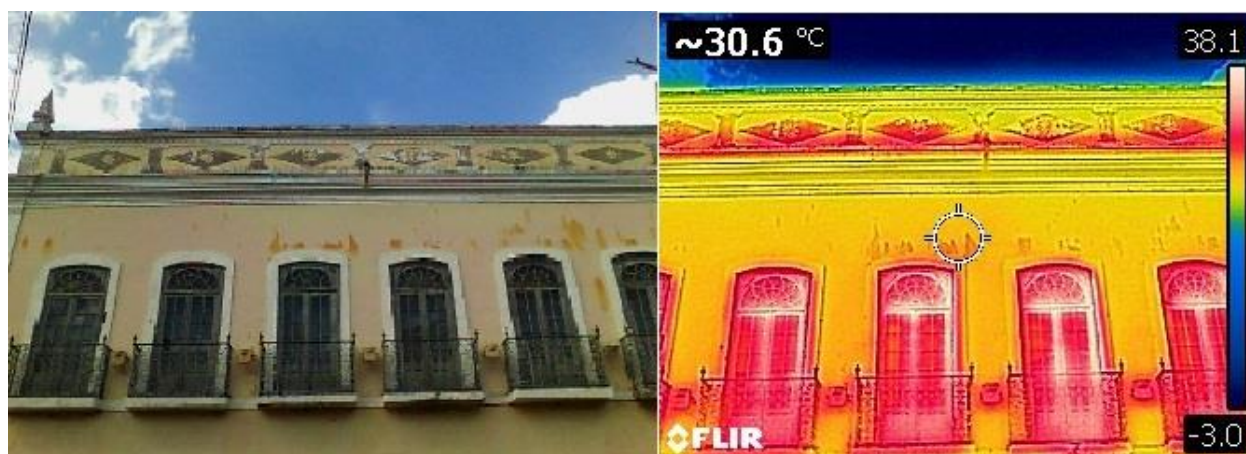
However, on the side facade (Figure 17) some stains were visibly identified on the upper part, which could be caused by an outcrop of internal or external agents, but with the help of the thermal camera it was possible to guarantee that it was only a matter of wear on the paint, which with a restoration using a suitable product with flexibility and resistance to humidity in the new painting, it solves the visual problem, in addition to guaranteeing a greater durability of the structure.

**Figure 17** - Verification of pathological manifestations on the facade of the Dom José Museum.

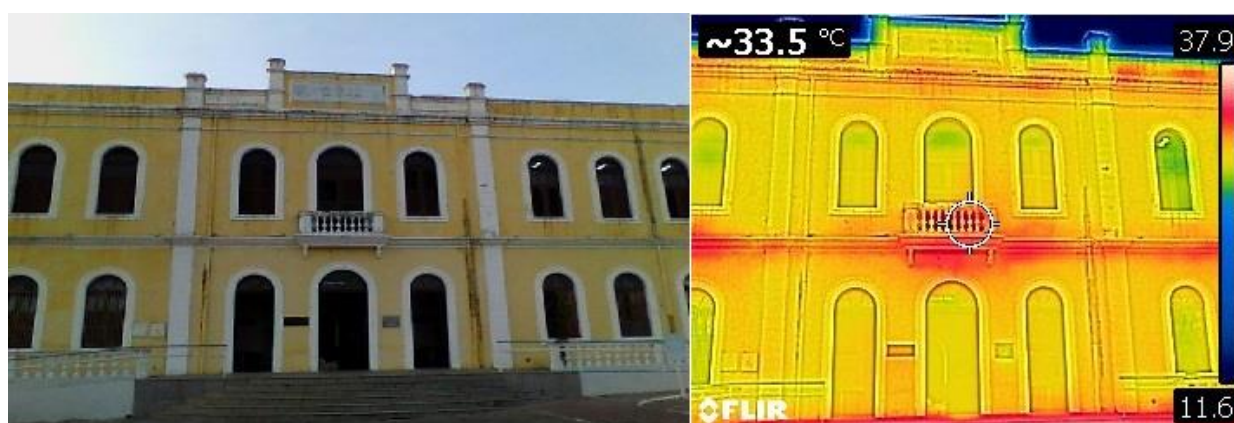
In the general view of the thermographic map (Figure 18), it showed a uniform distribution without sudden or perceptible alteration of agents that cause pathological manifestations, leaving the only marked differences due to the alternation of shades. Already in the morning (Figure 19) with a higher temperature it is possible to find darker marks around the rainwater pipes that pass through the facade, this shows the transmission of humidity between the elements due to leaks in the pipes, in addition to the bottom of the building, characterizing the presence of capillary rise.

**Figure 18** - Thermographic map of the Vale do Acaraú State University (UVA) - Betânia Campus façade in the afternoon.

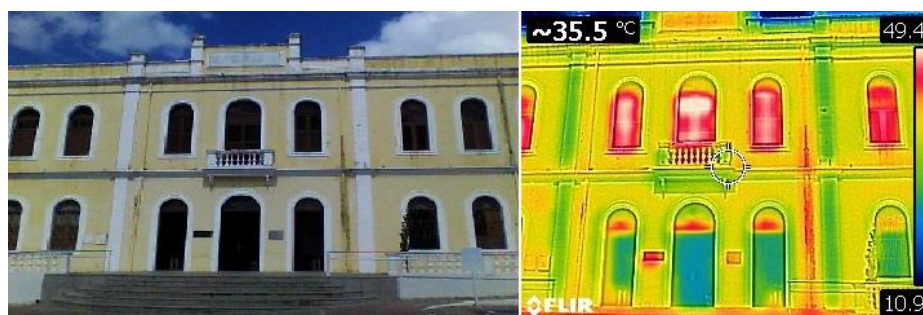
**Figure 19** - Thermographic map of the Vale do Acaraú State University (UVA) - Betânia Campus facade in the morning.

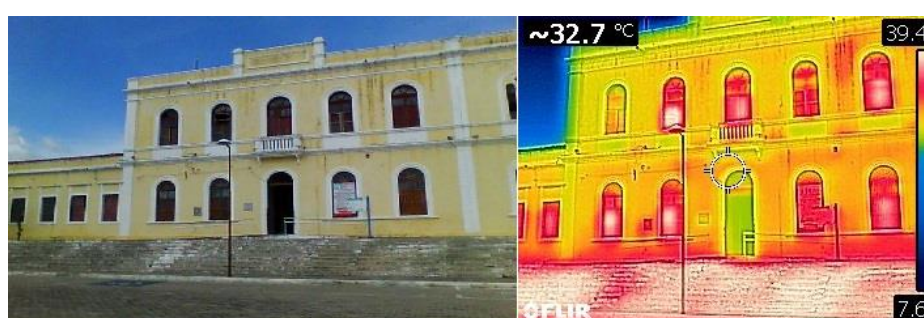
By analyzing Figure 20, a large red spot can be seen exposing the outcrop in a shape that tapers down, like a funnel, in addition to, just above the thermal anomaly, there is a galvanized iron pipe responsible for the rainwater runoff from the roof, caused by the presence of from this device that is splashing this water on the facade, which, added to the wear of the paint, infiltrates the wall.

**Figure 20** - Thermographic map of the Vale do Acaraú State University (UVA) - Betânia Campus facade in the morning at the secondary entrance.

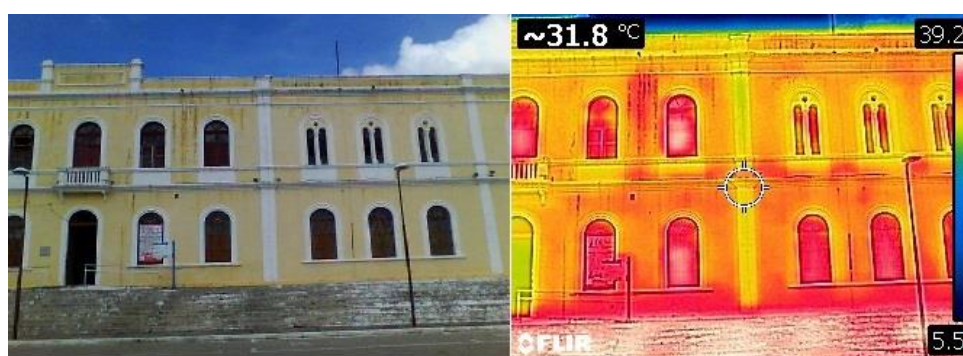
Figure 21 shows the intensification of humidity near the inspection boxes and grease present on the sidewalk through leaks in the same that are absorbed by the structure. In Figure 22, a constructive defect due to the lack of a structural element, tit, causes infiltration through the wall.

**Figure 21** - Thermographic analysis of an outcrop on the facade of Campus Betânia- Vale do Acaraú State University (UVA).

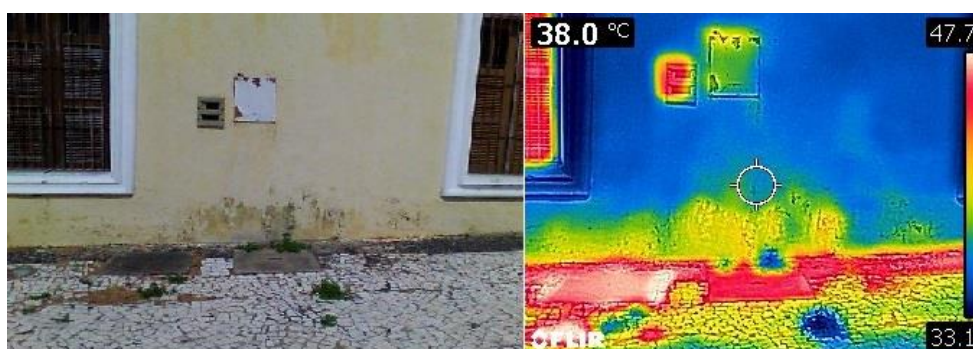
**Figure 22** - Thermographic analysis of moisture transmission from inspection boxes and grease to the façade walls of Vale do Acaraú State University (UVA) - Betânia Campus.

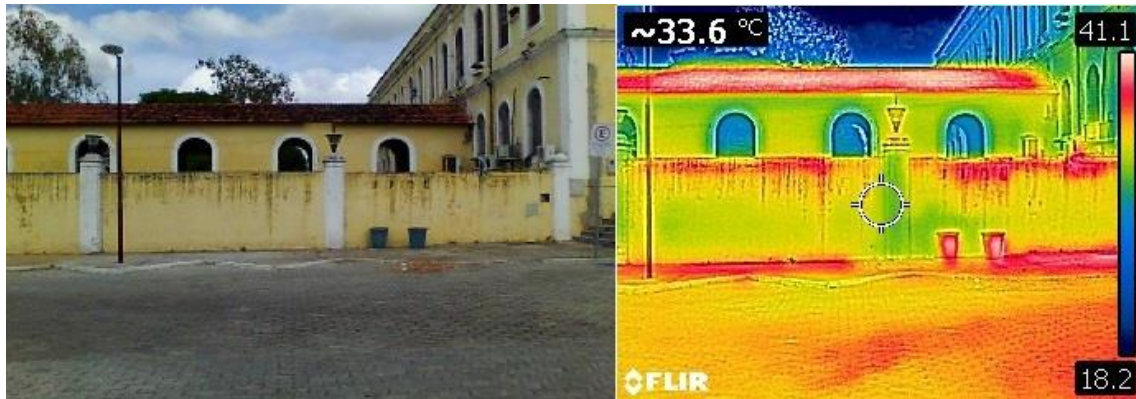
A Figure 23 show the thermographic analysis of the wall on the façade of Vale do Acaraú State University (UVA) – Betânia Campus with a temperature of 33.6 °C.

**Figure 23** - Thermographic analysis of the wall on the façade of Vale do Acaraú State University (UVA) – Betânia Campus
