Civil construction pathologies

E. D. Reis^{1*}, G. M. Gava², M. A. Souza², B. C. Silva³

This work aims to present the main pathologies of civil construction, as well as some constructive or design flaws, besides showing what can be the main procedures of intervention and maintenance. For this, a wide bibliographic review was performed, through the reading and analysis of books, articles, and monographs on such pathologies, being made their due analysis and considerations. It has been demonstrated that there are several mechanisms or processes, from different causes, that can degrade the constructions, that some cares taken in the stages of design and execution of the work can considerably increase the durability of the construction, and that the user also has part of responsibility in the durability and useful life of the building, and should do regular maintenance and be attentive when abnormal characteristics appear. This study concluded that civil construction pathologies can have several causes, and many of them could be avoided if there was regular maintenance of the construction.

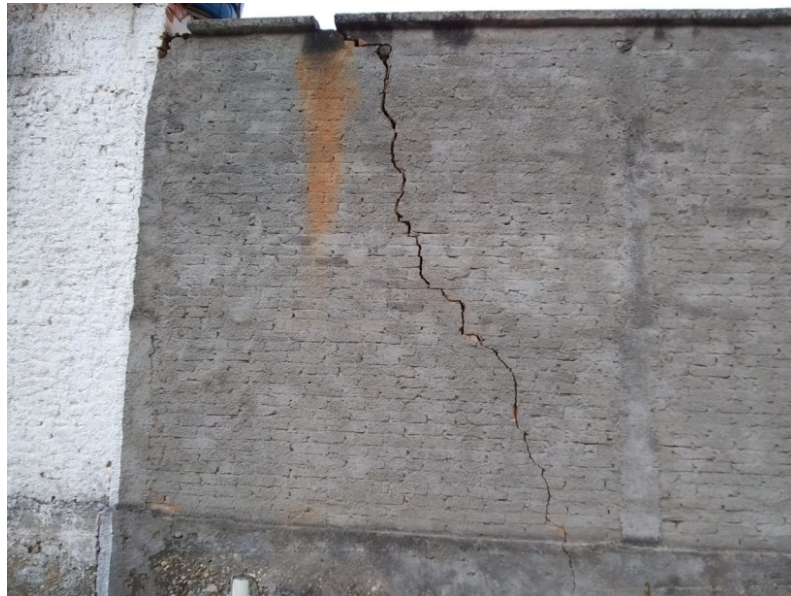
Figure 1. Crack in wall caused by settlement.

According to Militisky et. al. (2015), the pathologies called settlements or densification have a duration time measured in years, being a process in which occurs the reduction of the soil volume due to compression in the clay, generating excess pore pressures, which leads to settlements that affect the superstructure, as can be seen in Figure 1 and Figure 2.

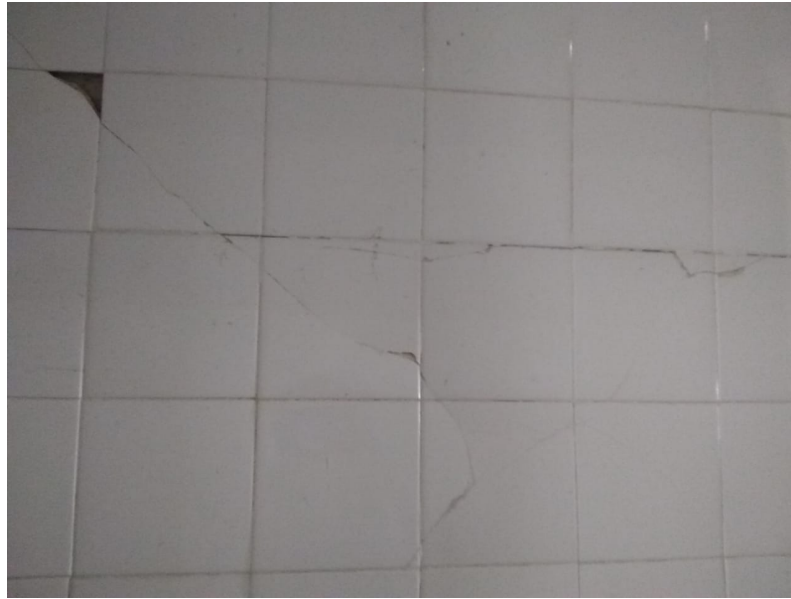
Figure 2. Cracks in ceramic tiles caused by settlement.

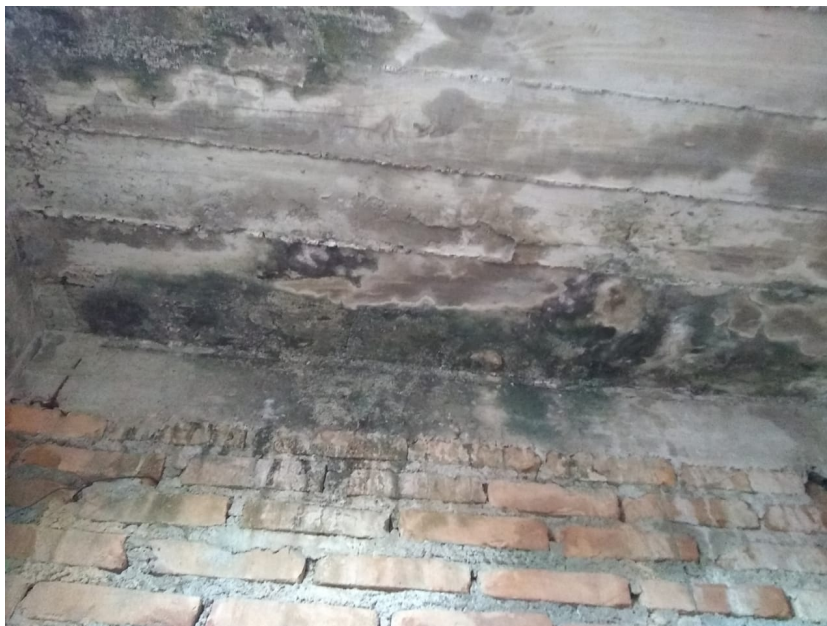
Figure 3. Reinforced concrete slab with mold and stains.

According to Sena et al. (2020), the presence of mold indicates a high degree of humidity, which can bring degradation to the structure as a result of vegetation that grows through small cracks and expansion joints, causing a mechanical type interaction. Figure 3 exemplifies this type of pathology.

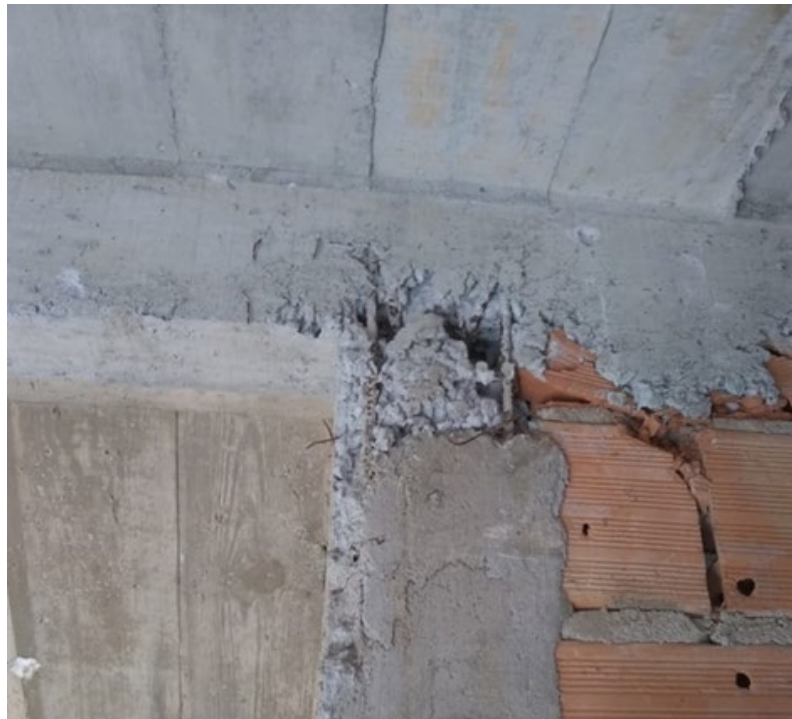
Figure 4. Drill in the beam-column connection that favors the corrosion of the reinforcement.

Figure 4 and Figure 5 exemplify the corrosion process in the reinforcement of reinforced concrete structural elements.

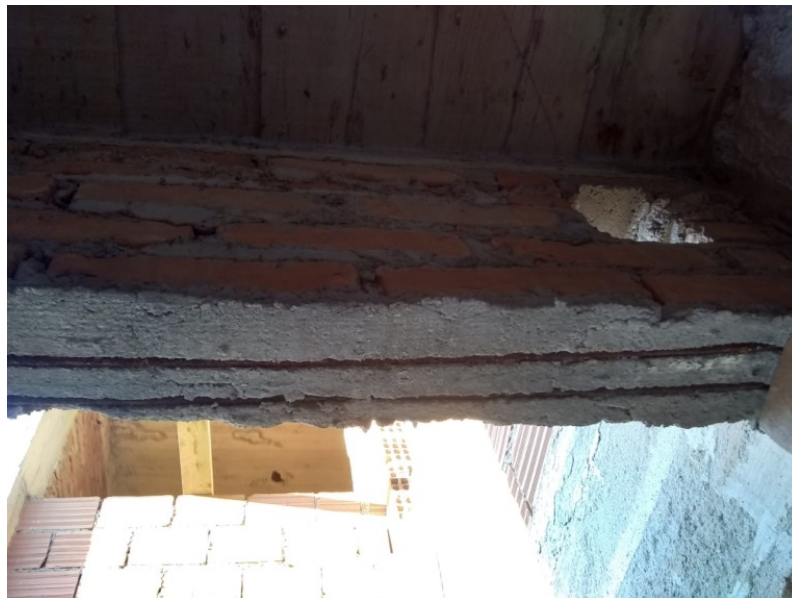
Figure 5. Exposed reinforcement in the frame support beam.

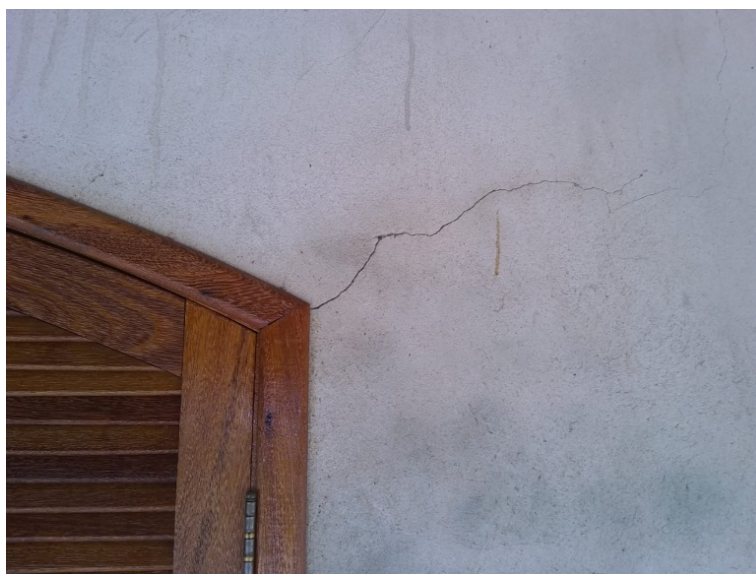
Figure 6. Crack in lintels.

- Cracks due to thermal movement - occur in the structural elements, especially in upper floors, and induce tensile and shear stresses in the seals;
- Cracks due to the absence or inefficiency of lintels and counter-verges - the lintels and counter-verges are regulated by the Brazilian standard NBR 8545 (ABNT, 1984). They can be executed by means of blocks, channels, pre-molded, and even executed directly on-site by means of formwork, recommending that they have at least two bars along their length. When these elements are not executed correctly, cracks may occur. Figure 6 shows a crack due to the lack of lintels and Figure 7 due to the lack of counter lintels.

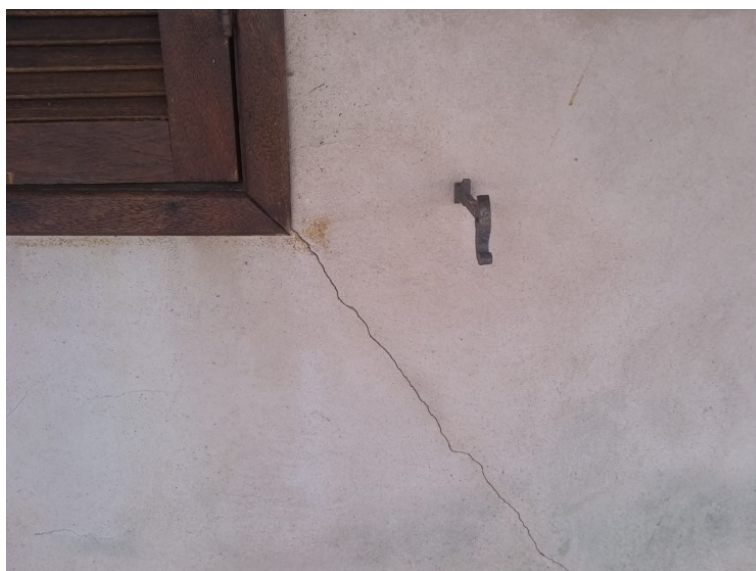
Figure 7. Crack in counter lintels.

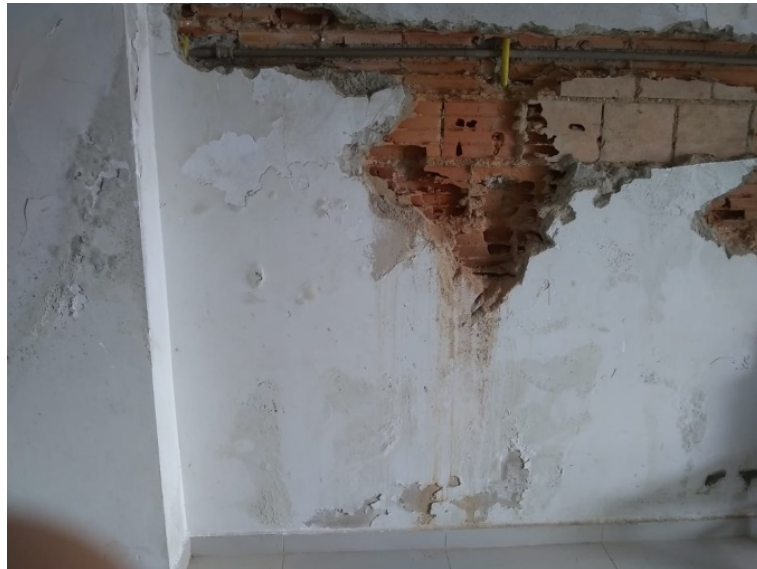
Figure 8. Moisture due to leakage in a water tank.

- Pathological manifestations from humidity - humidity is linked to the amount of water absorbed by a material, depending on its porosity and capillarity. Most construction materials are hygroscopic, absorbing or losing moisture according to the increase or decrease in relative humidity. This moisture may act as a degradation material or components through expansion or shrinkage. Figure 8 shows moisture occurring in a wall as a result of a leak in the hydraulic installations, while Figure 9 shows moisture due to capillary rise from the ground.

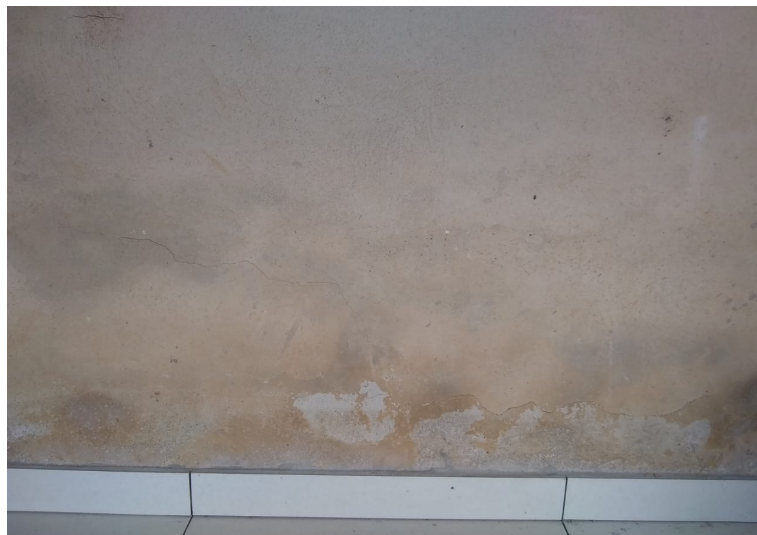
Figure 9. Moisture due to rising dampness from the ground.

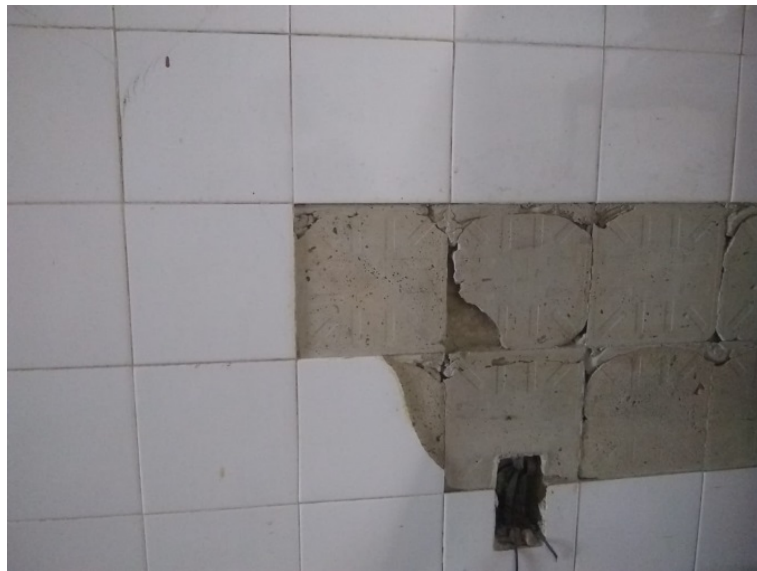
Figure 10. Ceramic detachment.

Among the main problems found in both ceramic and grout coverings are efflorescence and cracks. Ceramic detachment, exemplified in Figure 10, is among the anomalies that most occur in ceramic tiles.
