## Analysis of the Pathological Manifestations of the Casa Grande Foundation – Memorial of the Kariri Man in Nova Olinda – Ceará

**Abstract:** The Casa Grande Foundation – Kariri Man Memorial is a non-governmental institution located in the city of Nova Olinda – Ceará, with about 15,000 inhabitants. This institution is a provider of education, culture and tourism for children and adolescents. The building consists of a museum, educandário and the theater Violeta Arraes – Engenho de Artes Cênicas. With this, a study was carried out that aims to point out the main pathological manifestations so that correct interventions are carried out according to the level of criticality. For this purpose, theoretical and physical materials were used to obtain the results and it can be concluded that this heritage needs preventive and corrective maintenance to continue transmitting its historical and cultural legacy.

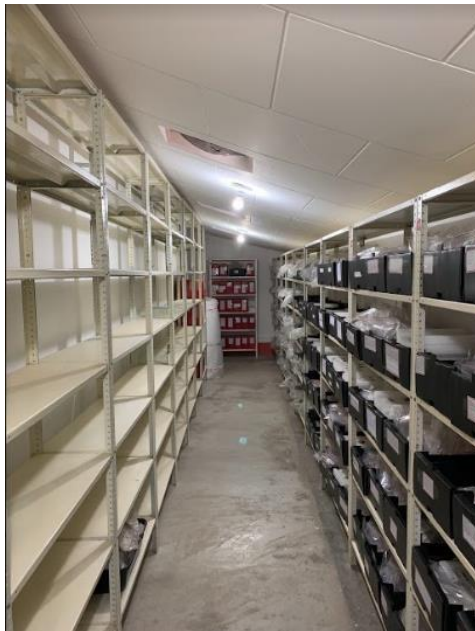
Figure 3 – Archeology room

In figure 3, Environment with important objects for archaeology without having a fire extinguisher nearby:

| LOCAL | PATHOLOGICAL<br>MANIFESTATION | DEGREE OF RISK |
|---|---|---|
| EDUCANDÁRIO | LACK OF EXTINGUISHER | CRÍTICAL |

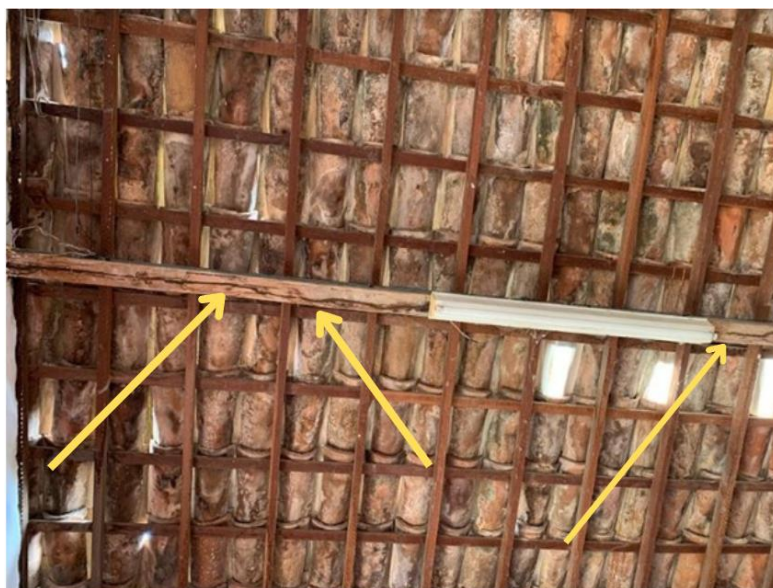
**Figure 4** - Roof of the Hall of the Sacred Heart of Jesus

Relevant presence of termites performing the degradation of the mainwood:

| LOCAL | PATHOLOGICAL<br>MANIFESTATION | DEGREE OF<br>RISK |
|---|---|---|
| MUSEU | PRESENCE OF AGENTS<br>BIOLOGICAL | CRÍTICAL |

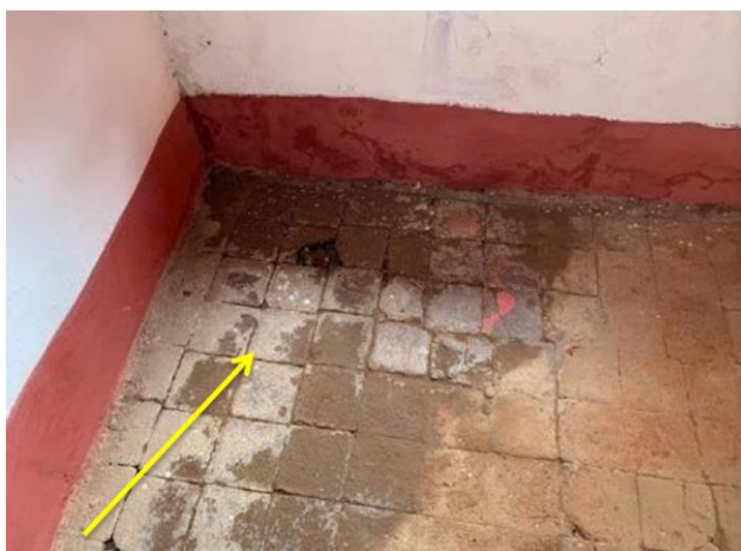
**Figure 5** - Floor of the Blue House

In figure 5, Floor of the museum suffering a sinking, generating an unevenness and risk of falls:

| LOCAL | PATHOLOGICAL<br>MANIFESTATION | DEGREE OF<br>RISK |
|---|---|---|
| MUSEUM | FLOOR UNEVENNESS | MÉDIUM |

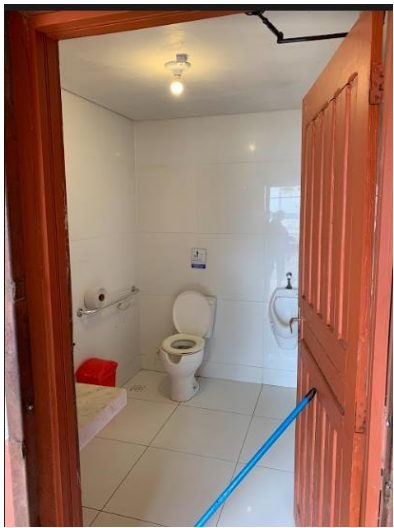
Figure 6 – Theater Bathroom

In the figure below, Bathroom adapted without having the attendances to the Technical Standard:

| LOCAL | PATHOLOGICAL<br>MANIFESTATION | DEGREE OF<br>RISK |
|---|---|---|
| THEATRE | Not attending to ABNT NBR 9050:2020 | CRÍTICAL |

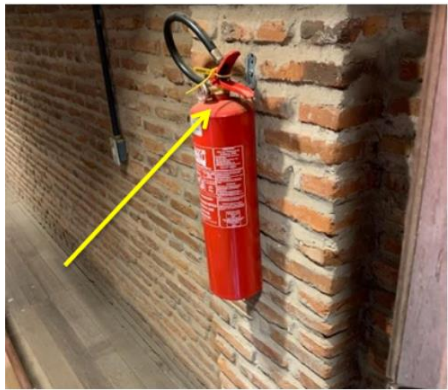
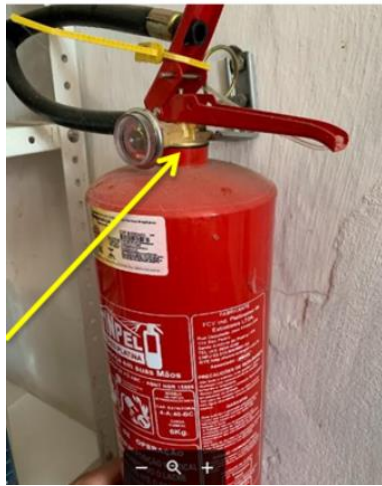
Figure 7 - Extinguisher present inside the Theater

Fire extinguishers out of validity, which may cause possible failures at the time of use:

| LOCAL | PATHOLOGICAL MANIFESTATION | DEGREE OF RISK |
|---|---|---|
| THEATRE/ EDUCANDÁRIO | EXTINGUISHER OUT OF DATE, WITHOUT THE MAINTENANCE RING. | CRÍTICAL |

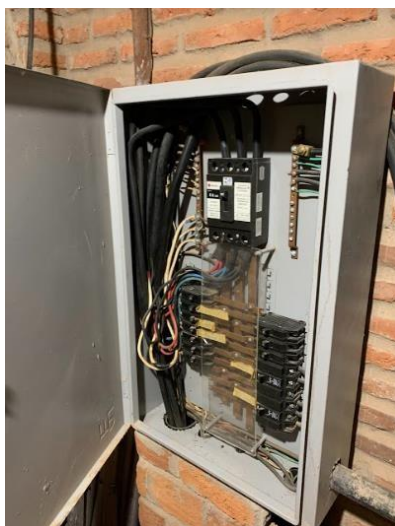
Figure 9 - Electric Theater Board

In figure 9, lack of identification of electrical panel:

| LOCAL | PATHOLOGICAL MANIFESTATION | DEGREE OF RISK |
|---|---|---|
| THEATRE | LACK OF IDENTIFICATION AND ORGANISATION OF CIRCUITS | CRÍTICAL |

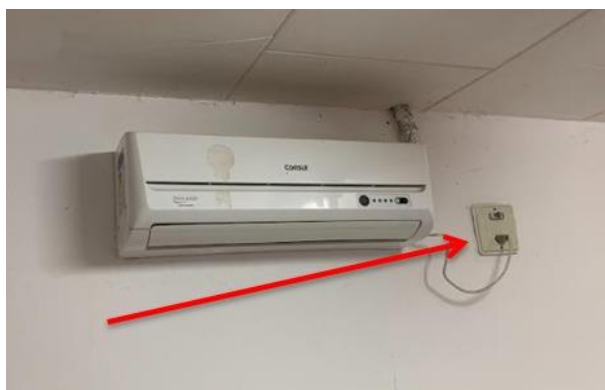
Figure 10 - Educandário air conditioning

Air conditioning installed improperly, which may cause possible risks of electrical accidents

| LOCAL | PATHOLOGICAL MANIFESTATION | DEGREE OF RISK |
|---|---|---|
| EDUCANDÁRIO | AIR CONDITIONING PLUG CONNECTION | CRÍTICAL |
