## Characterization of damage to Brazilian built Heritage: case study in the old electoral justice building, in Teixeira, Paraíba

**Figure 4** - Damage map of the former Teixeira electoral justice building - (a) front facade (b) right side facade (c) rear facade and (d) left side facade

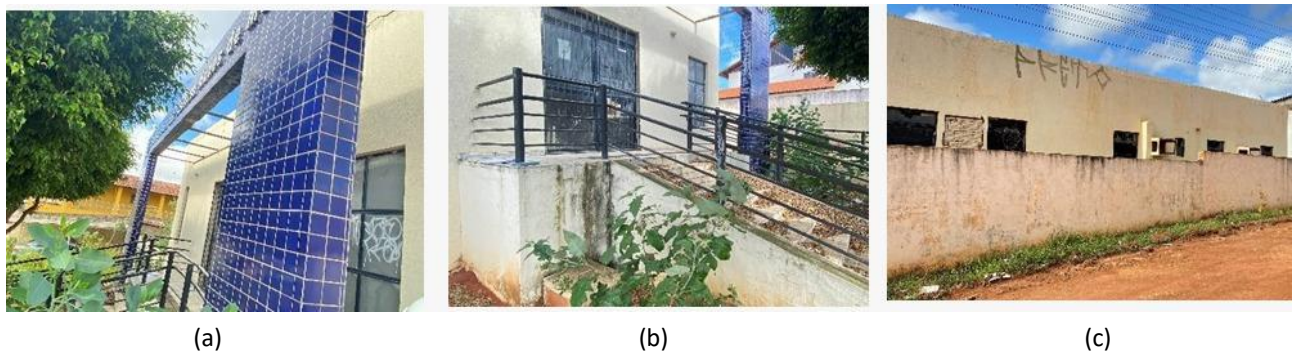
**Figure 3** - Situational status of the old Juiz Adeilson electoral forum building (Teixeira-PB) - (a) Right lateral perspective (b) Left lateral perspective (c) External perspective

With years of use and without routine maintenance by the Federal Government, the building is banned/abandoned, which led to the relocation of the headquarters to several buildings in the municipality. Because the restoration of the building of the former municipal electoral justice forum would entail a high expense for the government, with priority being given to the relocation of the building. The figures below (Figure 3) show the situation of the building studied in this work.

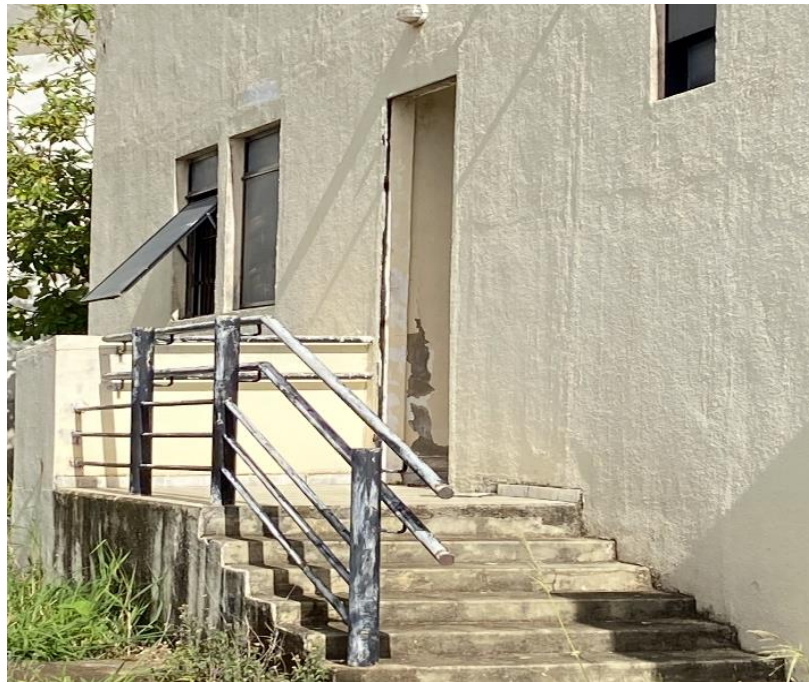
**Figure 5** - Visual aspects of the presence of peeling of the pictorial layer

On the front facade and left side, it is possible to see how the peeling of the paint film acts as a result of the presence of humidity and subsequent exposure to high temperatures. According to Sousa (2020), peeling can be classified as the separation between the paint film and the surface. For your intervention, you should scrape or brush the area in order to remove all the loose parts, clean the area, apply the preparatory base coat and apply the new paint. The visual aspects of this type of pathological manifestation can be seen in Figure 5.

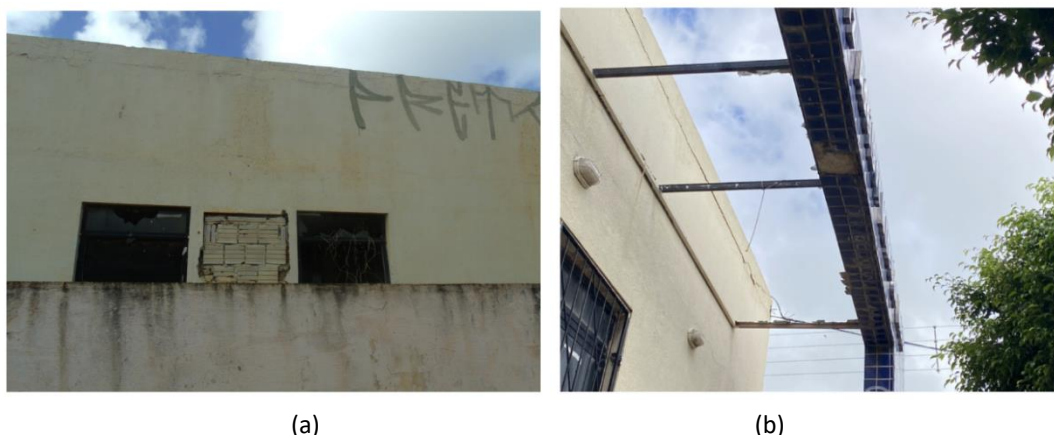
**Figure 6** - Visual aspects of pathological manifestations - (a) absence of material and (b) visual pollution/elements not belonging to the original project

With regard to the absence of material and visual pollution/elements not belonging to the original project, they are linked to interventions carried out inappropriately, reaffirming the disregard for the built historical heritage of Teixeira, since its origin is directly linked to the lack of maintenance and the devaluation of the building. Regarding the absence of material seen in Figure 6a, it consists in the deterioration of the fixed canopy, of the canvas type on the front facade, which has as an intervention suggestion the insertion of the missing elements, by a compatible one, respecting the harmony with the other elements and its original function. The visual pollution present in Figure 6b, on the other hand, is related to the process of inadequate interventions in a frame present on the right side facade, where the frame was sealed using ceramic brick masonry, however, the process was carried out inappropriately, leaving the substrate exposed to the weather, which can result in pathological manifestations throughout the useful life of the building, the intervention suggestion consists of preparing the substrate and applying a coating compatible with the original, with due repainting of the missing part.

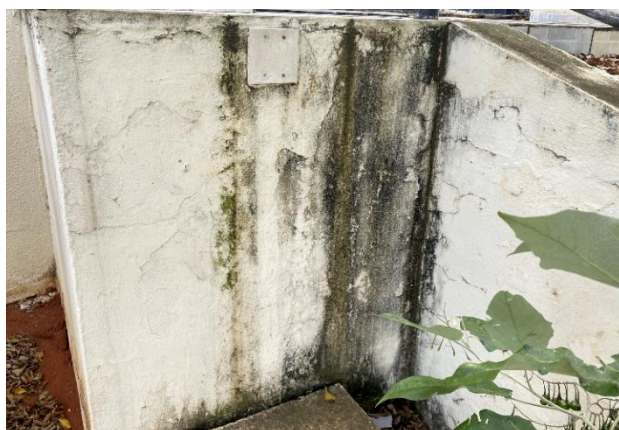
**Figure 7** - Visual aspects of the presence of mold/biofilm caused by the absence of the marquee

In a detailed analysis regarding the absence of elements, it is noted on the front facade that one of the most recurrent damages is mold, also known as biofilm. The presence of this damage is linked to the absence of a fixed marquee, of the canvas type existing on the upper part of the facade, the marquee was used for protection due to the action of bad weather, such as precipitation, however, with the degradation of the element, the presence of humidity and the lack of planning to carry out its replacement, resulted in the accumulation of moisture, contributing to the mischaracterization of the building, as can be seen highlighted in Figure 7. According to Lima et al. (2022), it is possible to avoid this problem through some measures, such as the use of waterproof materials in the construction stages, opting for good sunlight, as well as cross ventilation, insofar as it does not harm the well-being of individuals. . When it comes to the exterior of the building, when there is greater contact with constant humidity, it ends up making the therapy process for this damage difficult, so it is necessary to carry out interventions aimed at repairing the agent that caused the humidity.

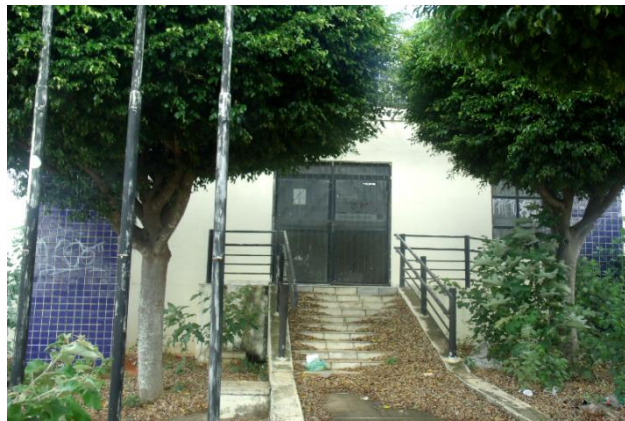
**Figure 8** - Presence of vegetation

Another pathological manifestation that can be highlighted, because it is also caused by the lack of maintenance and is very recurrent, is the presence of vegetation, which occurs all around the building, as can be seen in Figure 8.

Vegetation can offer structural risks to the construction, since, if organic matter had been introduced into the structure in the execution phase, there would be the presence of reactive substances throughout the structure, facilitating the contact of the concrete with sulfates and alkalis, being harmful to its life. useful. In the absence of maintenance, the areas accessible to water will eventually be colonized by roots, they can settle in cracks and, thus, potentiate them, compromising the structure (Lima et al., 2022). In the case of the old electoral justice building, the plants found do not pose any risk to the built heritage, as they have shallow roots, affecting only the architectural aesthetics of the place. However, while a building is located in an area rich in vegetation, there is a high probability of termite foci on the ground, which benefit from the lack of maintenance of buildings, as is the case of the building under study (Barros et al., 2021).

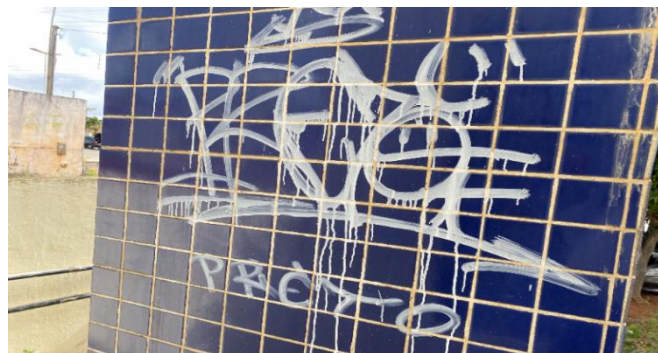
**Figure 9** - Visual aspects of the presence of vandalism

Then, it is possible to highlight the neglect with the heritage due to the presence of pathological manifestations such as dirt and vandalism, which impair the aesthetics of the place. In the study by Lemos et al. (2022), this type of pathological manifestation is specified in a special degree and deserves special attention, since they are the only ones with their origin from directly human actions, extremely common in buildings located in urban areas, they are pathological manifestations composed of paints used by vandals, as can be seen in Figure 9. In the case of the building under study, the pathological manifestations are visually identified by the presence of phrases or names written on the outside of the structure using commercial paints.

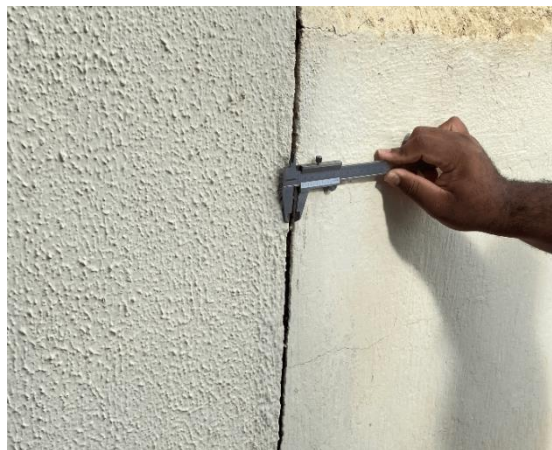
**Figure 10** - Longitudinal crack located at the junction of materials

To carry out the mapping of cracks and fissures, a fissurometer was used to assist in classifying the damage. The standard, from the Brazilian Association of Technical Standards - ABNT, NBR 9575 (2010), which concerns waterproofing, selection and design, defines cracks as openings of up to 0.5mm, and cracks as openings of up to 1mm. In the case in question, the presence of cracks and fissures was observed, appearing on all the facades of the building. According to Rodrigues et al. (2021), this type of damage is mainly caused by overloads or stress concentrations, thermal changes in humidity, excessive deformation, retraction of products based on hydraulic binders or chemical changes in building materials.

According to Sousa (2020), to avoid cracks and fissures, it is important to have adequate expansion joints where the project requires them, they are places to relieve tensions and provide safe space for the structure to move without damaging the building. Cracks can be found throughout the front facade of the building, in Figure 10 cracks located at the junctions of materials can be seen, it is the presence of a longitudinal crack between the wall of the original facade and a masonry wall executed after construction of the building. Thus, it can be seen that its origin is linked to the incompatibility of the materials present on the two surfaces and/or the lack of expansion joints between the meeting regions. In addition, it is important to monitor this pathology in the presence of this structural integrity.
