## Corrosion in structural elements of the satellite unit of a reference hospital in Ceará, Brazil

**Abstract:** The study of pathological manifestations that occur in buildings is based on the analysis of failures to diagnose their causes and offer rehabilitation methods. In summary, this paper's main objective is to diagnose the possible causes of corrosion manifestations in the structural elements, steel and reinforced concrete, of the satellite unit of a reference hospital in Ceará (Brazil) and to propose an adequate rehabilitation and prevention plan. The methodology adopted in the paper is divided into three stages: field visits for data collection; analysis of the results; and the proposition of therapies that offer the best recovery of construction systems, considering the cost. Considering that civil engineering has a social role, this article intends to show that the ensuring of safety and comfort is essential for maintaining the well-being of the population, especially in healthcare facilities. In conclusion, the proposed rehabilitation aims to offer a safe environment so that the establishment can regularly perform its activities without constraints to patients with a

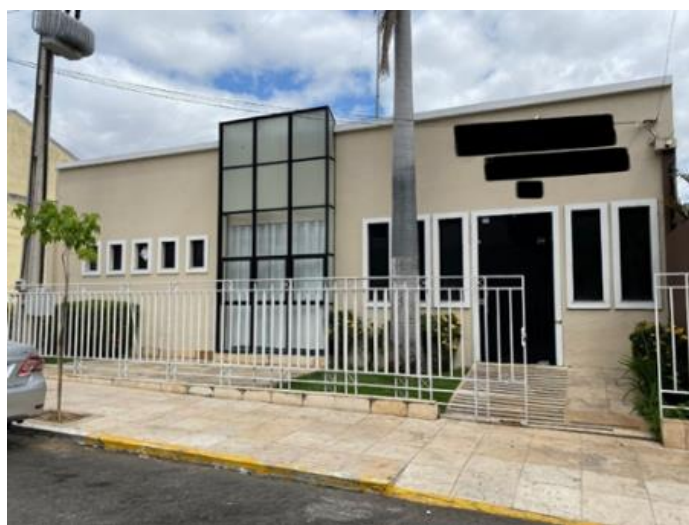
The building under study is a clinic that operates as a satellite unit for dialysis and kidney transplantation of the reference hospital in Sobral, in Ceará, Brazil. According to information provided by the administrative sector, the facility can assist up to 130 patients. The unit has competencies in emergency and inpatient care and operates in preventing kidney disease, early diagnosis, and hemodialysis treatments. The clinic is located in the city center, an area with a high flow of cars (Figure 1).

**Figure 1** – Building's façade

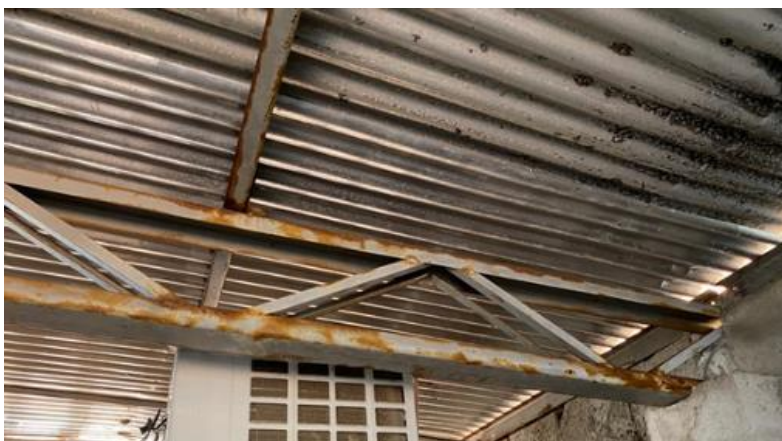
The roof's structure in the region of the building's water storage tank consists of metallic sections and is affected by uniform and crevice corrosion. The uniform corrosion process is visible in Figure 4, where a uniform crust of corrosion product is apparent along the entire structural element length.

**Figure 4 – Corrosion in the steel structure**

Initially, supposing that the local administration chooses to replace the structure, it is essential to elaborate on a project based on an anticorrosive design to improve surface preparation, painting, inspection, and maintenance. Several scenarios must be considered, such as bolted connections, rivets, irregular welds, and sharp corners. One of the most crucial points in the project for corrosion control is to avoid cracks, where water-soluble compound deposits can accumulate and not have a visible or accessible location for maintenance.

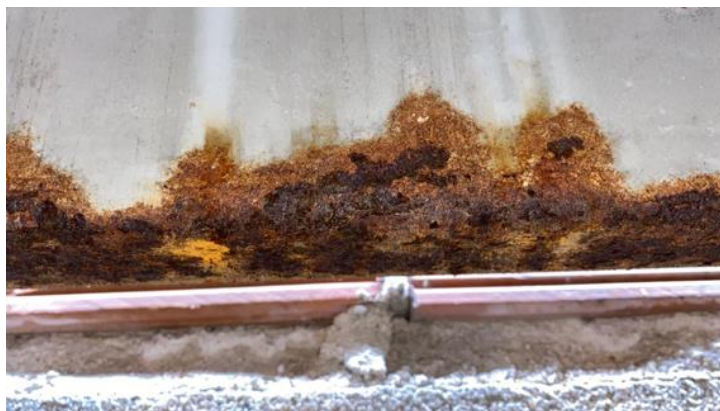
Potentially, the unsealed screwing regions allow rainwater to enter and run down the metal profile. Eventually, this mechanism operates in conjunction with the oxygen in the environment, causing corrosion of the sections. Figure 5 shows the advanced state of the corrosion that consumes the element.

**Figure 5 – State of corrosion of the steel section**

A painting system stands out among the various forms of protection for metallic structures. To ensure the durability and efficiency of this system, it is necessary to previously prepare the steel surface through cleaning and subsequent mechanical anchoring. Fragata (2009) explains that a properly clean, dry surface, free of corrosion products or contaminants, is an ideal substrate for a good performance of a painting system. At first, it is essential to remove the mill scale that can prevent direct contact of the paint with the steel.

The surface preparation for scale removal can be achieved by cleaning with solvents, abrasive blasting, or even manual tools. Nunes *et al.* (2007) sustain that the preparation by abrasive blasting is the most recommended method since it has a high performance, offers adequate cleaning, and ensures that the surface has the ideal roughness for anchorage the paint film. Ensuring the increase in surface roughness is essential, as it increases the contact surface between steel and paint, increasing adherence.

After blasting, it is necessary to apply a paint that offers resistance to weathering. Bertolini (2010) states the benefit of effective and lasting protection through a painting cycle that starts with the surface preparation, continues with the application of a layer of paint with active pigments (primer), and completes with a thick layer that ensures a barrier effect to the penetration of water and oxygen. This procedure ensures that the

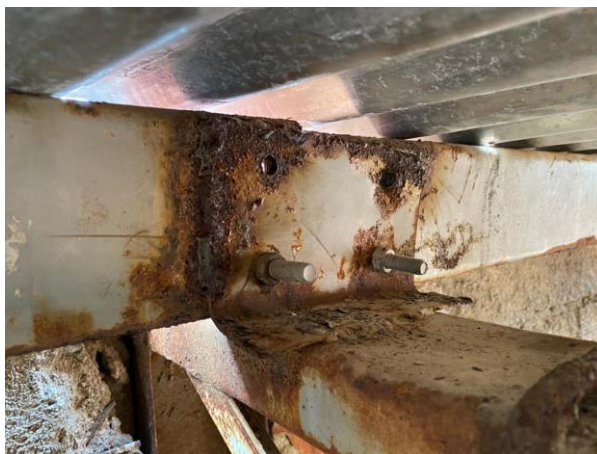
In some regions of the metal roof, the identification of localized crevice corrosion was possible: regions of bolt connections that allow water retention, providing ideal conditions for the corrosion mechanism to develop. At the moment of the photographic record in Figure 6, it is possible to confirm that the corrosion is already in such an advanced state that the two upper bolts have been expelled, probably due to the shearing of the stem.

**Figure 6 – Crevice corrosion**

As previously highlighted, the metallic element under analysis presents several points where the crevices manifest corrosive processes, causing the deterioration of the bolted connections. If the local administration prioritizes the restoration of the structure, it is required to repair the cracks and protect the structural steel by applying anti-corrosion paint. An additional recommendation is the execution of roof gutters to avoid the rainwater's direct contact with the metallic section.

Pannoni (2015) claims that this corrosive process can be inhibited by sealing the crevices with an epoxy sealer or polyester filler. The crevice filled with a steel shim project from the section and is welded all around it. In order to prevent the ingress and storage of water and dirt, sealing coupling regions with continuous welding is a viable alternative. Cardoso (2013) emphasizes that using a good coating prevents the direct exposure of the metallic element to the corrosive environment, offering a physical barrier.

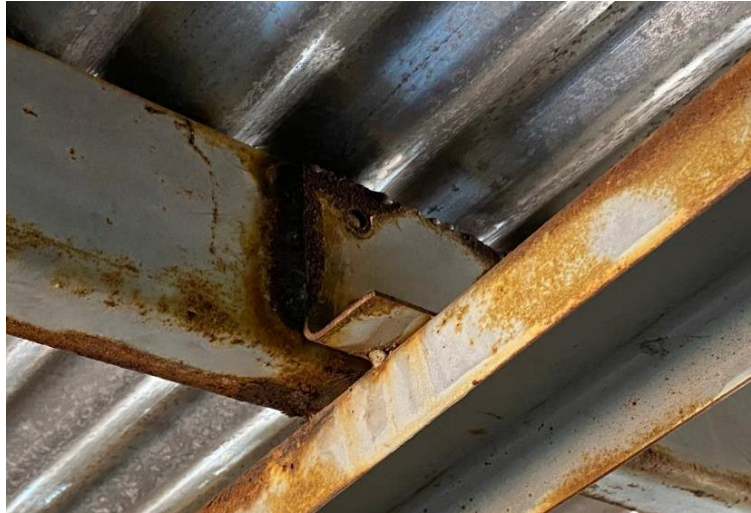
As uniform and localized corrosion (with the exception of galvanic corrosion) do not occur without moisture, the arrangement of the metal sections should not enable water retainment. Screwed or riveted joints and discontinuous welding points are some construction features that leave voids that allow the retention of water, dirt, and even the abrasives used in the surface preparation since points where a small distance separates two metallic surfaces are potential corrosion cells. Figure 7 shows the absence of bolts in the joint, probably also due to the advanced corrosion state of the joint.

**Figure 7 – Crevice corrosion**

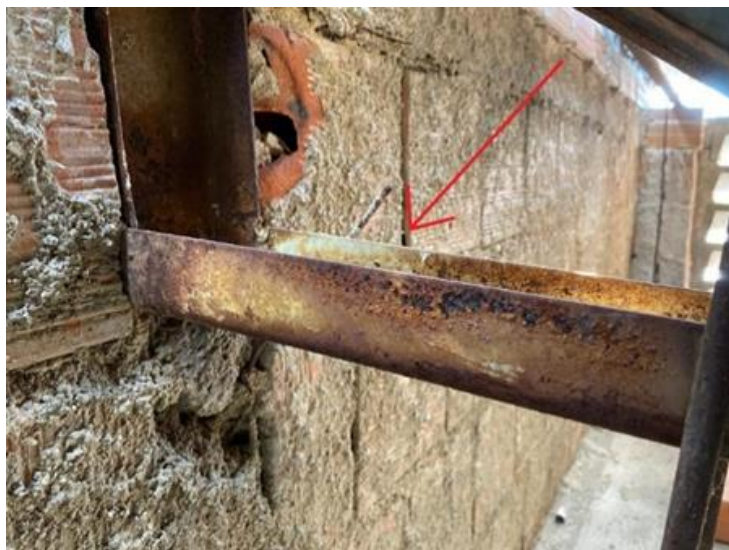
It is fundamental to avoid some geometrical design that allow the accumulation of water and dirt since it enhances the deflagration of the corrosion mechanisms. As the structural geometry of the system at the joints of the metallic element is not appropriately suited, as Figure 8 illustrates, water and dirt are deposited at these points of "open section," which allows the corrosive process throughout the extension of the metallic element, because the water has access to drain through the entire profile. Figure 8 indicates one of the existing irregular designs that enable water to accumulate and flow through the section.

**Figure 8 – Irregular geometrical design**

Pannoni (2015) highlights that rounded corners ensure a more accessible application of a uniform and long-lasting protective coat of paint, as the coating film on sharp corners can become flawed and accelerate deterioration in these areas. Figure 11 shows straightforward examples of precautions and recommendations for geometric details to avoid water and dirt accumulation points on the steel. A structural geometry

designing inclined or chamfered surfaces and eliminating open sections are some precautions that allow water to drain away from the structure.

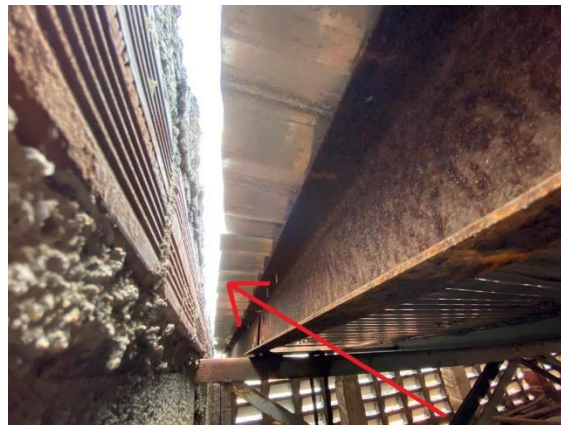
Figure 10 indicates the absence of elements that prevent infiltration of water, which allows direct contact of the metallic element with rainwater drops and allows the accumulation of dirt. The corrosion prevention system (such as painting) used to block the exposure of the material to the corrosive environment is inappropriate since corrosion spreads throughout the entire length of the sections. The combined action of all these constructive flaws observed enables the manifestation of corrosive processes.

**Figure 10 – No elements to prevent rain splashes**

The employees reported that there had not been any inspection of the metal structure for two years, resulting in an advanced deterioration at the most damaged sections.

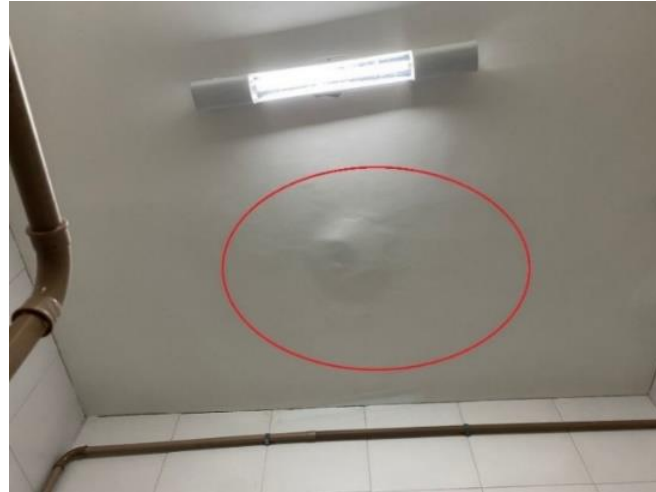
In the ceiling lining of the water treatment room, a protuberance was identified in the coating, representing expansion reactions caused by corrosion of the structure's reinforcement (Figure 12).

**Figure 12** – Concrete expansion

The room is located below the building's water storage tank, indicating that the tank has an ineffective waterproofing system that enables water infiltration into the slab and reinforcement corrosion.

Initially, it is crucial to ensure an efficient waterproofing system for the bottom of the building's water storage tank, to inspect and treat all existing cracks, preventing water percolation through the slab. Subsequently, repair the structural element affected.

The indicated technique is the most common in cases of non-accelerated corrosion (without loss of steel section), based on the reconstitution of the deteriorated concrete and cleaning of the corroded rebars. Before any intervention, it is necessary to shore the structure to relieve the element's tensions and ensure the safety of all those working on this service. The repair contour must be delimited for subsequent scarifying of all the deteriorated material until an entire concrete surface. The reinforcement is then manually cleaned using a steel bristle brush and compressed air blasting to remove any remaining dirt. This procedure allows the repair materials to reach the whole reinforcement.

The repair of the rebars is done by isolating the structure with physical barriers, and controlling the access of water and oxygen to the structure, to ensure higher efficacy in preventing the recurrence of the corrosive process. For the safety of this anticorrosive system, it is essential to paint the reinforcement with epoxy paint enriched in zinc since this element behaves as a sacrificial anode, meaning that in case of scratches in the paint, the zinc will suffer corrosion, protecting the steel.

The next stage refers to the reconstitution of the removed area of the structure using cement mortar with an epoxy or polyester base since these are notable for a faster process, incorporating the boost in resistance, adherence, and waterproofing. Finally, the objective is to protect the structural element to prevent the ingress of corrosive agents such as water. Among the materials on the market with this purpose, organic paints are indicated because they usually have a lower cost and offer a successful performance in protection.

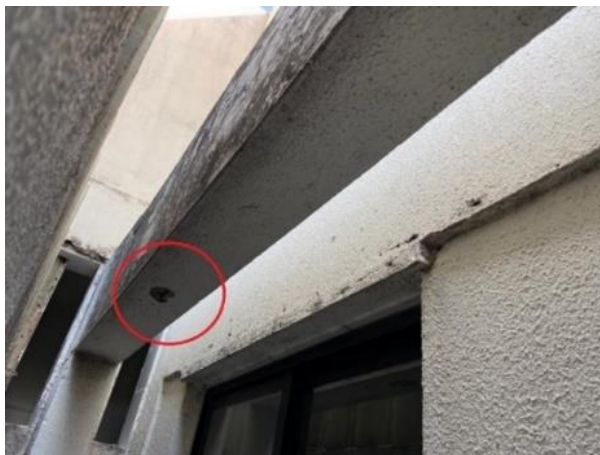
A reinforcement corrosion process was identified in a concrete beam with concrete cover peeling, exposing the rebars to the atmosphere (Figure 14).

**Figure 14** – Beam corrosion area

The absence of reinforcement covering is one of the main causes of corrosion in this context since the lack of this thickness of protection can favor the attack of chemical agents. Onofre et al. (2021) explain that these agents can attack the concrete, reducing its pH and accelerating the steel oxidation. Eventually, this process will expand the section of the steel, leading to cracks and loss of section. Figure 15 highlights the corrosion process of the exposed rebar.

Localized corrosion spots must have the rebars exposed and rigorously cleaned using steel bristle brushes to remove all corrosion products. Subsequently, it is necessary to apply a primer to the reinforcement and replace the concrete coating with a minimum thickness of cover for the reinforcement adequate to the environmental aggressiveness to which the structure is exposed. According to the Brazilian normative ABNT NBR 6118:2014, the minimum coverage must be 30 mm since it is an element in an aggressive environment II (urban environment).

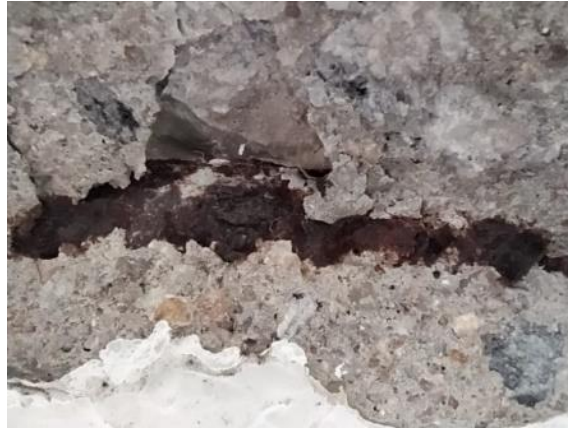
**Figure 15** – Exposed rebar

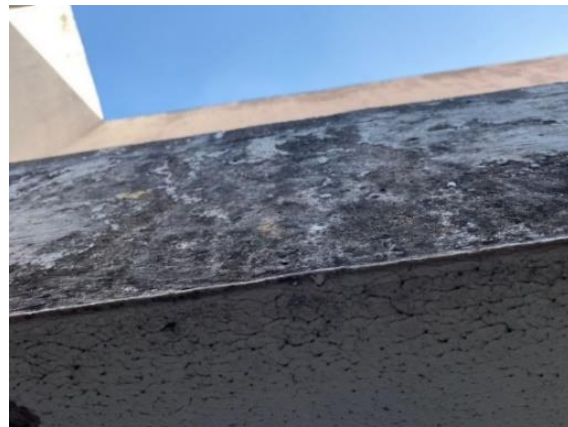
The absence of elements that allow the proper drainage of rainwater (such as roof gutters) favors corrosion in the area (Figure 16). The rainwater runs down the structural element and accumulates under it, in a shaded region, with slow evaporation and absorption through the pores of the concrete.

**Figure 16** – Absence of drainage elements

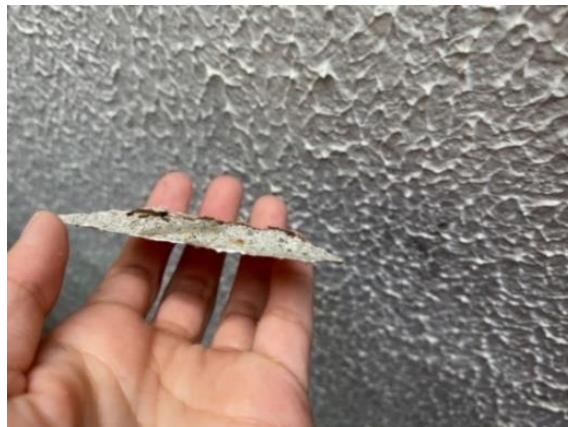
The process of reinforcement corrosion progresses from the concrete surface to the interior of the structural element. The concrete cover is a physical protection that prevents aggressive agents from coming into contact with the steel. Removing part of the beam cover made it possible to identify that this cover was insufficient (Figure 17).

**Figure 17** – Insufficient concrete cover
