## USG Method in the assessment of construction defects in foundations of wind turbines

**Abstract:** This paper proposes the use of the Urgency, Seriousness and Growth (USG) Method in the assessment of construction defects in foundations for wind turbines. To present how the method can be applied in the evaluation of defects in foundations for wind turbines, we critically analyzed filed data from the construction and inspection of foundations at an onshore wind farm in Brazil using the USG Method. Results demonstrate the importance of using the USG Method.

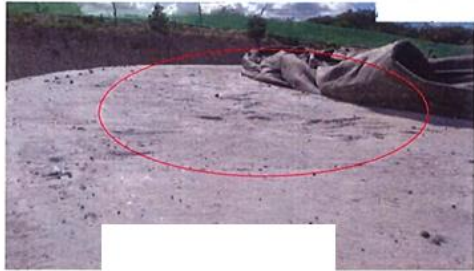
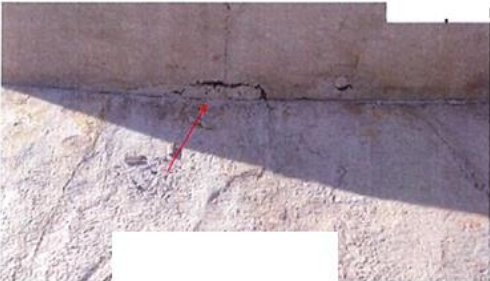
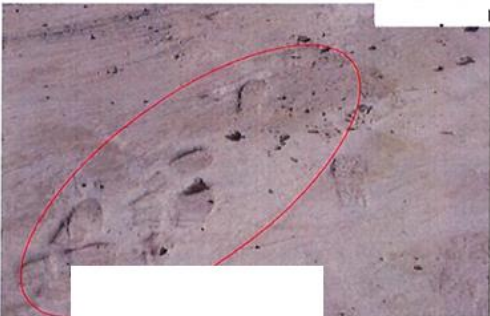
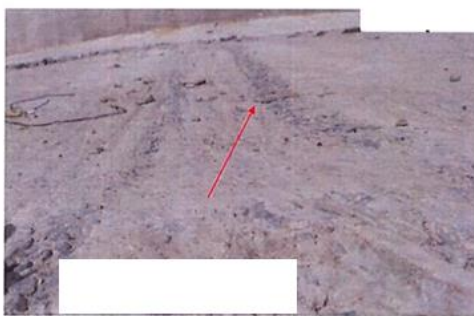
Defects had been catalogued previously in quality control inspection forms by construction company's workers. An example of inspection form defect presentation is shown in Figure 3.

**Figure 3** – Example of quality control inspection form.

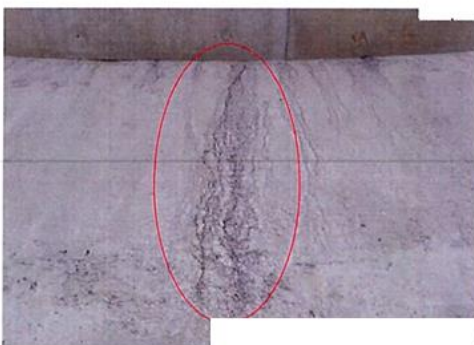
Photographs of all defects have also been analyzed in order to help classifying them according to the USG Method. Figure 4 presents an example of a crack at the base of one foundation.

**Figure 4** – Example of a crack at the base of a wind turbine foundation.

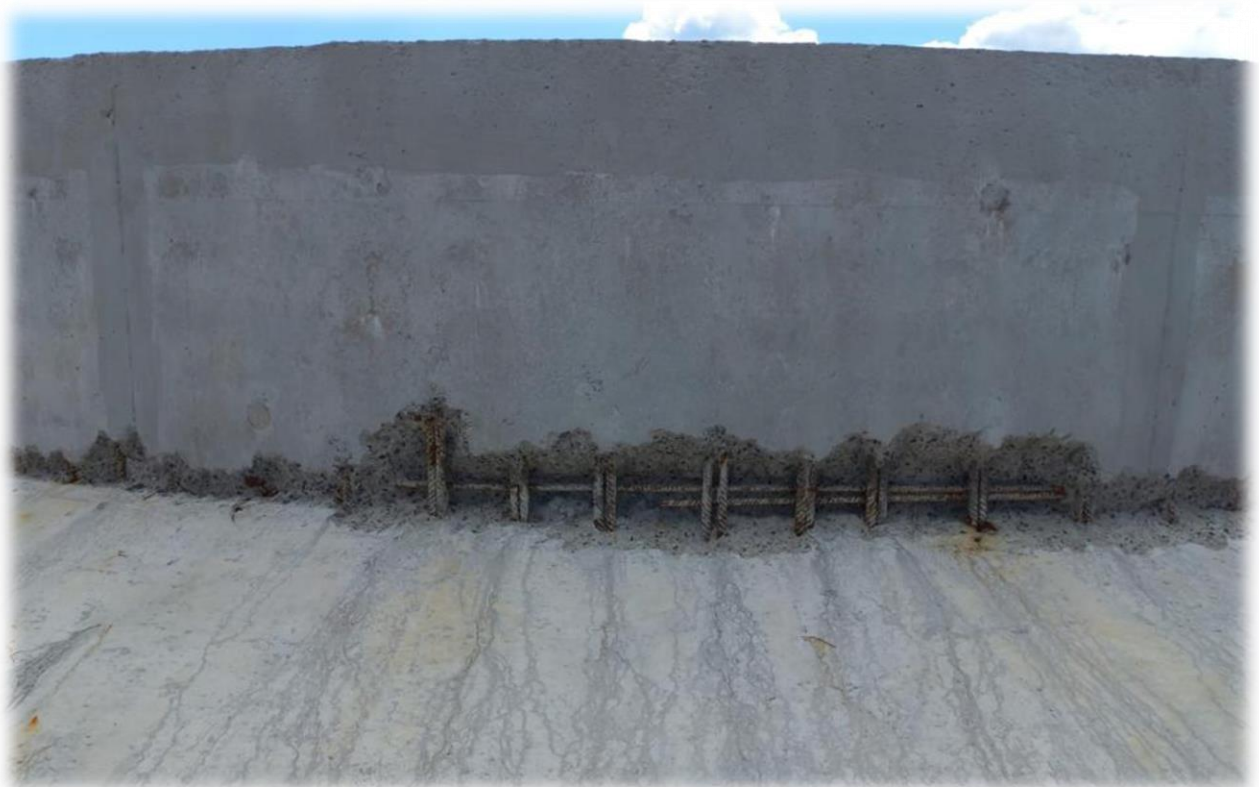
Figure 5 illustrates a honeycomb in a wind turbine foundation.

**Figure 5** – Example of honeycomb in a wind turbine foundation.

| Number | Nonconformitie description | Defect location | USG METHOD | | | |
|---|---|---|---|---|---|---|
| | Concrete honeycombs | Top | 4 | 3 | 3 | 36 |

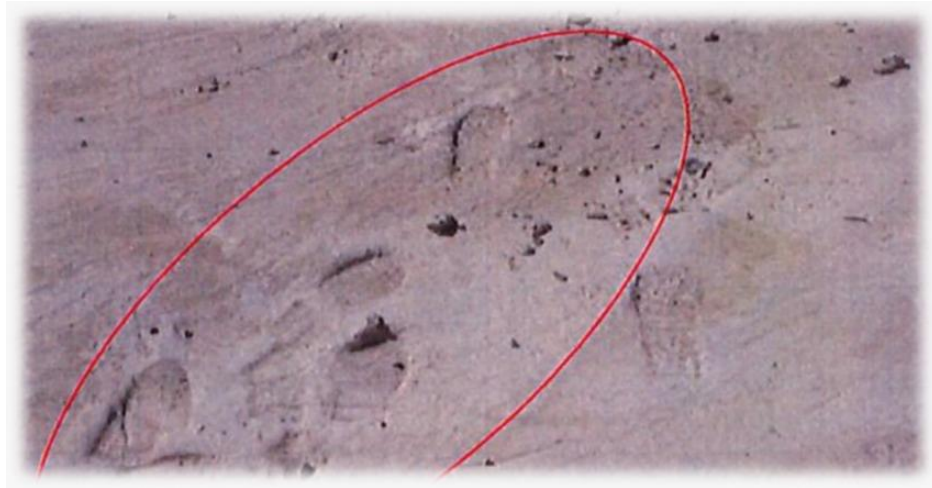
An example of footprint is shown in Figure 6.

**Figure 6** – Example of footprints at the base of a wind turbine foundation.

| Number | Nonconformitie description | Defect location | USG METHOD | | | |
|---|---|---|---|---|---|---|
| | Footprints | Base | 1 | 1 | 1 | 1 |

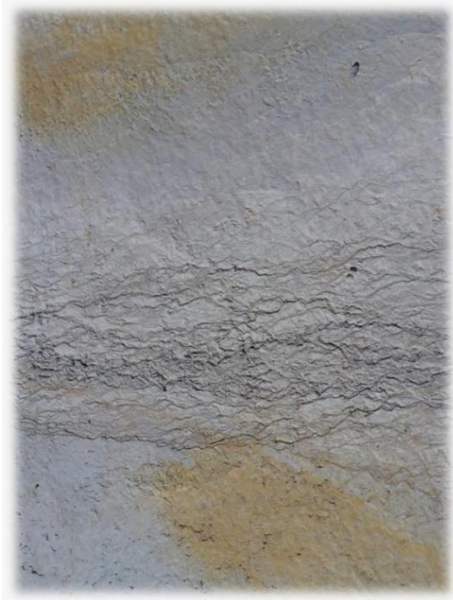
**Figure 7** – Example of concrete segregation in a wind turbine foundation.

| Number | Nonconformitie description | Defect location | USG METHOD | | | |
|---|---|---|---|---|---|---|
| | Concrete segregation | Base | 4 | 3 | 4 | 48 |

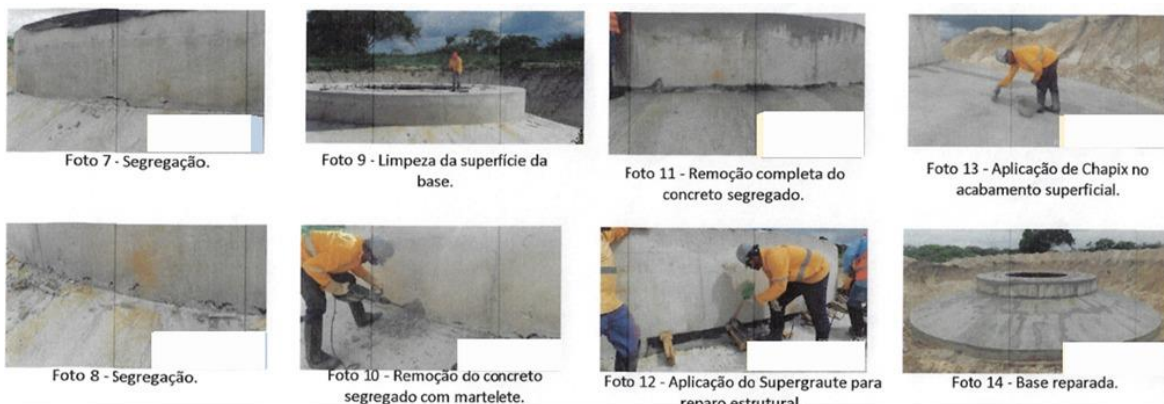
**Figure 8** – Repair action reported inspection form.
