## Structural Evaluation and Rehabilitation Proposal of an old building located in a Region of High Seismic Hazard

**Abstract:** In regions with high seismic vulnerability, there are many old buildings that could be damaged or collapse with a major seismic event. This is the case of a church built in Argentina in 1956, and to date, it has been subject to more than a dozen earthquakes of intensity VI or higher. This situation has not only led to the appearance of pathological manifestations in the building, which allow us to infer abnormal structural behaviour, but has also revealed the need for a comprehensive structural adaptation in accordance with the descriptions of current constructions standards. In this regard, the objective of this work is to show the evaluation methodology carried out for the aforementioned building, as well as the proposed structural intervention strategy in order to achieve its rehabilitation.

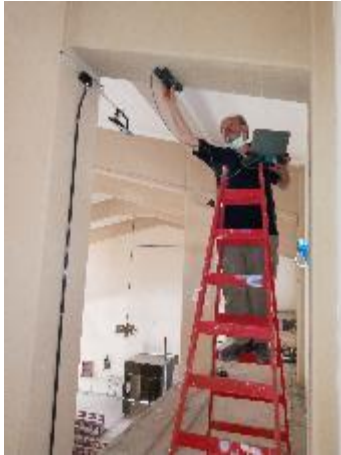
In order to establish the presence and location of reinforcements, they were detected using the electric flow measurement technique using the PROCEQ Profometer 650 AI device (Serial No. UP01-002-1738). Figure 8 shows the results of the procedure carried out. The results obtained were contrasted with the available structure documentation.

**Figura 8:** Reinforcement detection

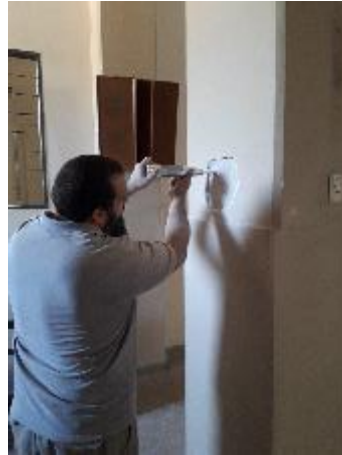
In order to infer the quality of the concrete, in terms of resistance to surface compression, a NDT technique was used. This technique consist on the interpretation of the rebound or sclerometric indices (IE) obtained on the tested concrete surface, Figure 9. The ELCOMETER 181 Type N equipment (Serial No. 16005120) with an impact energy of 2207 Nm was used according to the provisions of the IRAM 1694 Standard.

**Figura 9:** Sclerometry test

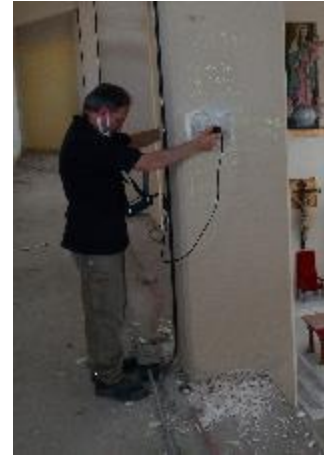
This NDT technique allows evaluating the homogeneity of the concrete, and with it, its quality, since the speed of the wave is dependent on the density of the concrete and the cavities and/or cracks present in it. The types of measurements carried out were direct, with the transducers on opposite sides of the material, Figure 10. It proceeds in accordance with the provisions of IRAM 1683 Standard. The PROCEQ Pundit PL-2 equipment (Version 200, N Serial No. UP01-001-0554) was used.

**Figura 10:** Ultrasound test
