XVIII CONGRESSO INTERNACIONAL SOBRE PATOLOGIA E REABILITAÇÃO DAS CONSTRUÇÕES

XVIII INTERNACIONAL CONFERENCE ON BUILDING PATHOLOGY AND CONSTRUCTIONS REPAIR

17 TO 19TH NOVEMBER 2022

## STRUCTURAL REINFORCEMENT IN METALLIC COVER DAMAGED BY CORROSION

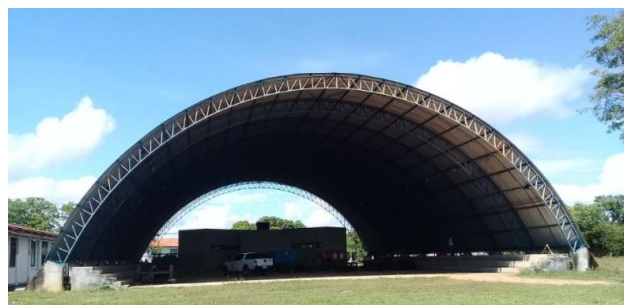
The roof structure has 10 flat arched metal trusses supported on reinforced concrete pillars by bolted base plates. It has a total width of 32.30 m and length of 48.78 m. It presents the following elements: Shears or Plane Trusses, purlins, braces, rigid chains and ties. The structure was not being used because it had already been damaged due to pathologies and because the project had not been completed. This study performed a field reconnaissance of the structure executed until the time of the research, identifying possible disparities between the designed structure and the one executed on site, mapped the pathologies already present, and proposed elements of structural reinforcement in an intervention project. Figure 1 below is a record of the structure executed in the first moment.

**Figure 1** - Sports Gymnasium Covering  
Source: Author (2020)

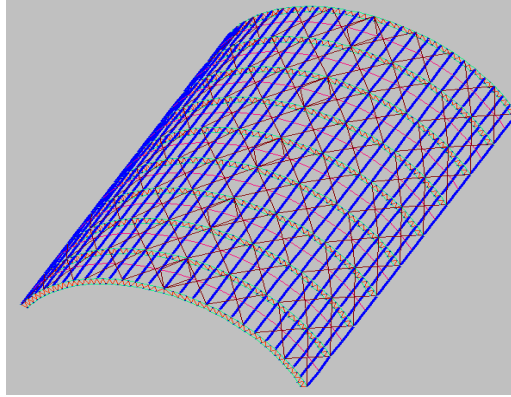
The modeling of the roof structure was done in CypeCad software. The roof was modeled on site according to the information collected during the visit, informing the proper steel characteristics, loads, combinations for the ultimate limit state and support conditions. The objective of the modeling was to perform a stability analysis of the roof. It should be noted here that the stability analysis performed considered the structure executed and inspected on site, since the design provisions were different from reality. Figure 3 below shows the modeling performed in CypeCad software.

**Figure 3** - Modeling of the executed roof seen from the right side  
Source: Author (2020)
