## Analysis of cracks in family houses buildings in the city of Erechim - RS

Mariana KROGEL<sup>1</sup>, Marinês LANGOSKI<sup>2</sup>, Rodrigo Gazolla FERRARESE<sup>3</sup>

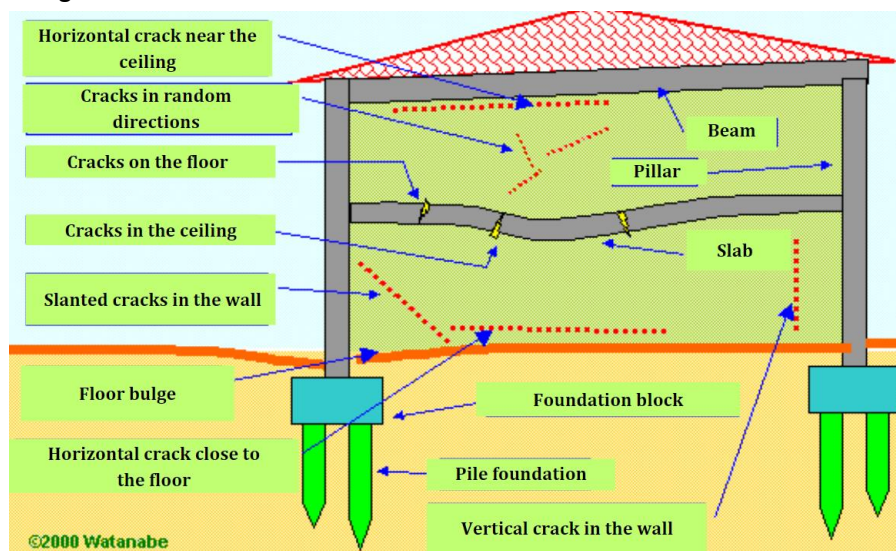
**Figure 1** – Possible fissures and cracks found in a residence. From: Watanabe.

The sooner the corrections are performed, the more durable, effective, easy to perform and cheaper they will be (HELENE, 1992; MILITITSKY et al., 2008). IBAPE (2014) points out that cracks are mainly observed in slabs, beams, pillars, floors, walls and coatings and have typical characteristics, as shown in Figure 1.

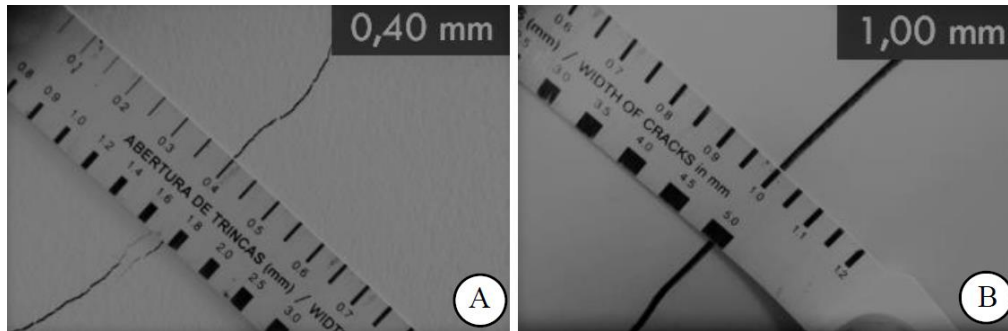
According to NBR 15575-2 (2013), structural components cannot present in their service limit state fissures with openings larger than the limits indicated in NBR 6118 (2014) and NBR 9062 (2017), that is, of the order of 0.4mm or 0.5mm, as shown in Figure 2A. Therefore, openings greater than or equal to 0.6mm will be considered a crack, as shown in Figure 2B, with no limit restriction, so the crack limit will be adopted as in the literature, in the order of 2mm or 3mm (THOMAZ, 2020).

**Figure 2** – (A) Fissures of 0,40 mm e (B) cracks of 1,00 mm. From: Nascimento and Cicuto (2019).

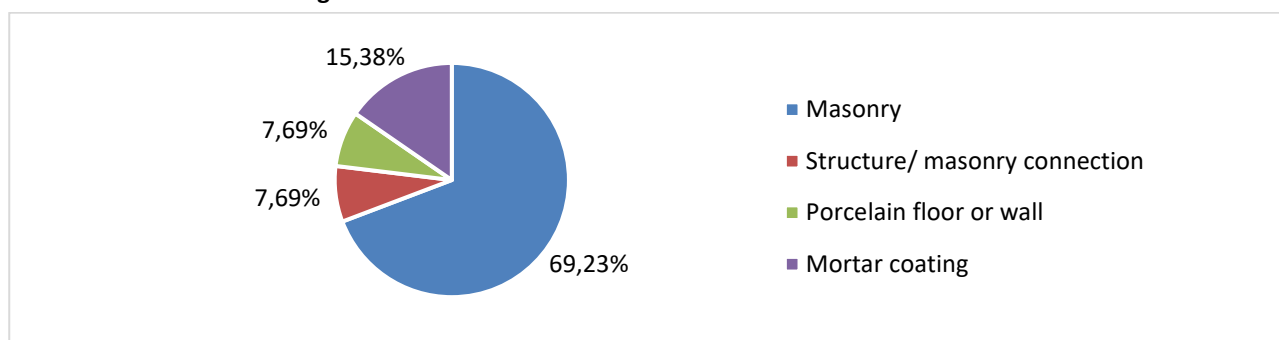
**Figure 13** – Incidence of crack variation in construction elements.

Cracks in the building elements were quantified, considering all residences, accounting for 9 cracks in sealing masonry, 1 in connection structure/sealing masonry, 1 in porcelain coating and 2 in rigid mortar coating. In total, 13 cracks were evaluated; Figure 13 shows the incidence of crack variation in construction elements.

As expected, the most affected building elements, with an incidence of 69.23%, are the sealing masonry, as it is a more fragile building element, in addition to the composition of ceramic blocks being susceptible to the appearance of pathological manifestations (NETO, 2022). As in the study carried out by Lourenço (2022), it was observed that the constructive system that presents the highest occurrence of cracks was in masonry with 50% of the total observed.
