## Damage maps of façades of a public university

Thus, the objective of the present work is to carry out the identification of the building defects present on the façades of Block D of POLI and to elaborate a map of damages, with the intention of contributing in the planning of maintenance and conservation of the façades of the structure.

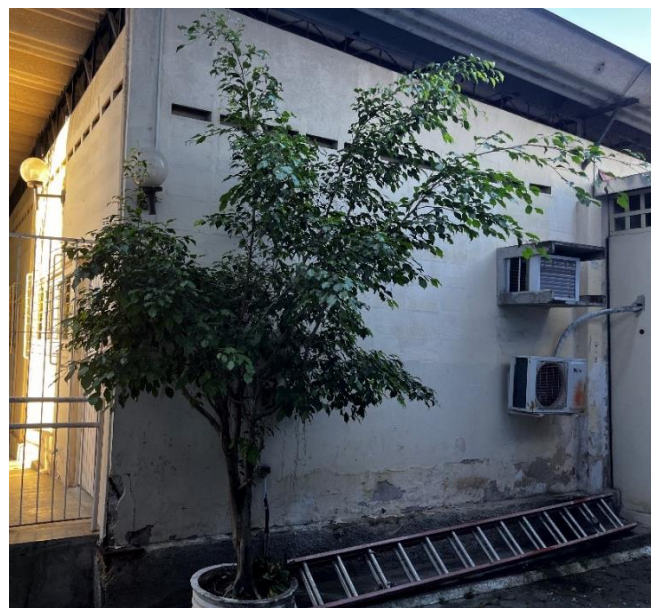
**Figure 13** – Right side façade

On the right side façade, as shown in Figure 13, it is possible to see only the part of the concrete pillar as, right after, there is a small entrance that is also part of Block D. During the inspection, it was not possible to remove the objects present in front of the façade for a better photo, however, this did not hinder the identification of the present problems.

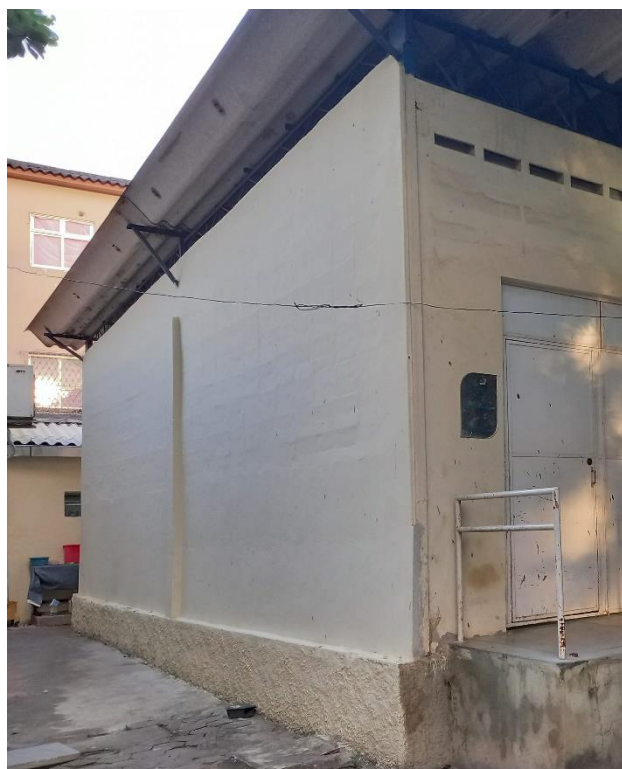
**Figure 19** – Left side façade

The left side façade, as shown in Figure 19, is in better condition than the other façades.
